Case Study on Fracture Treatment in Dam Foundation

Er. Sharad Goel¹, Prof. Priyanka Patil²

ABSTRACT: This case study presents Investigation, Structural Analysis and further Treatment of a fracture encountered in the foundation of a dam. The concrete gravity dam in subject is 38m high above deepest foundation level. This dam is approx. 400m long with 21 number blocks with 15 NOF blocks. In the geological mapping of the dam foundation, shear crack/ fracture (suspected fault) of thickness 10-30 cm reported to be stretching in 5 blocks. Based on field investigations and FEM modelling treatment was proposed and executed.

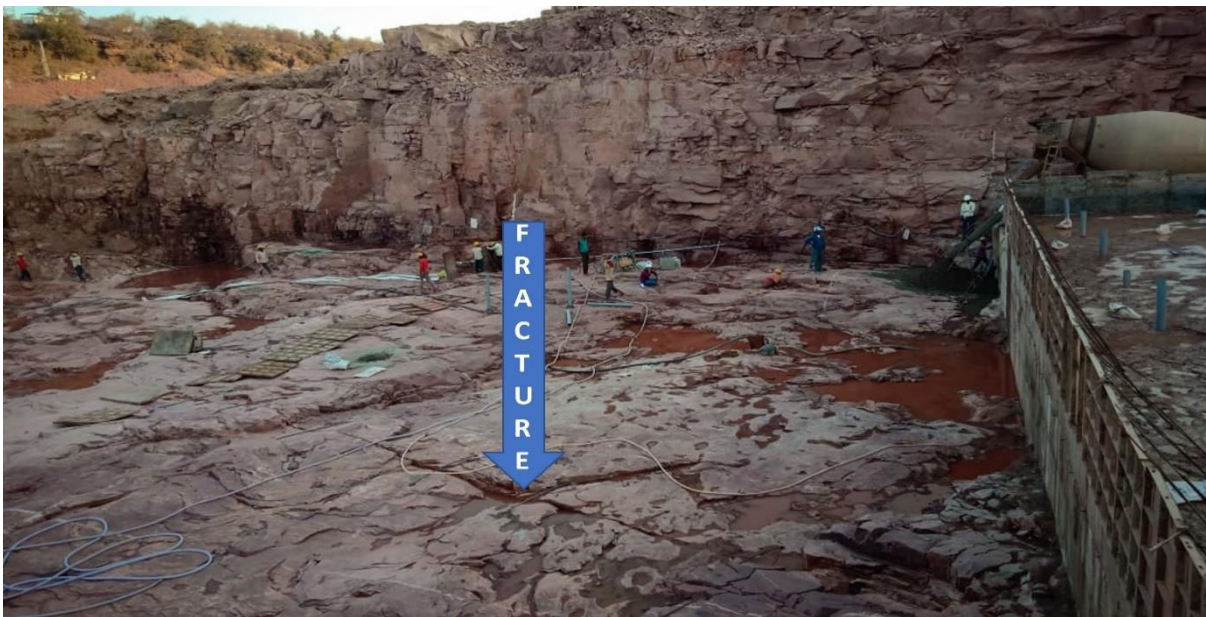
Figure 3: Fracture/ Shear Crack in Dam foundation

The geological mapping of all the dam block foundation was carried out and recorded the geological features including discontinuity patterns. In the geological mapping of the dam foundation, shear crack/ fracture (suspected fault) of thickness 10-30 cm reported to be stretching in 5 blocks. This crack was trending N75°W to S75°E direction with sub-vertical dip and crossing upstream to downstream of the dam. It was interpreted that the rock blocks on either side of the crack plane can move in any direction, so it was recommended to treat this zone with necessary treatment before taking up the concreting.

The crack in the foundation was trending in N75°W to S75°E direction with sub-vertical dip. A 10-30cm crushed rock material along with fractured rock fragments was present within this crack plane. A 5-7 cm crushed gouge (yellow color silt and sand material along with fractured rock pieces) was present within this plane.

No visible vertical displacement is observed in the vertical scarp faces however minor shearing & crushing along the crack zone were observed at places. As per opinion of the geologist, the fault in the absence of any visible displacement may not be considered as Active Fault (Slemmons and McKinney, 1977)^[1] and is most likely to be a shear zone along the axial plane joints.

Based on investigations and analysis, the concrete dam was recommended to be safe over the fracture after adopting the remedial measures. A suitable designed raft of 3m width over the fracture was recommended to cater the stresses of the fault/ fracture zone.

- Grouting in the fracture zone to ensure permeability less than 2 Lugeon.
- Dental treatment after grouting by removing the material in a trapezoidal shape of 2.6m (w) x 0.5m (d) with side slope 1:1.
- Placement of anti-shrink concrete with reinforcement T25 Φ @ 200 c/c at top & bottom + 6L - T16 Φ @ 200 c/c.
- Contact grouting after concreting.

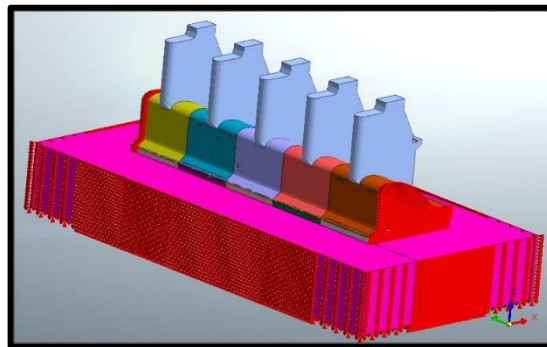
Figure 5: Diagram showing FEM model of dam blocks

FEM analysis of dam blocks was carried out in MIDAS FEA software by creating a 3D finite element model. Induced stresses in terms of major principal stresses in bottom face of dam mass concrete was considered to evaluate the suitability of proposed reinforcement. Based on FEM analysis, negligible tensile stresses found to be induced in the founding level of dam blocks, hence no reinforcement was required.
