To Arrive At Solution for Root Step Problem Occurring During Shaving Operation of Gear Manufacturing Process Using Root Cause Analysis

Raveen John¹, Dr. Y. S. Varadarajan², Paul Pereira³

International Journal of Innovative Research in Science, Engineering and Technology

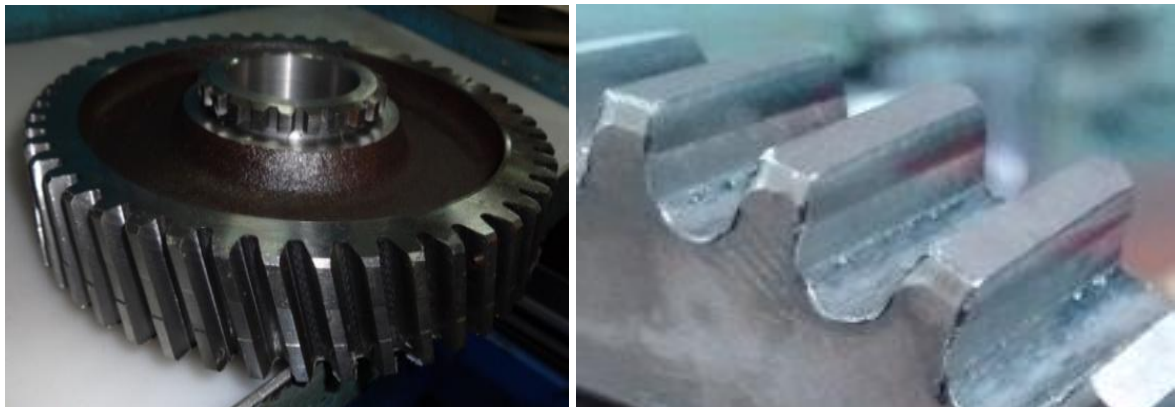
The present work focuses on solving Root step problem occurring near root fillet or near to start of active profile during shaving operation. The main objective is to arrive at authentic solution for the root step problem encountered during Shaving Process, also meeting quality, cost and delivery criterion. Figure 1 shows gear having root step problem.

Figure 1: Gear having root step problem

Initial hob protuberance provided to hob teeth was 0.05mm-0.063mm. This was increased to 0.090mm-0.11mm. When this modified hob was used, the required undercut was generated during hobbing operation and this eliminated the root step problem which was getting generated during shaving operation

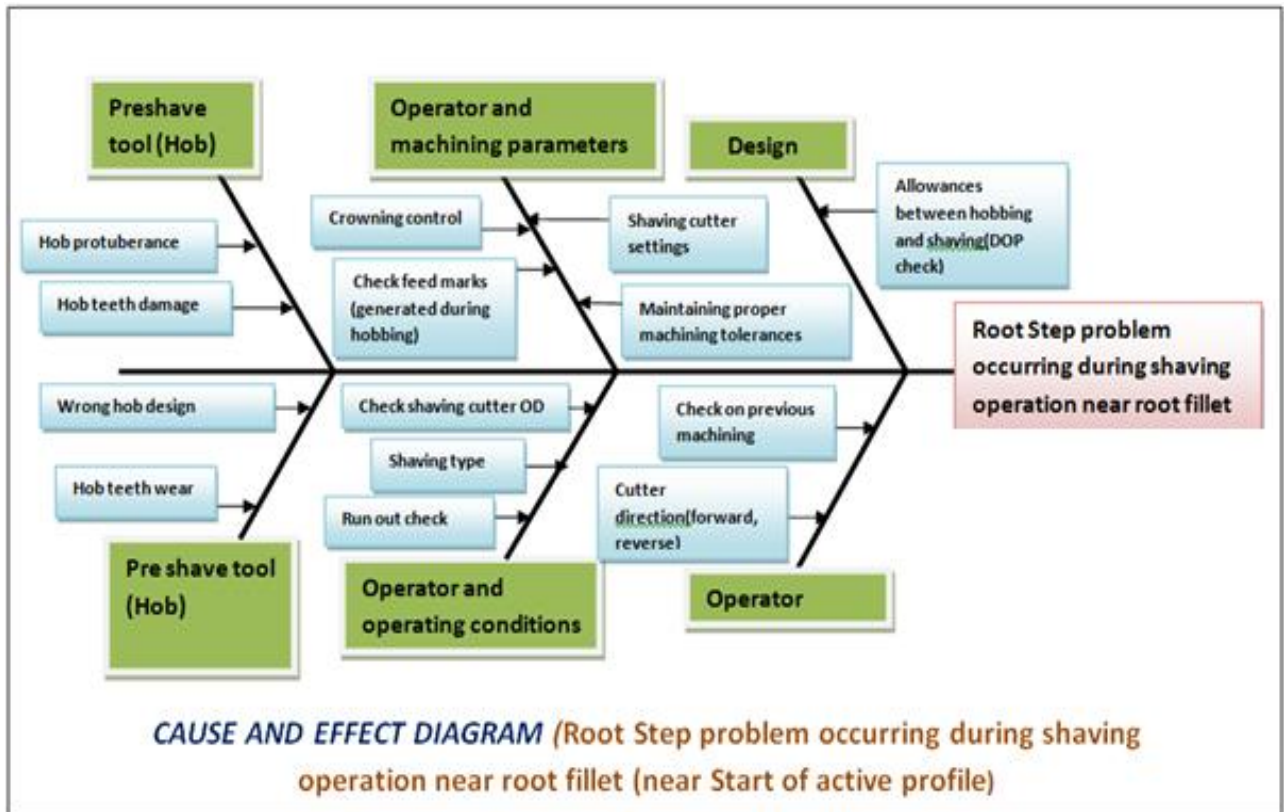
Figure 2: Cause and Effect Diagram for Root Step problem occurring during shaving process.

Using Cause and Effect diagram, causes and their effects were understood and based on the same experimentations were carried out so as to eliminate the problem. Combination of DMAIC and PDCA were used in order to solve this problem. Figure 2 explains the Cause and Effect Diagram framed in order to find out the cause for root step occurrence.

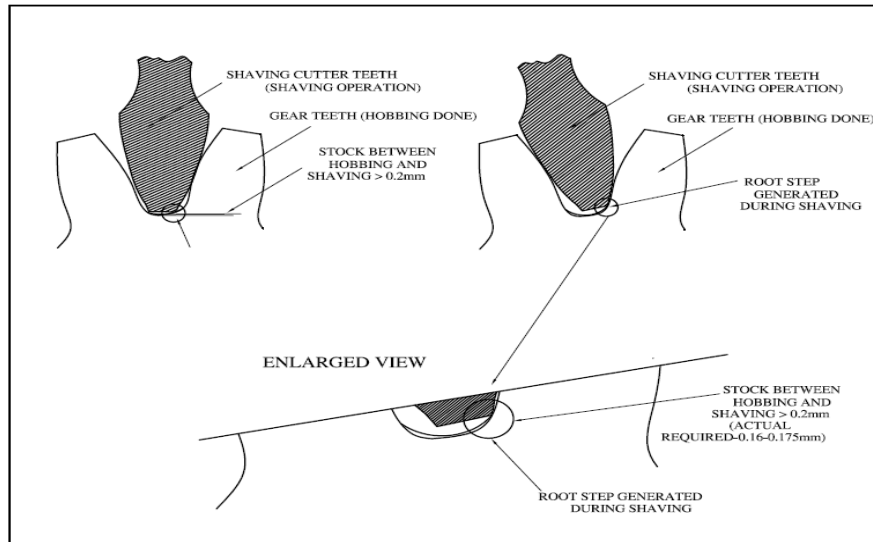
DOP stock/ allowances between Hobbing and shaving was checked for deviations. If higher allowances exist, then root step gets generated. When inspected, it was found that the dimensions between hobbing and shaving were as per specifications i.e. no higher allowances were found between hobbing and shaving operations.

Figure 3: Root Step getting generated

Figure 3 explains pictorially root step getting generated if higher allowances exists between hobbing and shaving operations.

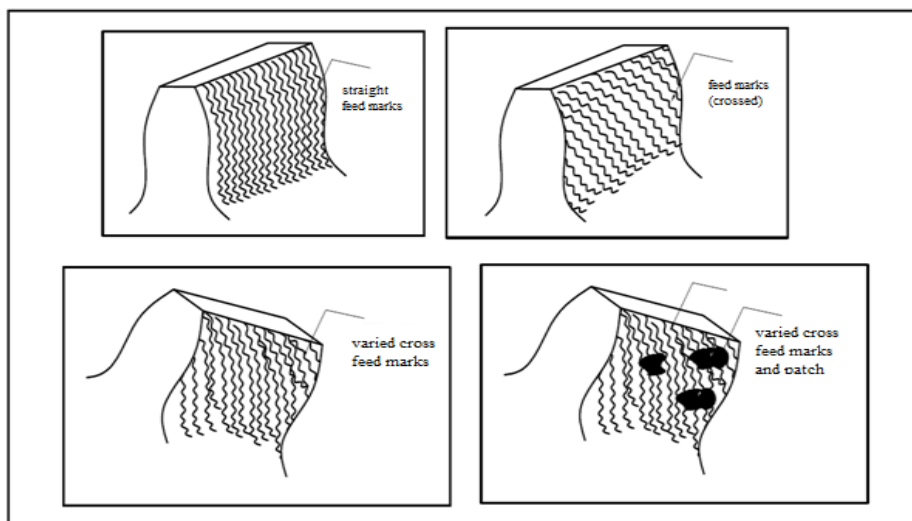
Uneven feed marks generated during hobbing can lead to generation of root step during shaving operation. Hence detailed visual inspection was carried out to check whether crossed feed marks, uneven feed marks, uneven feed marks with patches were formed during hobbing operation. But no such feed marks were noticed. This indicated that the root step problem was not because of wrong feed marks generated on the flanks of gear teeth. Figure 4a) and 4 b) portrays the types of feed marks and also the actual feed marks attained on the gear teeth flank.

Figures 4 a): in clockwise- Feed mark variations formed on gear flank after hobbing operation
1) Straight feed marks 2)Crossed feed marks 3)Uneven feed marks and 4)Uneven feed marks with patches

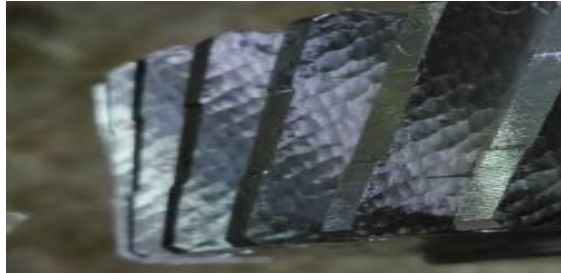
Figure 4 b): Actual feed marks attained on gear flank after hobbing operation

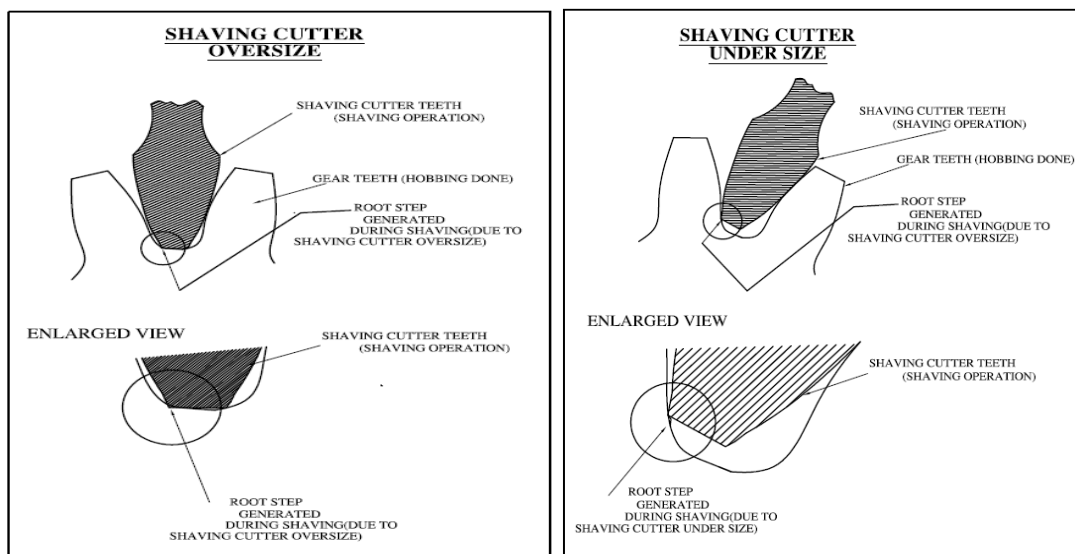
Shaving Cutter OD was checked using Coordinate Measuring Machine (CMM) and found that the cutter diameter is accurate i.e. shaving cutter OD was neither undersize nor oversize in its dimensions and thus no problems with the cutter diameter. Shaving Cutter accuracy plays a very important role during shaving operation.

Figure 5: Shaving Cutter OD-oversize and undersize effects

If shaving cutter OD is oversize, then there are greater chances that the cutter hits the centre and end areas of gear teeth's root fillet and if shaving cutter is undersize, there are high chances that shaving cutter hits the area near to the start or at the start of root fillet area. Figure 5 explains the consequences of shaving cutter oversize and undersize.

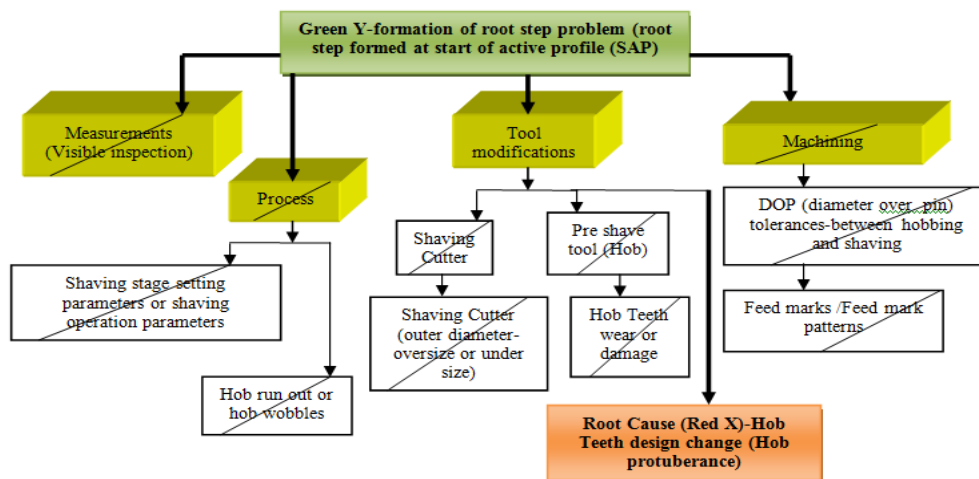
RCA-SHAININ METHODOLOGY (for Root Step Problem)

Figure 6: Shainin Tree Diagram for Root Step Problem

In the depicted Shainin Solution/ Tree Diagrams, the “Green Y” or problem statement for the problem encountered is Root Step formation and this problem has to be eliminated before the part is processed for next processing phases.

In order to find “Red X-Root Cause” for the problem encountered, investigations and experiments have been carried out at various phases of work gear’s processing and the correct phases, processes, experiments are eliminated in order to arrive or identify the root cause of problem. After elimination of correct processes, phases, experiments which are not causing problems, the anticipation of problem’s root cause converges and focuses to a problem causing area.

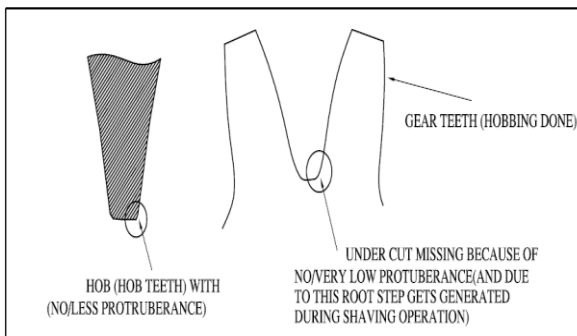
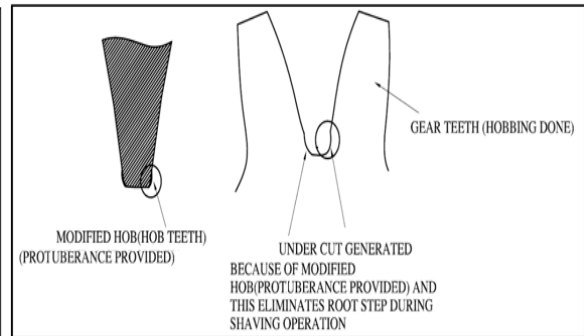
Figures 7 a) and 7 b), explain the undercut missing when low/less protuberance was used and undercut getting generated after hob modification (i.e. when increased hob protuberance is used).

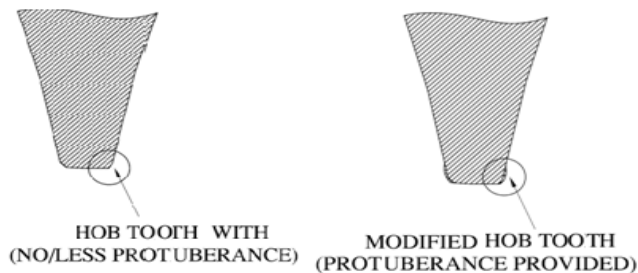
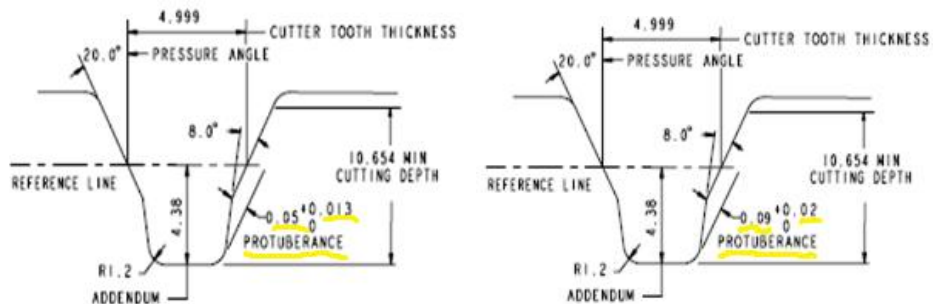
Figure 8) a) and 8 b): Hob teeth before and after modification.

The figures 8 a) b) and 9 a) b) show an example of hob teeth with less protuberance and hob teeth with required/increased protuberance.

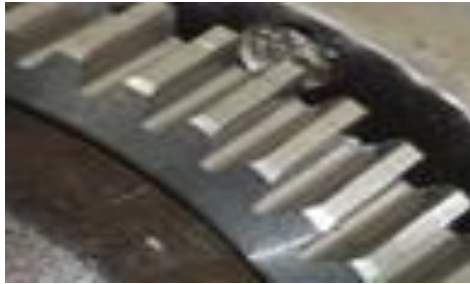
Figure 10 shows root step eliminated after shaving operation when modified hob was used during hobbing operation.

Figure 10: Root step eliminated after shaving operation

Root Step occurring at the entrance of root fillet area was eliminated as the increased hob protuberance generated the extra required undercut, because of which the shaving cutter could pass between the hobbled teeth of gear without hitting the shoulder of root fillet area. Hence clean shaving operation was performed without the shaving cutter brushing the start of active profile area. Root step, most of the times, is checked by visual inspection, using a pin to feel the ridge/root step formed. When modified hob was used, the root step that was occurring during shaving operation was no more evident.
