Scrap Loss Reduction using Root Cause Analysis

The main aim of this research study is to make use of root cause analysis technique to find out the factors influencing Single Hole offset defect in Schmolli drilling machine, correlating it with the equipment to find its involvement, and preparing a check list which needs to be followed to subsequently reduce scrap production.

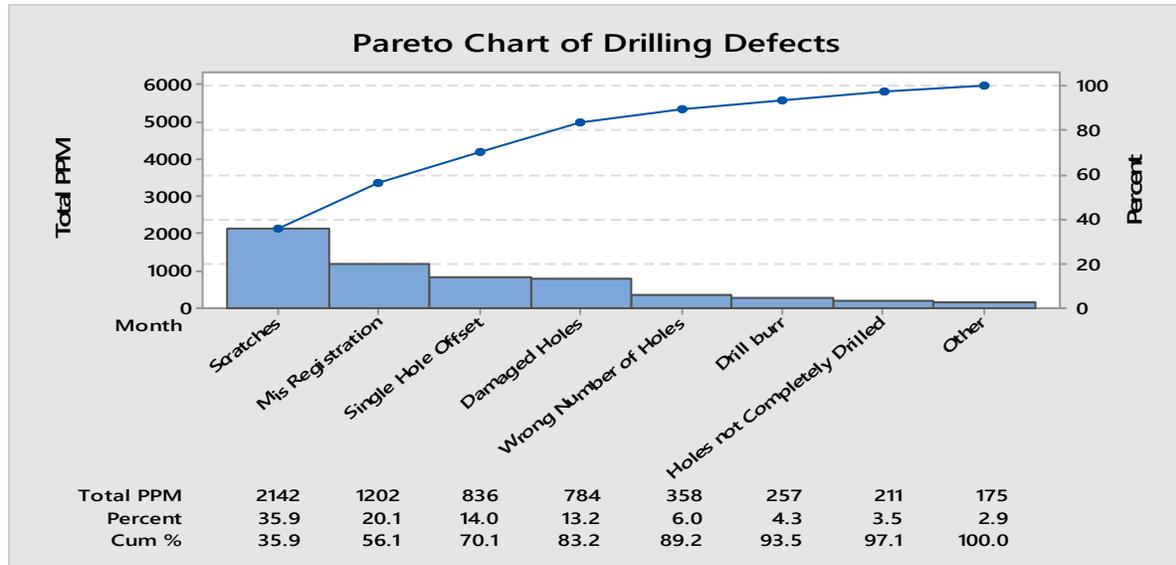
Fig1: Common defects observed in drilling of PCB

The trend shows various defects which may occur during drilling process. Among these scratches, mis registration and single hole offset contributes maximum to scrap production. Scratches are mainly due to improper handling of the PCBs without gloves and mis-registration of hole occurs when there is a minute error in the program or improper mounting of panel in the drill bed. The causes of these two defects are well known and it can be minimized by following proper guidelines and proper handling. But single hole offset is that kind of a defect which don't have a root cause, neither don't show any proper trend how they occur and it cannot be reworked.

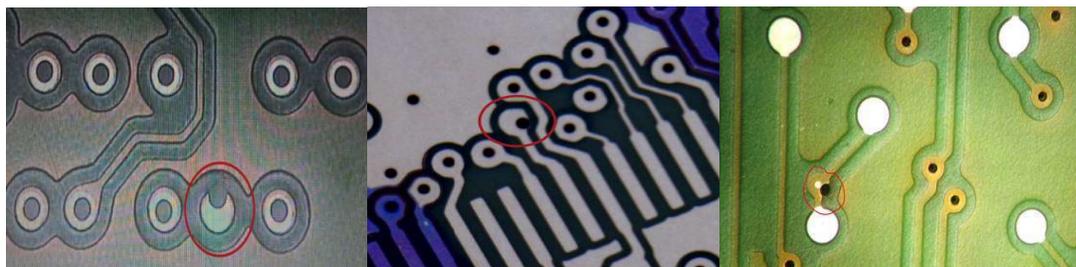
Fig2: Shifting of hole outside the annular ring

The designated area where the holes need to be drilled is called annular ring. As you can see in the fig, only one hole has been shifted outside the annular ring thus causing single hole offset.

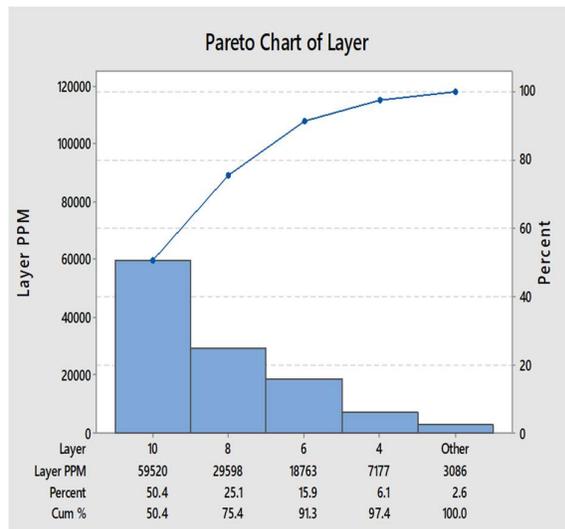
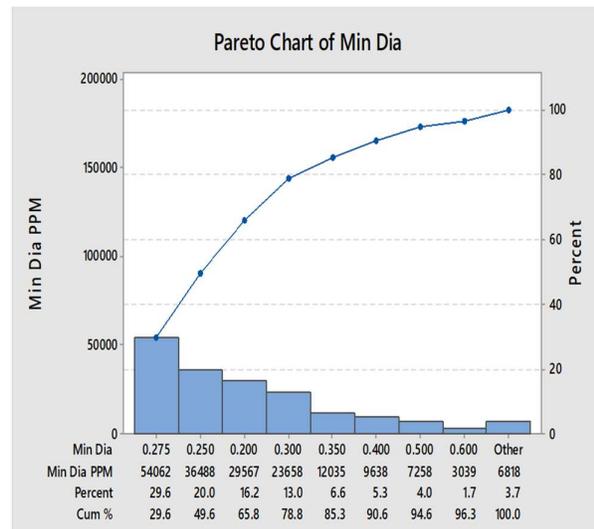
Fig4: Single hole offset vs layers and hole diameter

Fig4 shows two graphs which were plotted between different layers of PCB vs percentage of single hole offset and diameter of holes vs percentage of single hole offset.

Higher layers tend to have higher chances of single hole offset.

8 layers and 10 layers contributes around 75% single hole offset.

Lower diameter holes tend to have higher chances of single hole offset.

Lower diameter upto 0.3mm contributes around 78% single hole offset.

From both the above graphs we can conclude that lower diameter holes which are drilled in higher layers tends to have higher chances of single hole offset.

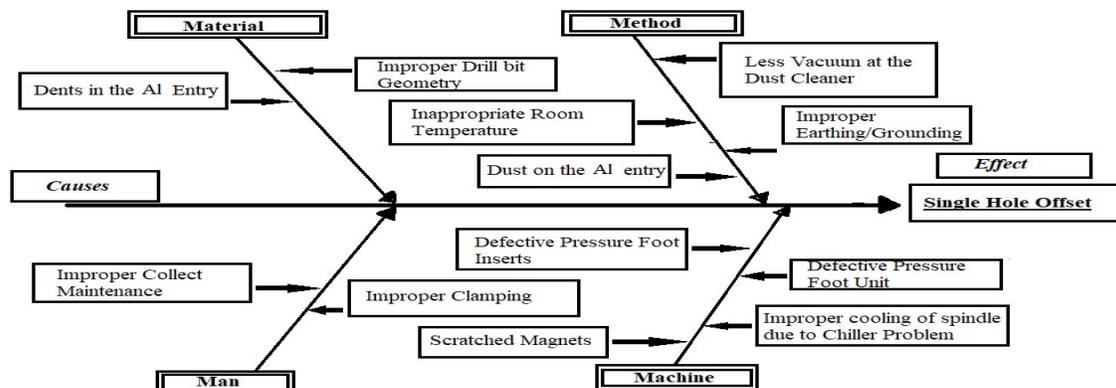
As shown in Fig5 all the potential causes for the occurrence of single hole offset are listed. Around 12 causes were identified and the probable causes were classified in to four categories.

Fig5: Probable causes for single hole offset

Cause	Effect	Correction
Defective collet	When the collet is defective, it is impossible to hold the workpiece in a fixed position which further results in shifting of holes.	Regular collet maintenance
Damaged pressure foot units	Damaged pressure foots will lead to vibration of the spindle during drilling leading to Drill bit deflection which will result in the single hole offset defect	Check for pressure foot defect units frequently
Damaged Pressure Foot inserts	The Damaged IPF will give poor support to the spindle collet leading to deflection of the drill bit which will result in Single hole offset defect	Ensure drill bit inserts are not broken, worn out or damaged.
Less vacuum in dust cleaner	The dust from drilled laminates needs to be sucked, if left untouched they cause accuracy issues which lead to single hole offset.	The vacume level must be > 50cm of water
Improper Cooling of spindles due to Chiller Problem	The spindles will be operating at high Rpm, chilled water helps to maintain the expansion and contraction of spindle rotor.	Chilled water must be supplied at 20 ⁰ c(±2 ⁰ c) and flow rate > 50liter/min

Scratched magnets	Linear and servo motors travels on the magnet. Scratched magnet hinders their movement. Magnets can be scratched from dust laminates or broken drill bits. So its important not to use scratched magnets	Check for the scratches in the magnet
Inappropriate room temperature	The panels are made of copper, so there are possibilities of expansion and contraction	Maintain the room temperature at 22 ⁰ c(±2 ⁰ c)which is ideal for copper
Earthing/ grounding	Static accumulation of charge causes fluctuation in DC volts where the encoder and scale will be affected and inturn the precision and accuracy gets impacted which results in single hole offset	Proper earthing/grounding need to be maintained and monitered every month

To ensure that all the corrections made during the study is properly followed, a check list has been designed. A check list is a fool proof tool to minimize the defect.

All the required parameters of the causes is listed in the check list along with their specification The frequency with which the parameters need to be checked is also stated.

Any operator within the drilling department at the beginning of their respective shifts should check whether the parameters are matching the specification mentioned in the check list based on the frequency

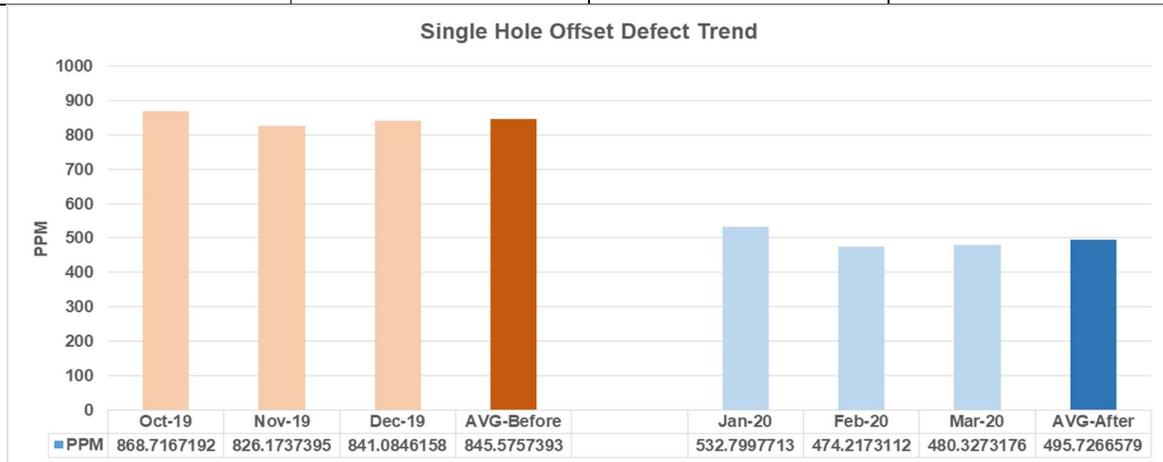
The check list was followed over a period of 3 months and the result is very much evident as shown in Fig6. Single hole offset from an average of 846 PPM has been reduced significantly by 350PPM to 496PPM. By following the checklist, occurrence of single hole offset has been condensed by more than 41%.

Fig6: Reduction of single hole offset
