Underwater Inspection of Upstream Face of Dam Surface, Using Remote Operated Vehicle

Birendra Pratap¹, Hari Dev²

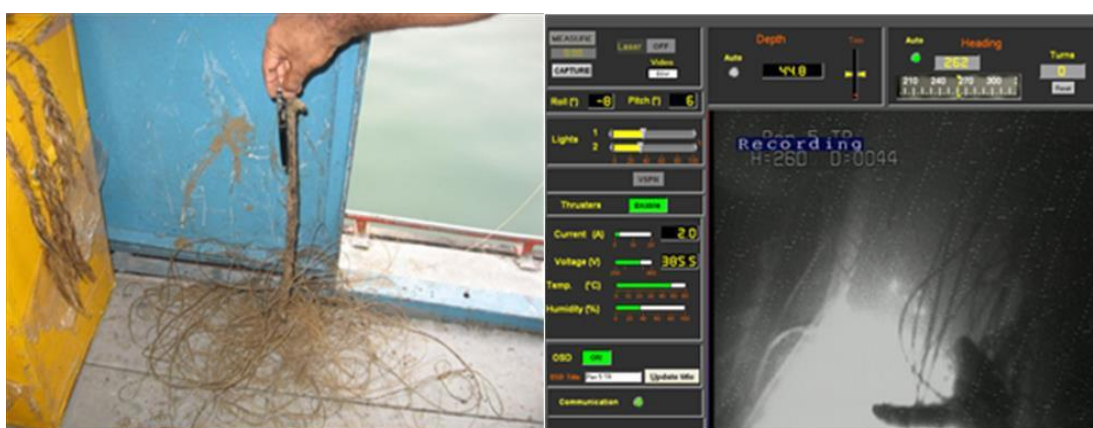
Generally, the concrete surfaces of the dams are intact at all the depths. Signs of any major deterioration/ defect could not be seen at any locations. Dam block joints, trash racks for river outlets and trash racks of penstocks were inspected using ROV. Underwater inspection was done up to a maximum depth of 81 m from the reservoir level at river outlets (R/o) 5, 6, 13 and 14. During the inspection of river outlet trash racks, a fishing string along with wooden stick and silt got trapped inside one of the thrusters of the ROV as shown in Fig. 4. Similarly, a fishing string was seen mingled with the trash rack bars of penstock 5 at a depth of 44 m in recorded video image Fig. 5.

Fig. 4. Fishing string along with wooden stick Fig. 5. Fishing string intermingled with trash rack bars of Penstock 5.

10.	Trash Rack for Pen-Stock No.5	55	1581.5	Second time ROV deployed at the same position and trash racks seen from a depth of 37 m to downwards. At a depth of 42-47 m fishing net was struck inside the ROV. A bunch of fishing net can be seen in the video Fig. 5.

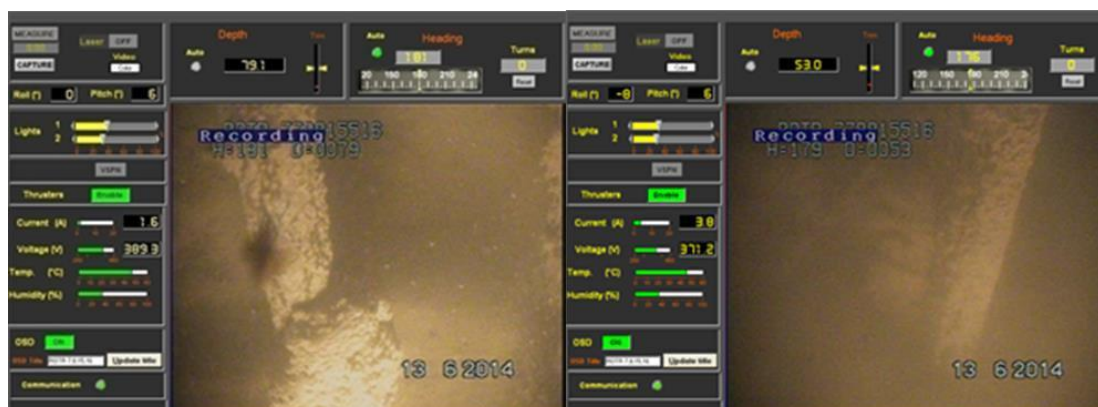
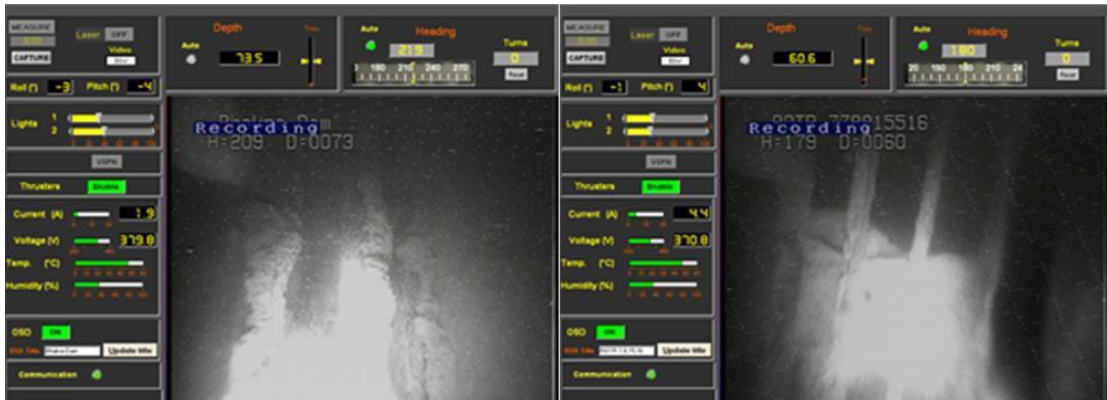
Thick layer of silt deposited was seen on the trash rack bars of the river outlets particularly those at lower elevation. It means the lower river outlets have not been operated since long time. Deposited silt gets detached from the bars, as the ROV strikes these bars. Scanning of trash racks of river outlets was possible up to a depth of 81 m due to poor visibility conditions as well as deposition of silt. Thick layers of silt deposition on the steel bars can be seen in Fig. 6. Suspended silt particles may also be seen, these suspended silt particles lead to visibility problems during underwater scanning work. Fig. 7 shows the condition of bars after partial removal of silt. The condition of penstock steel bars may be seen in Fig. 8. Lesser amount of silt was noticed in penstock trash racks bars as compared to river outlets.

Trash rack of river outlet at 79 m depth Trash rack of river outlets at 53 m depth

Trash rack of river outlet at 73 m depth Trash rack of river outlets at 60 m depth

Fig. 6: Silt deposition in trash racks of river outlets.

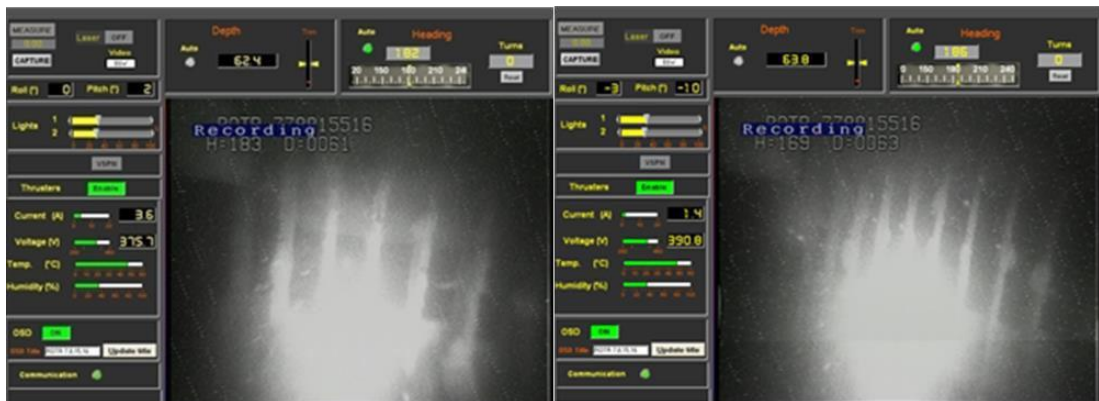
Fig. 7. Steel bars of river outlet trash racks after partial removal of silt.

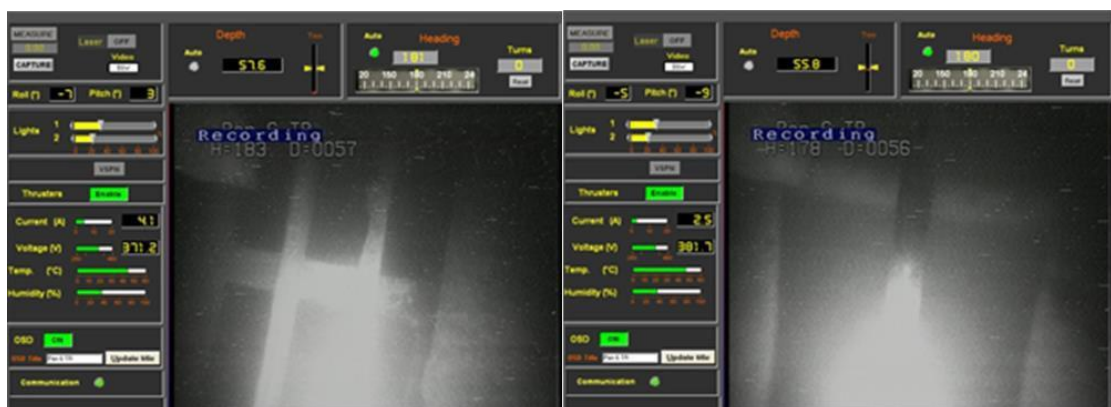
Fig. 8. Steel bars of penstock trash racks.
