Volume 11, Issue 6, June 2022

# Distress Assessment of a jetty after *Tauktae*-2021

Ms. Sayyad Tabssum Rafik<sup>1</sup>, Dr. M.B. kumthekar<sup>2</sup>

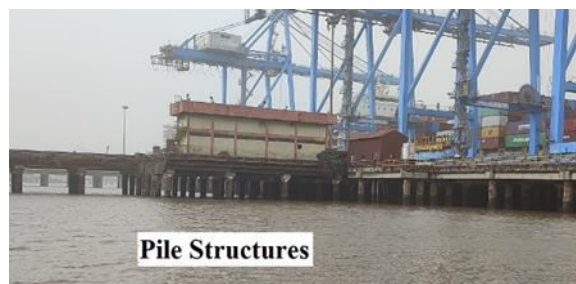
Fig 1.1 A Typical Pile Structure

India witnessed cyclone *tauuktae* in 2021 to its Arabian Sea coastal area and especially extreme severe in Gujarat and Maharashtra Region. The concerned jetty being located in Gujrat got extremely damaged (fig 1.1). It was a 1500 m X 300 m jetty with approach trestles. It had a triangular section (shown in fig 1.2). Due to highly turbulent wind waves it got collapsed causing serious damage to the un-collapsed structure. But due to vibration transfer along with the cyclonic air structure has been partially collapsed and partially intact with visible damages and cracks shown in figures below.

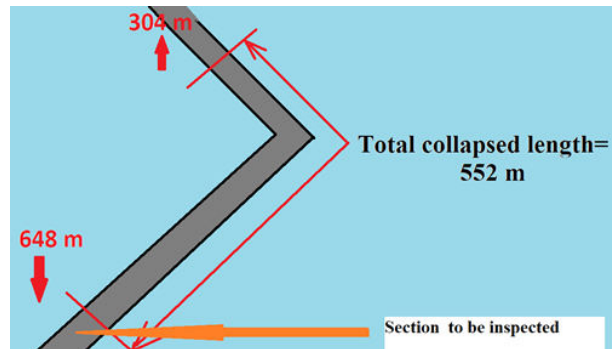
**Fig 1.2 Line diagram showing position of jetty**

The structure under reference consist of one main jetty structure and an approach trestles and existing deck on cluster of RCC piles, pile muffs and beams. The total length of berth used to be 1500 m long but now a length of 648 m is left. The section of jetty consist cross section consist of 375 mm thick reinforced slab (250 mm precast, 150mm cast-in-situ and 75mm overlay) resting on 1500 mm deep primary beams.

Supporting the primary beams are secondary beams 1.00m x 1.00m in cross section. The total width of jetty is 45m including 1.5m width of service area. The piles are spaced 5.40 m along the length of jetty and 5.00m along the width of wharf area. The beams rest on pile muffs 1.50m x 1.50m which are supported by piles of 750mm diameter.

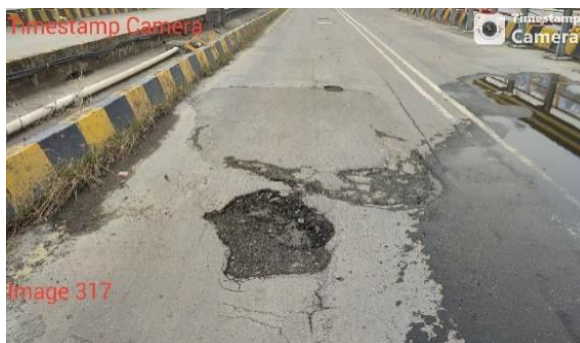
Following shows damages to the structures, which includes damages to pavement on jetty and approach trestles as shown in fig 1.3. Poor patchwork has been shown on several locations.

**Fig 1.3 Damaged pavements**

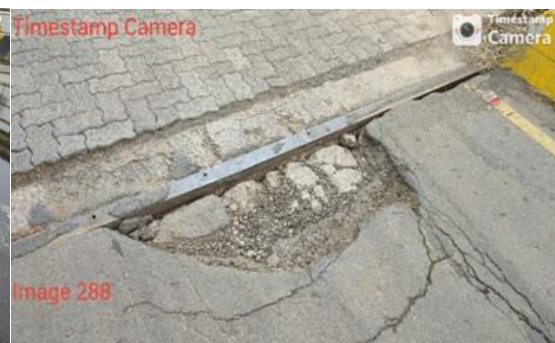
**Fig 1.4 Damaged expansion joint**

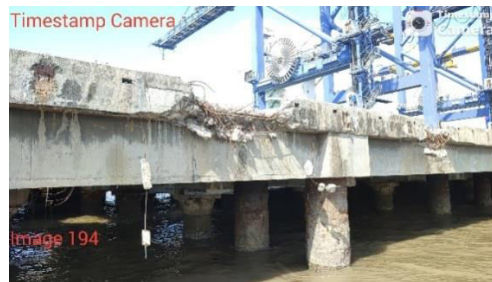
**Fig 1.5 Damaged side walk**

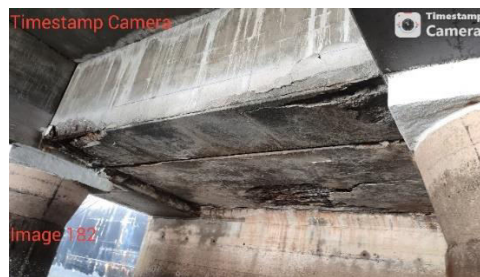
Small pores may lead to severe cracks and corrosion of the steel in the concrete as water percolates through. Which in turn provides better environment to the corrosion of steel. It is evidenced from site that there may be presence of percolating water up to the steel which is corroding steel resulting in increase in volume of steel and causing bulging of concrete in fig 1.6.

**Fig 1.6 Bulging of concrete**

1. Identifying and classifying the pieces according to the need for repairs. Distress maps are being prepared for the same.
2. Using sharp chisels or high frequency low impact hammers, prepare the rough surface by breaking/chipping off the loose delaminated concrete without injuring the existing concrete.
3. Using appropriate methods to remove corrosion from the steel, adding anti-rust coatings, and rebaring it with existing steel.
4. Determine the best technique of repair, such as grouting, guniting, or micro-concreting, based on the circumstances and the amount of formwork necessary.
5. Install sacrificial anodes at regular intervals to slow down corrosion.
6. Paint the completed surface with anti-carbonation or water resistant paints in layers.

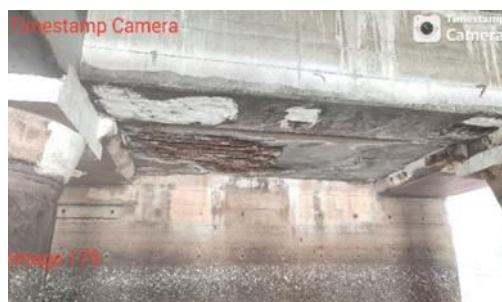
Sudden jerks, accidents, impact by water vehicles are also responsible for damages in the structures along with sudden and turbulent wind waves which breaks the piles or births which disturbs the stability and intactibility of the strcutre resulting in infunctionality of the strucutre. (Fig 1.7). Photograph shows the same kind of damages.

**Fig 1.7 Spalling of cover-Crete**

Due to bulging of concrete, weakens the cover to the reinforcement and spalling simultaneously (fig 1.7) which exposes the reinforcement to the saline environment which further speeds up the rate of corrosion. Exposure of the reinforced was also seen on the field as shown in fig 1.8.

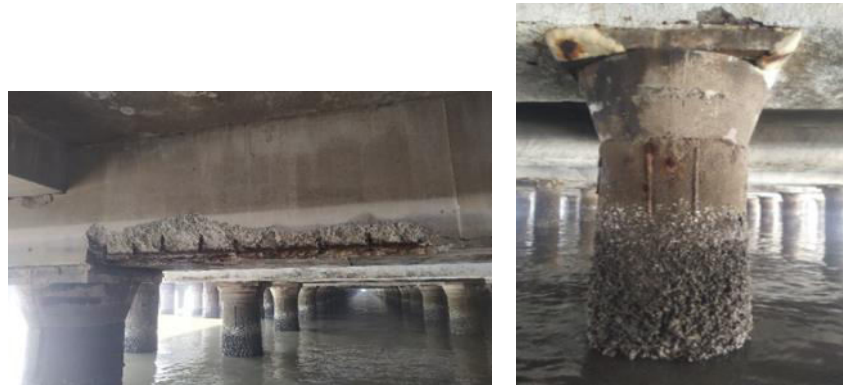
Fig 1.8 Exposure of steel 1.9 Corrosion on piles
