The Collapse World Trade Center Building 7

Auysh Dubey, Ankur More, Ganesh Yewale , Prof. Shivkumar Hallale

Department of Civil Engineering, Dr. D. Y. Patil Institute of Engineering Management and Research, Akurdi,
Pune, India

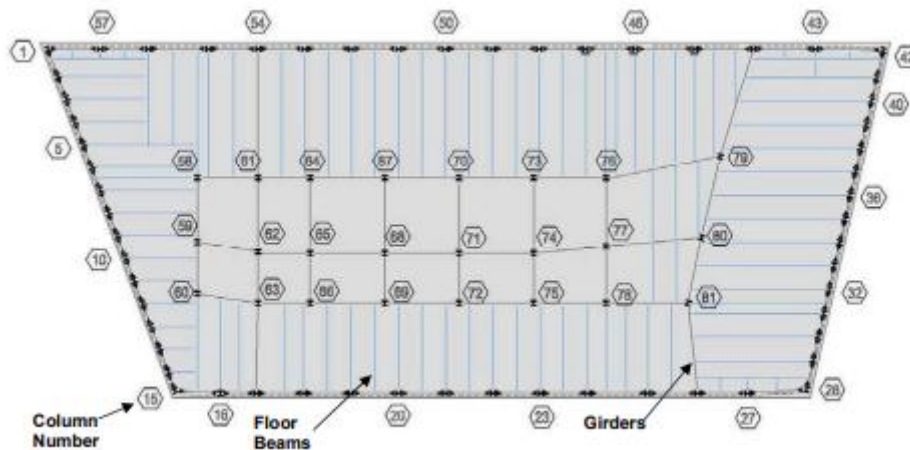
Fig. Showing Columns , girders and beams

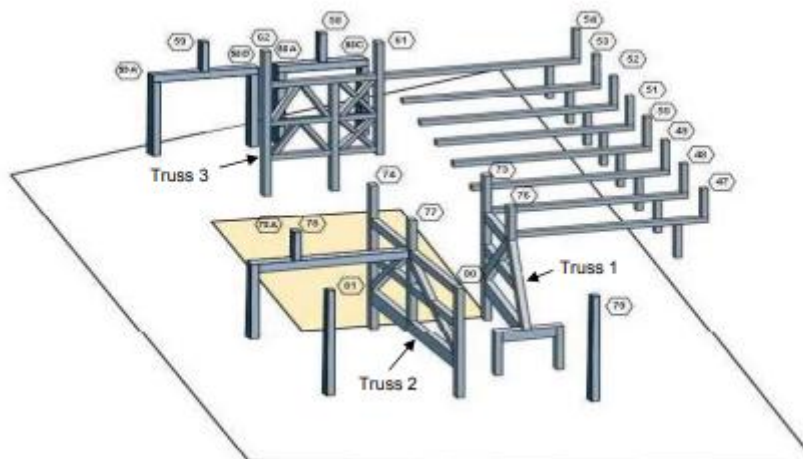
Fig.3D schematic view of transfer trusses and girders between Floors 5 and 7.
