# Assessing Quality in Machine Foundation Using UPV Measurements

Rajesh K. Morchhale<sup>1</sup>, Sanghratna S. Waghmare<sup>2</sup>, Tanvir Arfin<sup>3</sup>

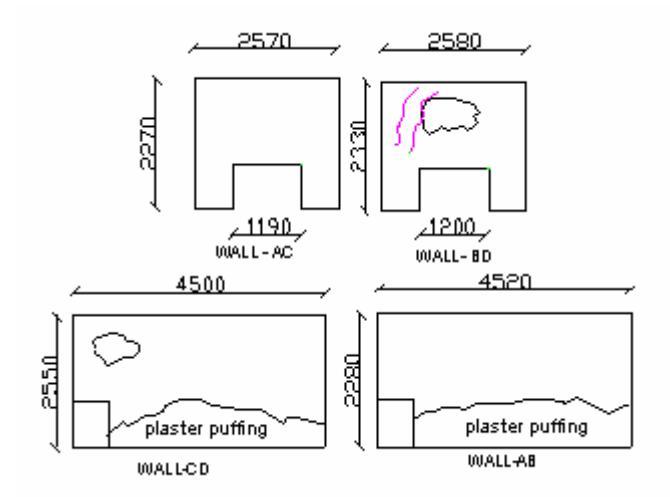
Figure 2: Elevation of foundation wall - ABCD

Figures 2 and 3 shows the elevation of foundation walls ABCD and IJKL respectively having internal chambers of size  $4.52 \times 2.58 \times 2.28$  m in height with undulated flooring. The internal dimension of the walls is not found in uniform in size due to deterioration of wall plaster and inferior workmanship.

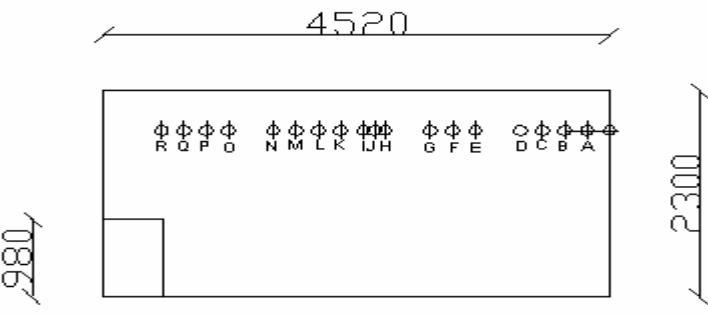
Figure 5: Transducers arrangement in wall – LK

The arrangement of transducers for the UPV test on the foundation wall 'LK' and 'IK' are as shown in Figures 5 & 6. The UPV test was conducted at 18 and 11 different locations in wall 'LK' and 'IK' respectively. The position of the transducer and receiver are placed directly to each other.

The UPV test results for walls LK and IK are shown in Tables 2 & 3.Some UPV results on wall IK were not measured due to severe honeycombing.

Table 2: Ultrasonic data of wall - LK (By Direct transmission Technique)

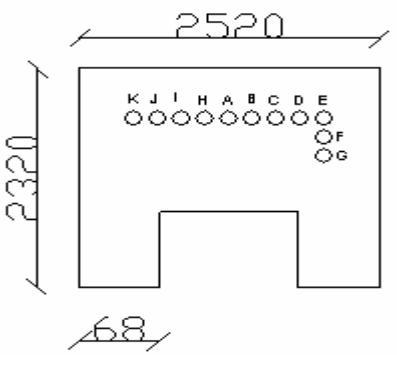
Figure 6: Transducers arrangement in wall - IK

Table 3: Ultrasonic data of wall - IK (By Direct transmission Technique)

\* Unable to link due to severe honeycombing

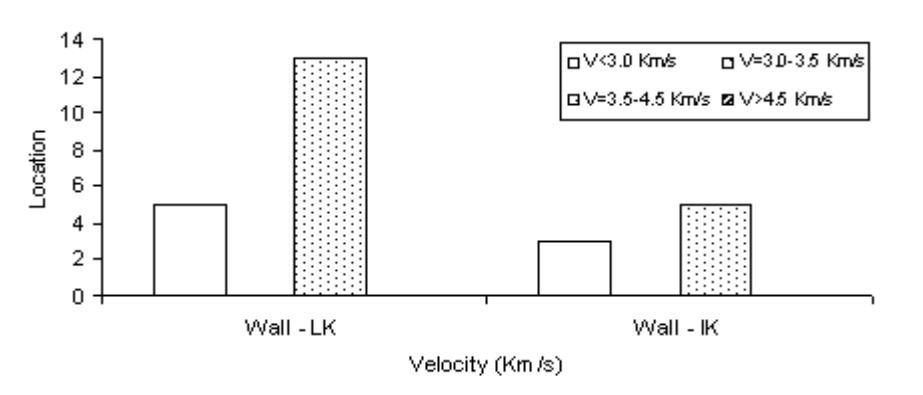
Figure 7: Histogram on UPV values of Machine foundation

The statistical parameters, for example, the number of readings, minimum velocity, maximum velocity, mean velocity, standard deviation and characteristic velocity corresponding to 90 percent confidence limit were calculated ( $V_{ck} = Mean-1.64 \times SD$ ) given in Table 4. From Table 4, the UPV values of machine foundation were found in the ranges of 1.90 - 4.5 Km/s. It was further noticed that the UPV values at some foundation bolt locations as well as at poor ringing sound zones come out to be in the range of 1.90 - 2.56 km/sec (i.e. At points A, I, J, M and N of wall LK as well as points C, E and F of wall IK) which implies that the quality of concrete is poor in those places, which is also verified by drilling hole of 25 mm diameter in a concrete and observed that the drilling was made very comfortably without any resistance which shows that the quality of concrete is poor as well as having honeycombing at particular locations.

The histogram of UPV values of machine foundation and its pulse criteria is shown in Figures 7 and 8. This study revealed that strength of machine foundation can be regained by adopting some minor strength recommendation suggested for improvement in its strength.

Based on overall investigations, the following recommendations were suggested to renovate the existing machine foundation of 40MVA MG set to regain its strength.

- Removal of plaster from entire walls.
- Cleaning of entire walls with alkaline solution.
- Proper arrangement for collection of spill over oil in foundation.
- Epoxy pressure grouting particularly at foundation bolt location 600X600 mm area and grouting nozzle should be inserted 150 mm c/c after drilling about 450 mm hole of 16mm diameter from both faces. Epoxy materials used for structural repairs should conform to ASTM C881 Type-VI.The repairs of cracks should be done as per procedure recommended by the American Concrete Institute Committee reports ACI 224.1R-93 [8].
- If there are no financial constraints, epoxy pressure grouting could be made at 200mm spacing on entire walls.
- Re-plastering of entire walls and floor with 1:3 cement mortar after grouting.

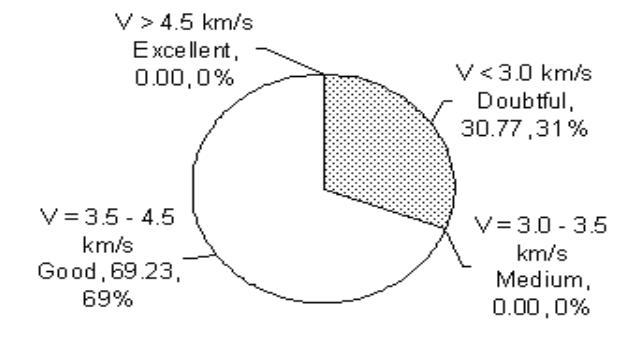
Figure 8: Pulse criteria of Machine foundation

The status of pulse criteria is given in Table 5, as per this table the overall percentage of doubtful and good quality of concrete were 30.77 % and 69.23% respectively.
