Accident Analysis of Anandapuram to Anakapalli Stretch via SH-38

ABSTRACT: Accidents are not normal but they are caused is a common cliché in the area of traffic safety. Thus, if accidents are caused by some, surely the ones responsible for could be identified and appropriate remedial measures developed and implemented to the extent feasible. Analysis of previous data indicates that 67% of the accidents occur due to human error and 32% due to road parameters such as road network of 3.3 million km consisting of National Highway (NH), State Highway (SH), Major District Roads (MDR) and Other District Roads (ODR). This paper lays emphasis on accident studies on the 49.4km long stretch via State Highway-38 section between Anandapuram and Anakapalli, in the state of Andhra Pradesh. The accident data for the last five years was collected from the concerned police stations and analyzed thereafter.

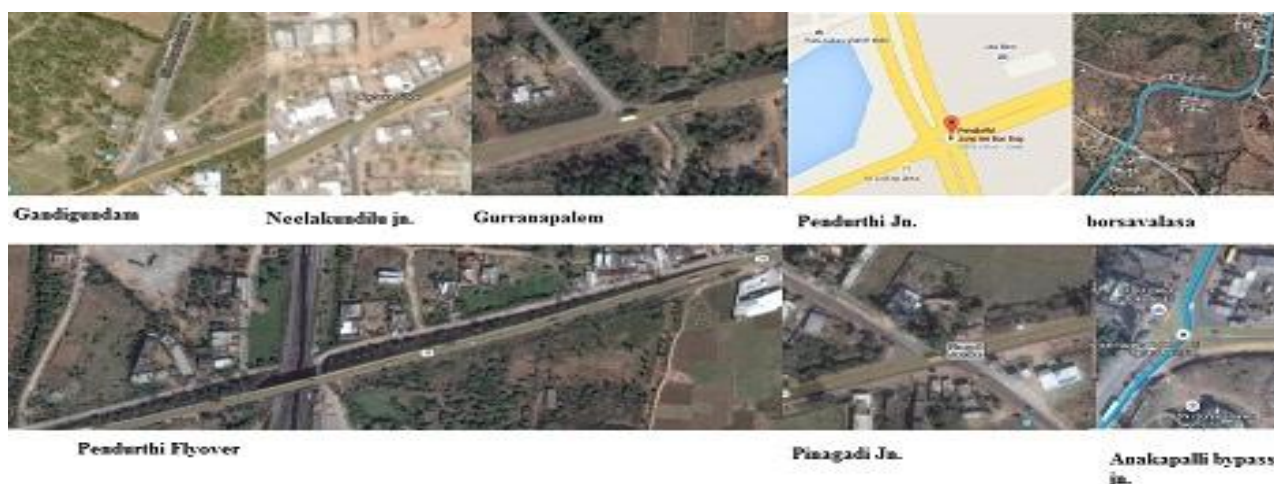
A. Black spot regions in the stretch

The below exposed photo snaps of the areas were the places where a minimum of 2-3 accidents take place in a span of 7 days. some are of non-fatal.

In order to improve the safety and ensure smooth flow of traffic, it has been suggested to construct service road on both sides of the State Highway-38, side drains along the road for free flow of water during rainy times. As illumination was one of the greatest factor for cause of accidents during night time, minimum requirements of illumination should be provided for free flow of traffic. Further, it is suggested for provision of improved junction geometrics, sign boards and high mast to improve illumination during night.
