Response of Seismically Detailed RC BEAM-Column Joints Strengthened With FRP

International Journal of Innovative Research in Science, Engineering and Technology

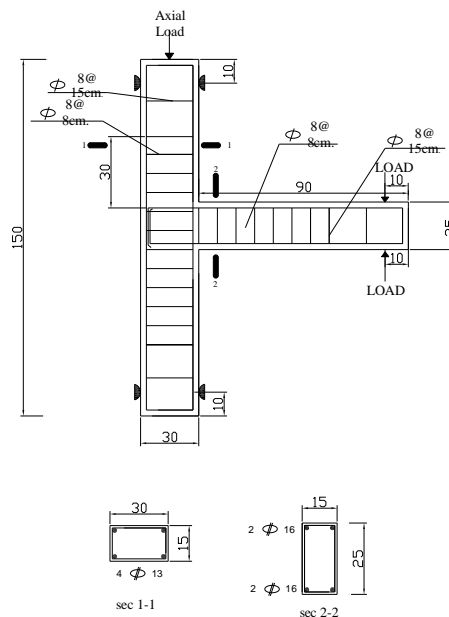
The experimental program included testing of five typical space exterior RC beam-column joints as shown in Fig. (1). The shown subassembly represented a beam-column joint between the mid height of two successive stories at the inflection points.

Also the reinforcement details of the tested specimens are shown in Fig. (1). the details of specimens' reinforcement were according to Egyptian code [12]. The longitudinal reinforcement ratio for beams was about 0.8%. While the ratio of longitudinal reinforcement for columns was about 1.2%. The compressive strength of the used concrete was about 30 N/mm². The steel used was grade 52 deformed bars for longitudinal reinforcement and grade 37 normal mild bars for stirrups which spaced at 80mm. Two specimens were retrofitted by using (GFRP) and another two specimens were retrofitted by (CFRP) using two different techniques, and the fifth was a control specimen. And then they had been cracked under cyclic loading, as will be explained later.

Fig. 1: Details of test specimens

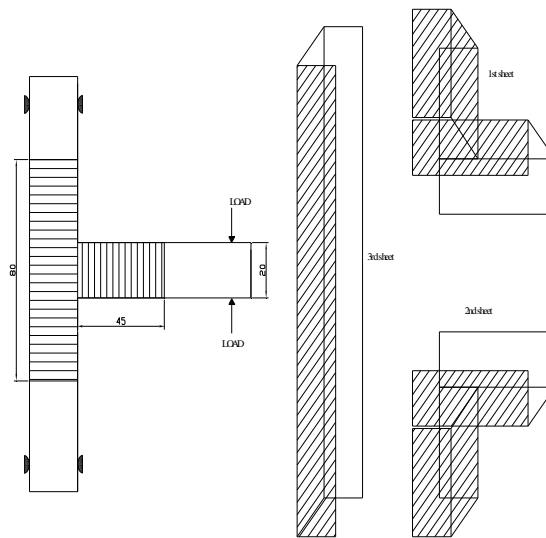
Second and third Specimen: The second specimen was wrapped with one layer of (GFRP). Three sheets of (GFRP) were placed as longitudinal reinforcement. The first one was placed on the top corner of the beam and the column. The second one was placed on the bottom corner of the beam and the column and the third one was placed on the column back. The third one wrapped as the same technique of the second specimen by using (CFRP), as shown in Fig. (2).

Fig. 2 : Details of the second and third specimens

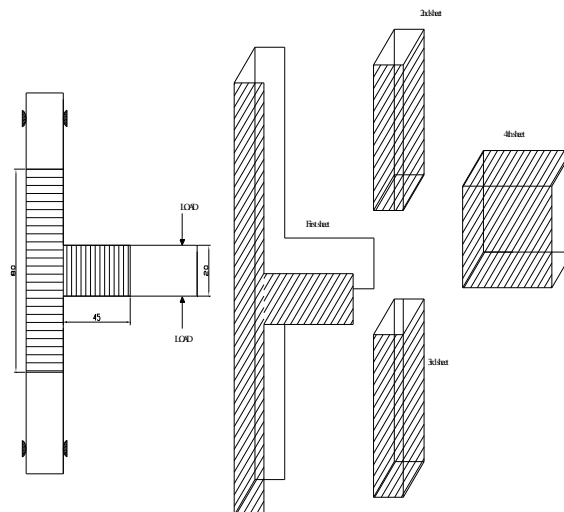
Forth and fifth Specimen: The forth specimen was wrapped with one layer of (GFRP). Four sheets of (GFRP) were placed as longitudinal reinforcement. The first one was placed on the beam and the column. The second one was wrapped the top part of the column above the beam. The third one was wrapped the bottom part of the column under the beam and the fourth one was wrapped the beam only. The fifth one wrapped as the same technique of the forth specimen using (CFRP), as shown in Fig.(3).

Fig. 3: Details of the forth and fifth specimens

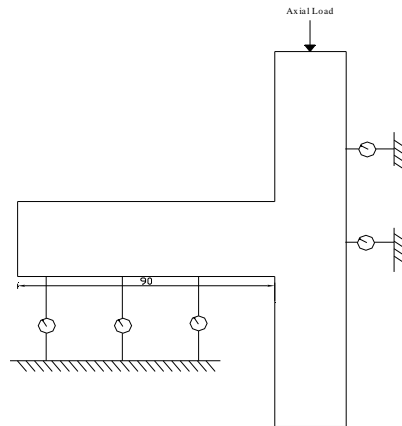
Three dial gauges 50 mms capacity and 0.01 mm accuracy were placed under the beam to measurer the vertical displacement and two dial gauges were placed behind the column to measurer the lateral displacement, as shown in Fig.(4) All data from dial gages were recorded. The load was applied by means of hydraulic jacks.

Fig.(4): Instrumentation and load arrangement

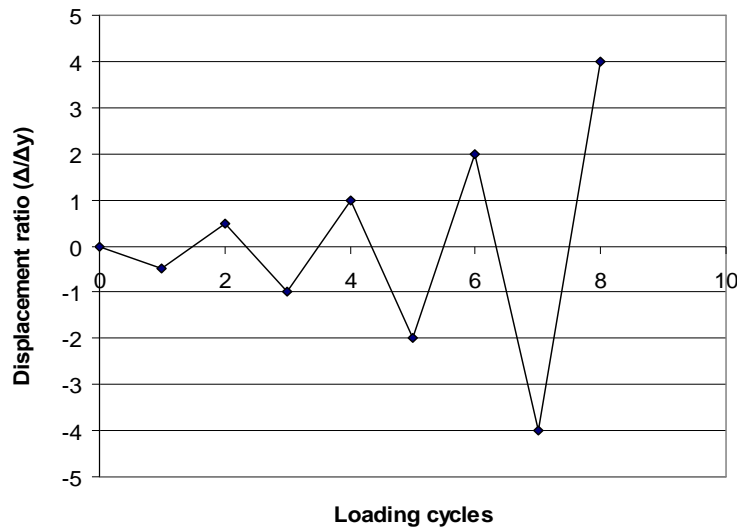
The loading was controlled by the displacement of the beam at the load point. The displacement controlled loading history used is shown in Fig. (5).

Fig.(5): Displacement time history (Load pattern)

The loading scheme provided information on strength as well as stiffness degradation of the specimens. The required axial load level was applied to the column and kept constant through out the test using 20 ton jack. Reversed cyclic displacements were applied to the free end of the beam simulating an earthquake type loading. The data acquisition controls the loading and the releasing of the test specimens. The loading process was controlled by the displacement with the load controls the releasing process. All the data gathered from load sensors and displacement transducers were recorded continuously during the test. Cracks were observed and traced for each load level.

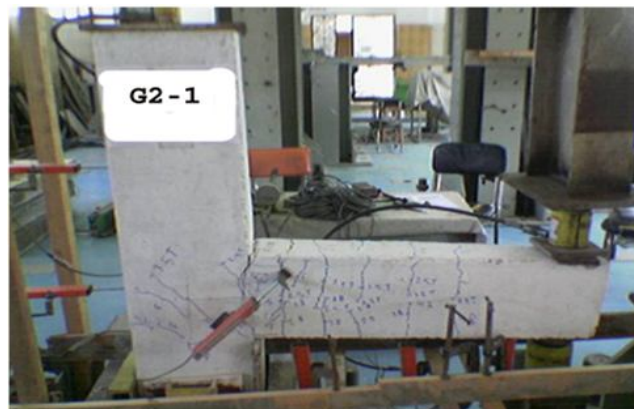
The crack patterns of the tested specimens are shown in Figs (6) to (10). In the control specimen flexural vertical cracks were observed along the beam in the top and the bottom sides at the early cycles (2,3), then a major flexure cracks started at beam top fiber just after the bent bars and continued diagonally parallel to its direction. In the latest cycle (6) this crack was the predominant failure crack and caused degradation in specimen strength during downward displacement. The specimen was crushed at 3.3 ton.

Fig.(6): Crack pattern and mode of failure for Specimen (1)

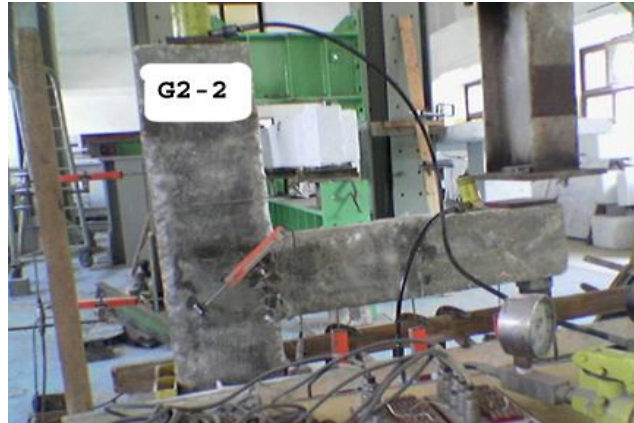
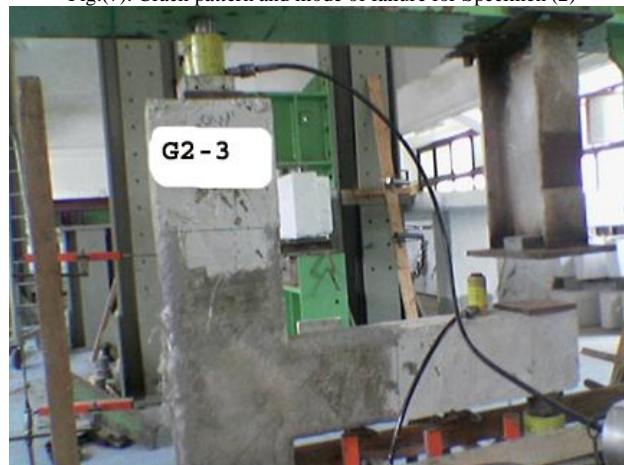
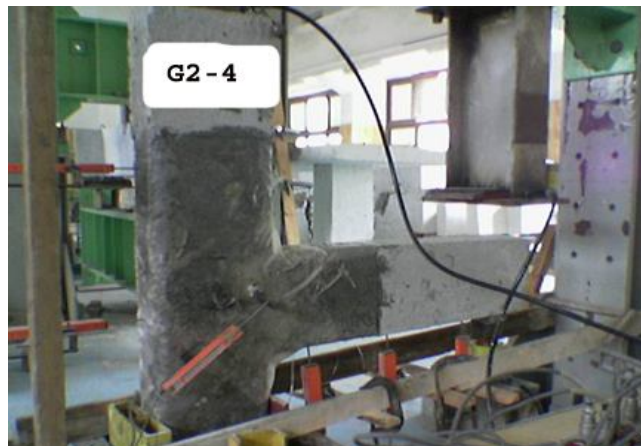
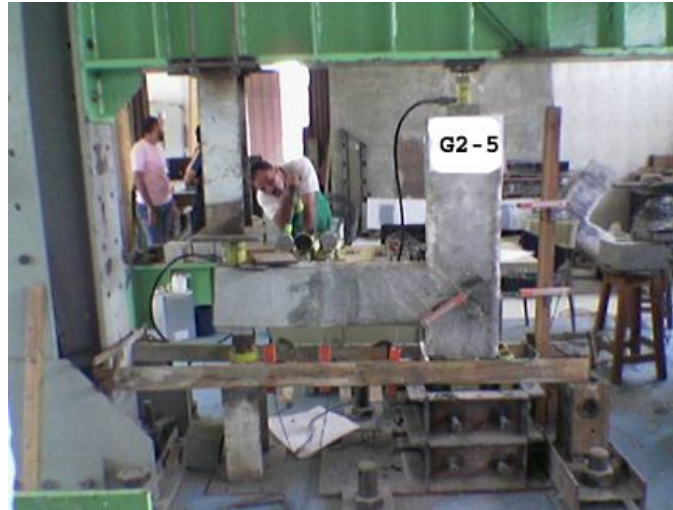
In the other specimens strengthened by GFRP and CFRP sheets only the vertical cracks adjacent to the end of the FRP during cyclic loading. Wrapping the beam with FRP prevent the spread of elastic hinge even at large displacement cycles. All the specimens showed a ductile flexure behavior up to failure. Table (1) show the ultimate load of all specimens and the load which FRP started to separate or cut form concrete.

Fig.(7): Crack pattern and mode of failure for Specimen (2)

Fig.(8): Crack pattern and mode of failure for Specimen (3)

Fig.(9): Crack pattern and mode of failure for Specimen (4)

Fig.(10): Crack pattern and mode of failure for Specimen (5)

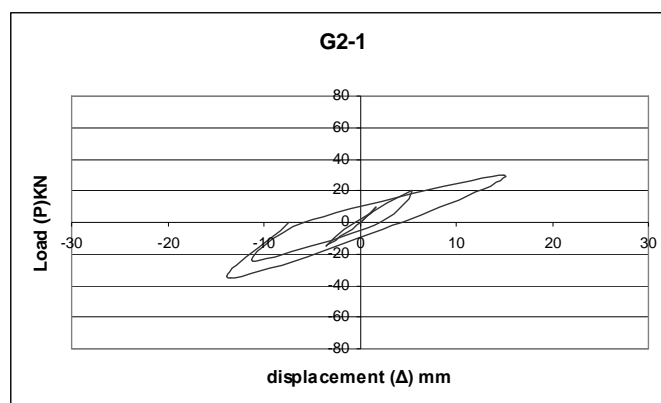
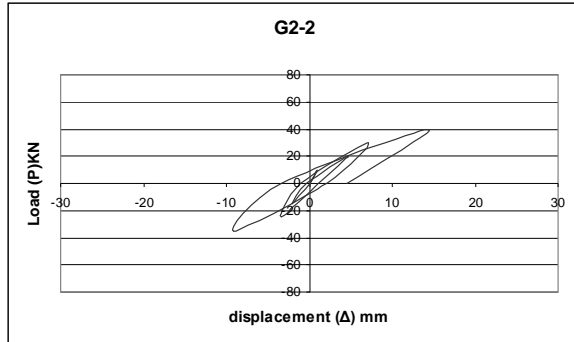
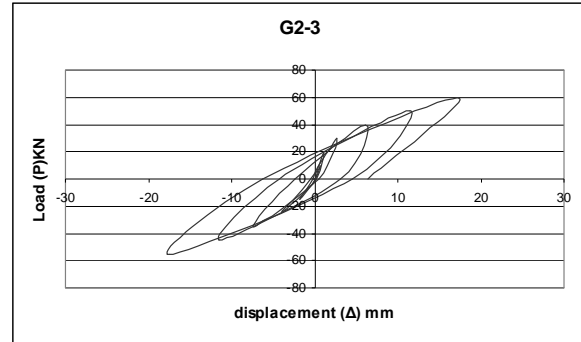
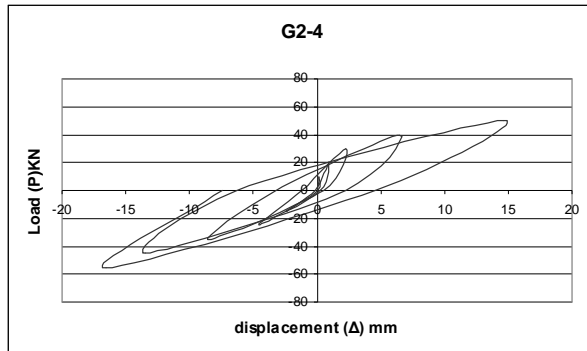
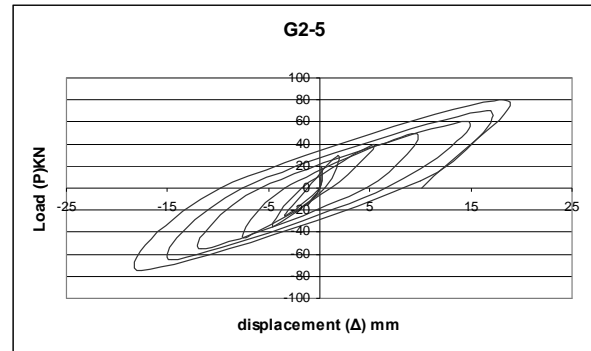
The measured loads were plotted against the associated applied beam tip displacement at different levels of loadings. Figure 11 to 15 presents the experimental load displacement hysteresis loops for all tested specimens. The load displacement hysteresis loops of all specimens displayed similar features. The figures revealed that all the specimens were able to retain wide stable hysteresis loops with large areas enclosed within the loops. For the initial small amplitude cycle, the response was almost elastic and only small residual displacement was observed. Upon reversal of displacement, cracks that were opened during the previous half cycle closed. After cracks closed, concrete resumed its previous role in resisting compressive stress.

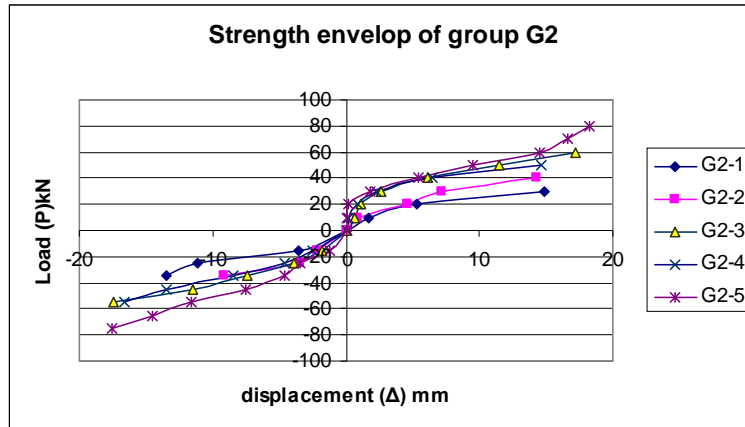
The strength envelope for all the tested specimens was presented in Fig. (16). It was noticed that the ultimate strength of the specimen NO. (5) were more than 2.2 times the ultimate strength of the control specimen.

Fig.(16): Load-Displacement curves for tested specimens

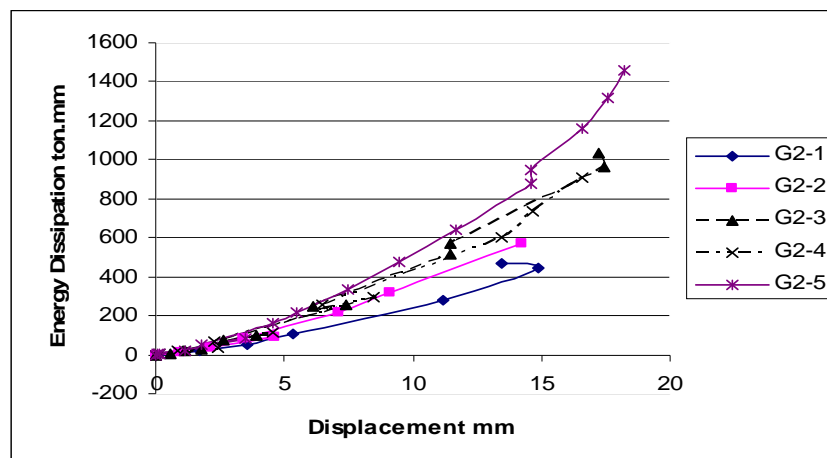
All strengthened specimens produced close values of cumulated dissipated energy was large enough to guarantee ductile behavior of strengthened specimens. The cumulated energy dissipated curves are shown in Fig. (17).

Fig.(17): Energy dissipation versus displacement relationship

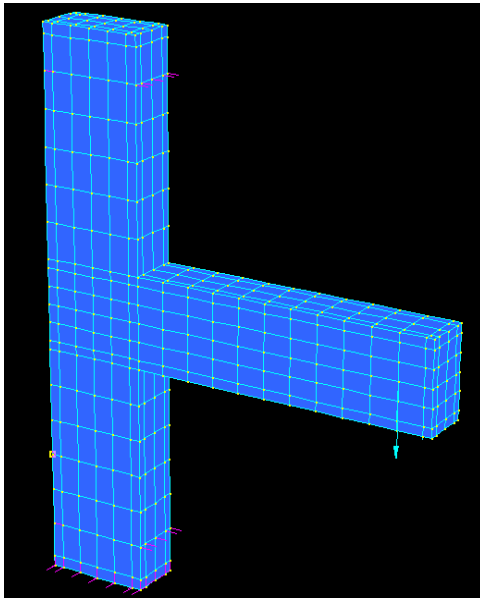
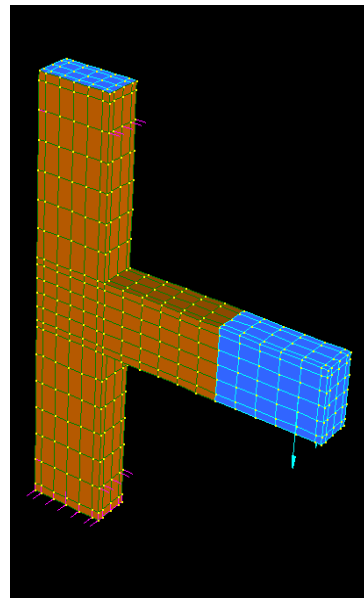
The two specimens (G2-1) and (G2-5) were analyzed using the computer program in order to check its accuracy. The model of the specimens, boundary conditions and type of loading are presented as shown in Figs. (18) and (19) respectively.

Fig.(18):Control specimen
(G2-1)

Fig.(19):Strengthened specimen
(G2-5)

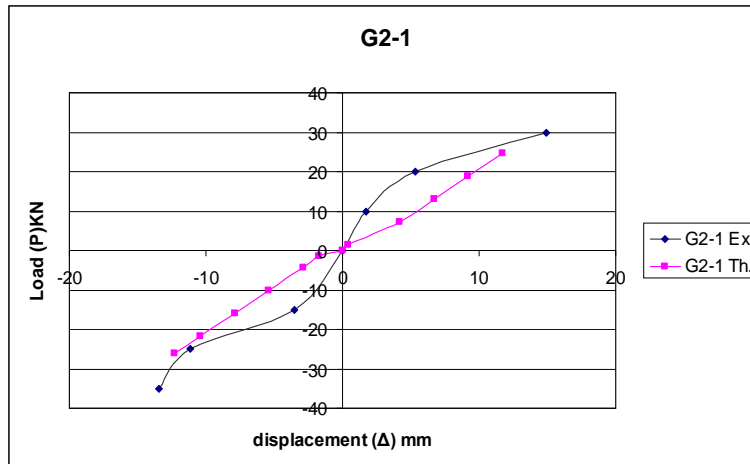
Figure (20) shows acceptable agreement when it compared with the experimental results from the load point of view. Also the figure shows a close behavior between theoretical and experimental hysteresis loops envelope. The theoretical ultimate positive load was approximately 16% lower than the experimental one and the displacement was approximately 21% lower than the experimental one. On the other hand, the negative load was lower than the experimental one by 25% and the displacement was approximately 8% lower than the experimental one.

Fig.(20):Strength envelope for specimen (G2-1)

A comparing between the load displacement relationship (strength envelope) of tested specimens (G2-1) and (G2-5) as previously presented experimentally, and the theoretical results of the same specimens which calculated by the computer program straus7 are shown in the Fig.(20) and (21) respectively.

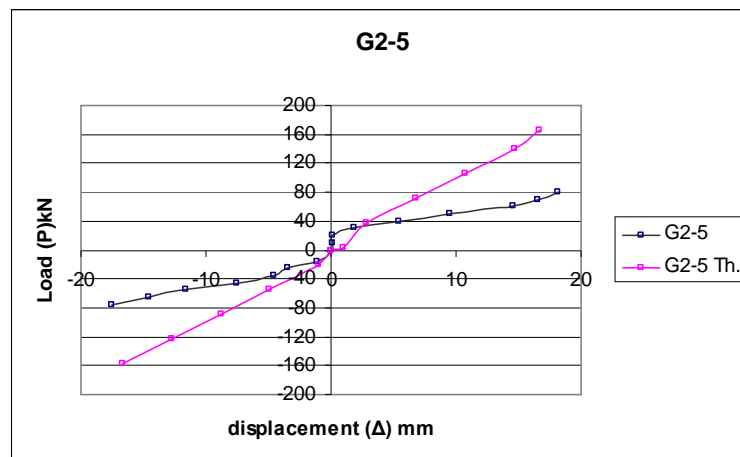
At the same time the results showed in Figure (21) not acceptable when it compared with the experimental results. The theoretical ultimate positive load was approximately 105% higher than the experimental one and the displacement was approximately 8% lower than the experimental one. On the other hand, the negative load was higher than the experimental one by 108% and the displacement was approximately 5% lower than the experimental one. There was a high difference between the theoretical and experimental load at the last cycle of loading, and it took place approximately at the same displacement.

Fig.(21):Strength envelope for specimen (G2-5)
