# **Landslides in Coorg District of Karnataka State**

**ABSTRACT:** Coorg district in Karnataka state lies in the southern part of Western Ghats with high range hills. The topography of the region is sensitive and any changes in the land use causes landslide or slope failures affecting the population. Thus, the district along with its scenic beauty and pleasant climatic conditions is also becoming known for natural hazards. Infrastructural development in the form of laying new roads and widening of the existing roads involved the modification of slopes thus the equilibrium attained by the nature has been deteriorated. Majority of slopes along the high way pose significant risk dominantly from rainfall-induced slope failures. The study was initiated with the preparation of landslide inventory map by field method. The factors generally responsible for the landslides or slope failures viz., lithology, structure, slope, morphometry, geomorphology, land use/land cover, drainage density, lineament density, rainfall data and soil map were considered and each contributory feature was transformed to a thematic map by using Arc GIS version 10. The study reveals that a large part of the stud

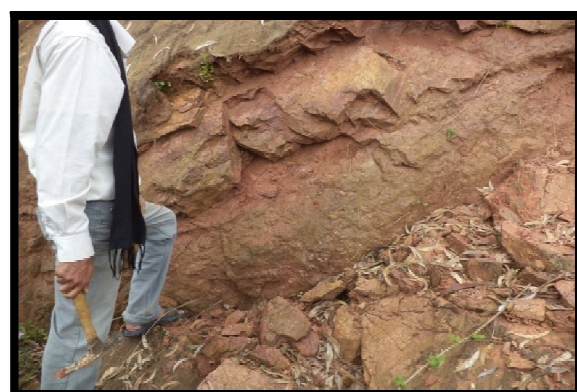
Fig.4. Sheeting joints in granite

Rockslides on minor scale are noticed all along the road connecting Madikeri to Virajapet in the Coorg district. According to Terzaghi, (1962a), the susceptibility of fresh bedrock to rockfalls, rockslides, or block glides depends upon a number of conditions, including (1) the angle of shearing resistance of the jointed rock, (2) the effective cohesion, and (3) the seepage pressures of water in the joints in such cases, the angle of inclination of rock joints is considered. Sheeting in granite often creates joints that are sub parallel to the ground surface, with critical slope angles as low as 30° to 40° (Fig. 4). Slabs of sheeted granite may slide down a slope as block glides (Terzaghi, 1962b). As weathering progresses, decomposed granite forms along the joint planes and decreases the effective cohesion while increasing the void ratio. As the study area receives heavy rain fall during monsoon season, it is possible that the hydrostatic pressures developed in joints due to infiltration of water might have contributed for the loss of shear strength thus bringing down the rock mass (Fig. 5).

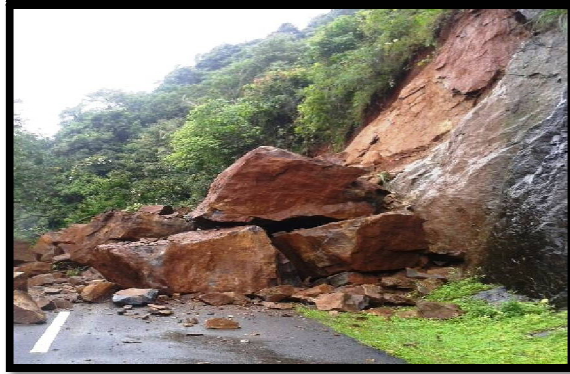
Fig. 5. Landslide along Madikeri-Virajpet road

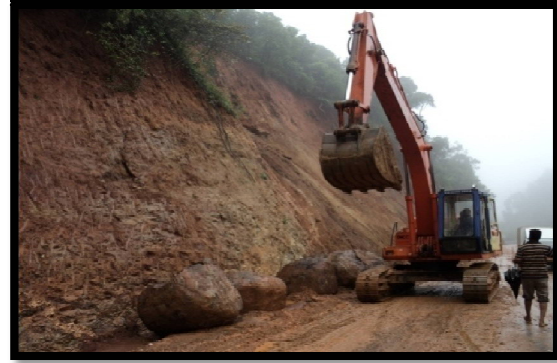
Fig. 6. Core stones in granite saprolite

The weathered zone develops outward from the joints and isolates blocks or boulders of fresh rock to form corestones (Durgin, 1977). In some areas, corestones become remnants on the ground surface and may roll down slopes during rainy periods, causing extensive damage (Barata, 1969; Da Costa Nunes, 1969 cited by Durgin, 1977). The type of

slide most characteristic of this weathering stage is the rockfall avalanche. This type of movement (Fig. 6) is seen along the SH-88 road shortly after Mercara town, on the way to Sulliya.

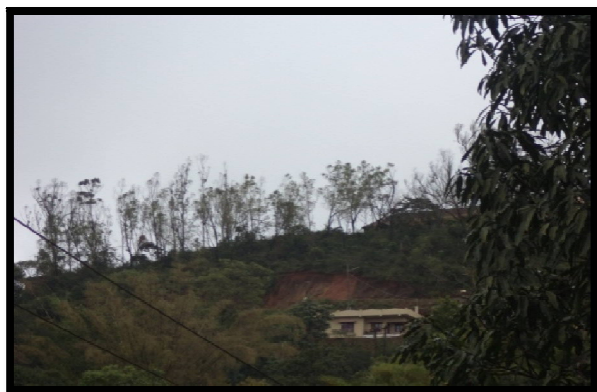
Fig. 7. Slump of the wet soil mass

In the final stage of weathering of peninsular gneiss a brownish saprolite with a cover of laterite is seen in most part of the study area, especially in the western part. The thickness of this layer varies however in most part; it is deep measuring more than 15 meters. A slope failure characteristic of saprolite is the slump or rotational slide (Durgin, 1977). In the central and western parts of the study area, where in the deep weathering has produced thick saprolite layer, frequently witnesses slump of the soil mass (Fig. 7). At places, retaining walls have been built (Fig. 8) both by government authorities and residents to arrest the movement of the soil, however excavating saprolite for construction of the buildings, causes slope failures.

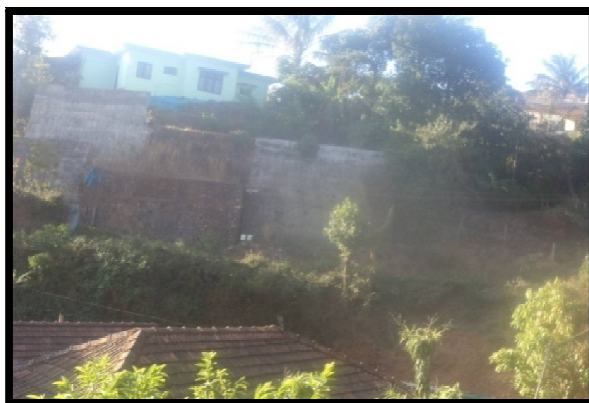
Fig. 8. Retaining wall – earth retention system in Mercara town

Landslides in parts of Coorg district may be correlated to the weathering stage of the peninsular gneisses. In the study area, the transition of fresh rock of peninsular gneiss to saprolite has been divided into four stages; (1) fresh rock, (2) core stone, (3) decomposed granitoid and (4) saprolite. Granitoid rocks in the hilly terrains are normally microscopically sheeted due to unloading of stress. These microsheets generally strike parallel to major slope surfaces and gently dip down slip forming cataclinal over dip slopes (Chigira, 2001). The cataclinal over dip slope accelerated the movement of microsheets granite thus causing rock fall in the region. Rock falls in the region are essentially translational slides wherein the surface of failure is essentially planar in geometry. Weathered zone develops blocks of fresh rock to form core stones. These roll down slopes during rainy periods causing extensive damage. Mitigation works carried out to reduce the damage both in the Mercara city and all along the highway roads include construction of retaining walls. Surface drainage control works in the form of U- ditches all along the road on either side, restricting development in landslide prone areas, construction of retaining walls with weep holes, providing armored protection with concrete blocks are some of the mitigation measures undertaken by the local authorities.
