# International Journal of Innovative Research in Science, Engineering and Technology

Vol. 7, Issue 6, June 2018

## Study on Dam Failure - A Review

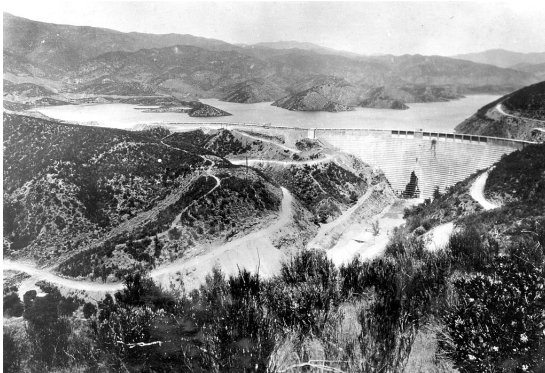
1(a)

damages were considered to be normal by engineers and they did not decide to give time to that. The walls of the dam could not hold the water on 12 March, 1928 and it collapsed. 47 billion litres of water started flowing down the canyon. Waves of 43 meters in height started moving towards nearby area and caused great damage. Figure 1 shows images of St. Francis dam, USA (a) before failure and (b) after failure.

The St. Francis Dam was located in San Francisquito Canyon and built in 1926. Cracks started in the walls of the dam due to geological instability of canyon walls. They were taken care of but not completely as most of

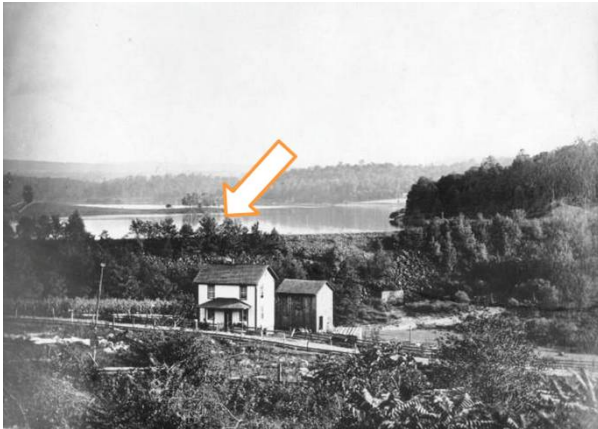
2(a)

4. Mostly 23% of dams failure are due to inadequate spillway capacity. Overtopping is the common cause of failure. Notable flood stemming from inadequate spillway capacity in Oros in Brazil and South Fork in United states.  
Water of South Fork Dam in U.S.A. was often reported to be leaking at certain portions. To solve the issue, all the engineers did, was filling up the cracked portion with straw and mud. This was a temporary solution, but not a permanent solution. However, immense rainfall in May 1889 caused the bases of the dam to weaken. The capacity of dam was less to withstand arrived water so the dam collapsed and 20 million tons of water released on 21thMay,1889 and it ran several miles downstream. The total damage was estimated at \$17 million. Figure 2 shows images of South Fork Dam, USA (a) before failure and (b) after failure.

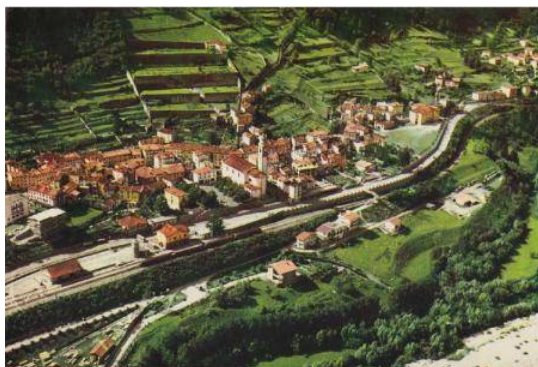
3(a)

5. For assessing safety in case of water storage we have to consider the possibility of sliding on slopes of reservoir and abutment. The Vaiont dam completed in 1959 and It did not suffer any serious damage. On October 9, 1963, 260 million cubic meters of rock broke off from the top of Monte Toc. It fell into reservoir of Vaiont dam, producing enormous waves of 50 million cubic meters of water. Flooding destroyed several villages and killed about 2000 people. Claystone and Shales are present in foundation of concrete dams, special precautions have to be considered. Figure 3 shows images of Longarone town, Italy (a) before landslide and (b) after landslide.
