Structural Health Inspection of Institutional Building (SGBIT CAMPUS)

Students, Department of Civil Engineering, S.G. Balekundri Institute of Technology, Belagavi, Karnataka, India^{1,2,3}

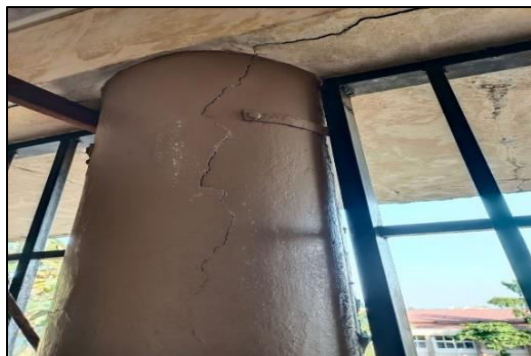
Fig.2 representation of vertical cracks

Vertical cracks: These cracks can indicate that structural components such as bricks or blocks have failed, and so can be a sign of significant stress in the building structure.

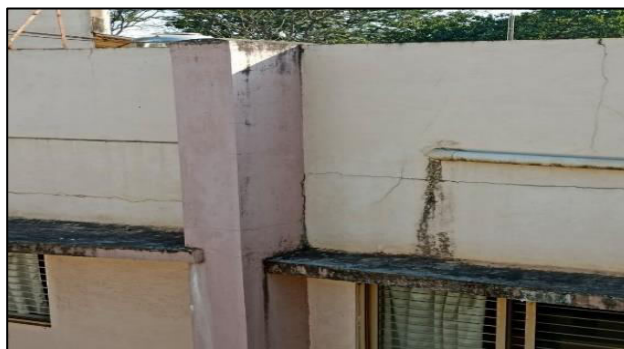
Fig.3 representation of horizontal cracks

Horizontal cracks: Occurs near the beam-column joint and column face where tensile stress is high. Columns with sufficient moment capacity, insufficient reinforcement, or the disposition of the installed reinforcement are prone to horizontal cracking; due to shear force and direct load and uniaxial bending

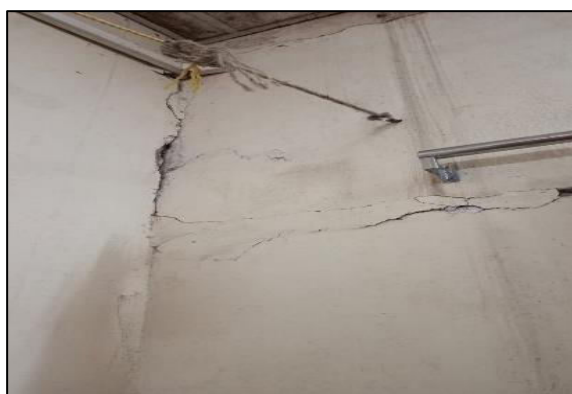
Fig.4 representation of diagonal cracks

Diagonal Cracks:

The main cause of diagonal cracks in concrete columns is the insufficient bearing capacity of the columns; insufficient cross-section and insufficient reinforcing steel. It can appear anywhere in the height. And it runs diagonally across a section of uniform thickness

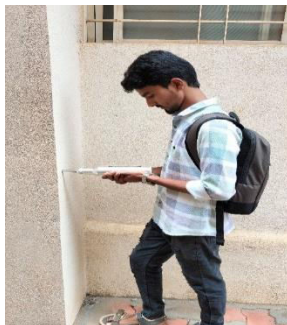
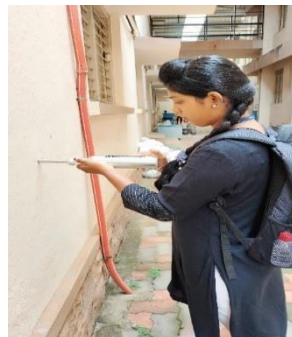
Fig. 5 Rebound Hammer test

Table 03 Rebound hammer test results

COMPONENTS	REBOUND VALUE	AVERAGE STRENGTH (Mpa)	REMARK
COLUMN	36	33.6	GOOD LAYER
BEAM	33	28.2	GOOD LAYER
SLAB	28	25.9	FAIR
WALL	33	28.2	GOOD LAYER

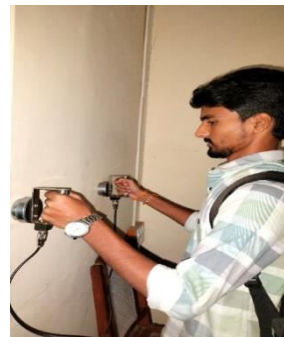
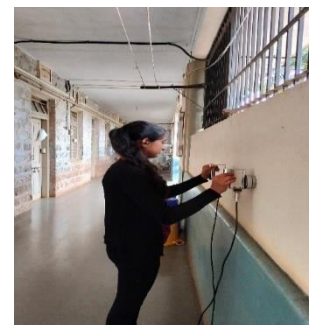
Fig 6. UPV test

Table 04 UPV test results

Building Type	Distance	Avg. Time	Avg. Velocity	UPV Method	Quality of Concrete
Civil Department (Wall)	400m	103.55	3.87	Indirect	Good
Civil Department (Column)	230m	47.17	4.89	Direct	Excellent
Auditorium (Column)	300m	67.84	4.43	Direct	Excellent
Auditorium (Wall)	300m	63.45	3.99	Indirect	Good
Girls Hostel (Column)	300m	74.54	4.09	Direct	Excellent
Girls Hostel (Wall)	262.33m	63.94	4.13	Indirect	Good

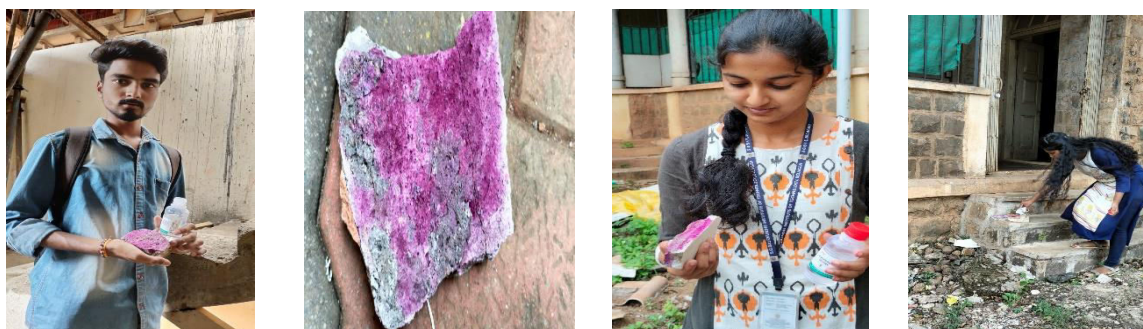
Fig. 6 Carbonation Test

Carbonation testing provides a means by which we can determine the presence of carbon dioxide infiltration into concrete. The carbonation test is performed by drilling a hole on the surface of the concrete up to the concrete cover. Remove the dust with a brush and blow air to clean the hole. Spray a 0.2% solution of phenolphthalein with a syringe over the cracked/holed concrete and observe the color change. Measure the depth of the uncolored layer (carbon layer) in millimeters from the outer surface at 6 to 8 positions. Take the average of the measurements.

Building	Carbonation present
Civil department building	No
Auditorium	No
Girls hostel	No
