Forensic Study and Crime Scene Investigation of a Road Accident Case

Mohan Patel^{*1}, Vikrant Singh Thakur², T. L. Chandra²

Scene of Crime Unit, Durg, Chhattisgarh, India¹

State Forensic Science Laboratory, Raipur, Chhattisgarh, India²

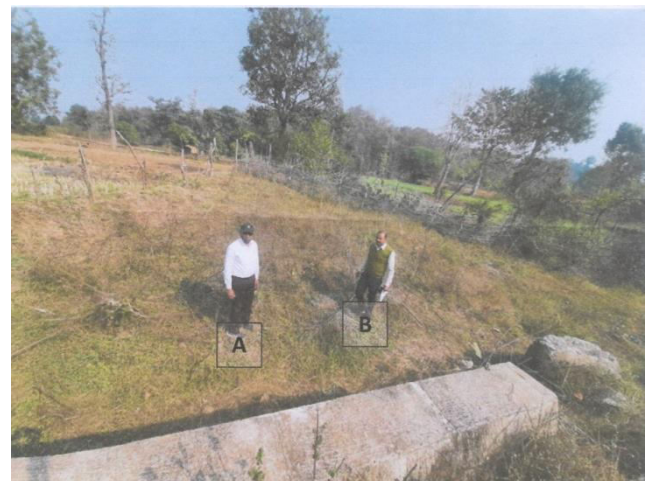
Fig. 6. Position of the Diseased "A" and Motorbike "B" after the Incident

Drawing of the crime scene is shown in Fig. 2. A 33 years old male was found dead besides the road along with his motorbike (Figs. 3, 4, 5). The spot was told to be near the drain pipe on the side of the road. It was said by the witnesses present on the date of the incident that the deceased was found at the place marked “A” and the motorbike was found at the place marked “B” in the Fig. 6.

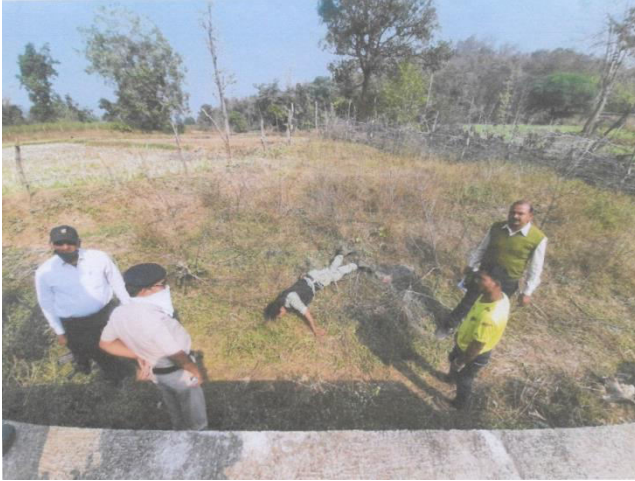
Fig. 7. Crime Scene Reconstruction

In the presence of the witnesses present on the spot, on the date of the incident; the scene was reconstructed to know about the situation of the deceased and the motorbike (Fig. 7). In the reconstruction of the scene, the height of the drain pipe was found to be 54 inches, the deceased from drain pipe was 93 inches and the distance of the motorbike from the deceased was 88 inches (Fig. 8). On the date of the incident, a stone was said to be found at the place of the fall of the deceased, which was said to be seized by the police and a pit was found to have been formed at that place due to the release of the stone (Fig. 9). There were no blood stains were present on the spot on the date of the incident. A 'babool' plant was found at the crime scene in the direction of the movement of the deceased, on which it was said to have been scratched by the motorbike of the deceased on the date of the incident. Scratch mark were present on the 'babool' plant even on the date of spot inspection (Fig. 10). The stone buried on the ground near the 'babool' plant was also found taken aback by the motorbike (Fig. 11). It was said to be a skid mark was present by braking the motorbike on the road (marked as "C"). The position of skid mark, the direction of movement of the motorbike, position of the diseased and the motorbike after the incident were all estimated using a thread (Figs. 12, 13). The direction of motion of the motorbike, the skid mark, the 'babool' plant, the stone dislodged by the motorbike and the direction of the fall of the motorbike were all found to be in a straight line. No dent mark or damage was reported on the motorbike due to the incident (Fig. 14).

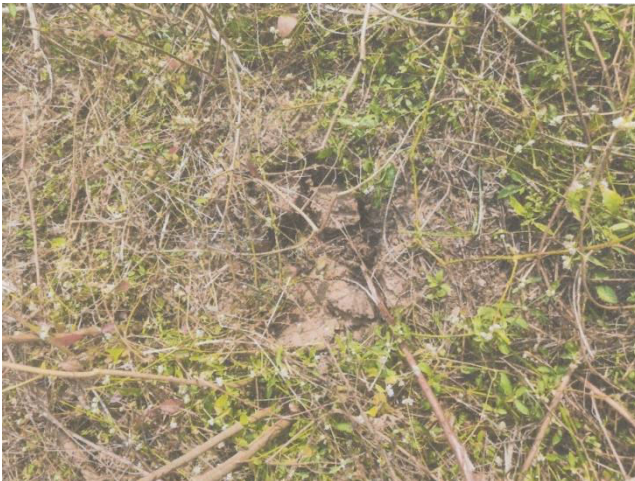
Fig. 9. Pit of the Stone Found on Spot

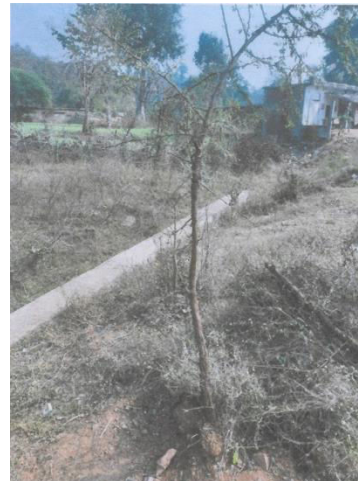
Fig. 10. 'Babool' Tree in the Direction of the Movement of the Motorbike

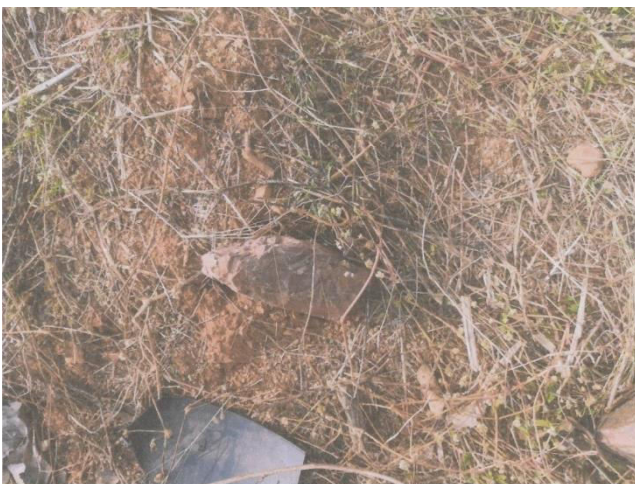
Fig. 11. Stone Taken Aback by the Motorbike

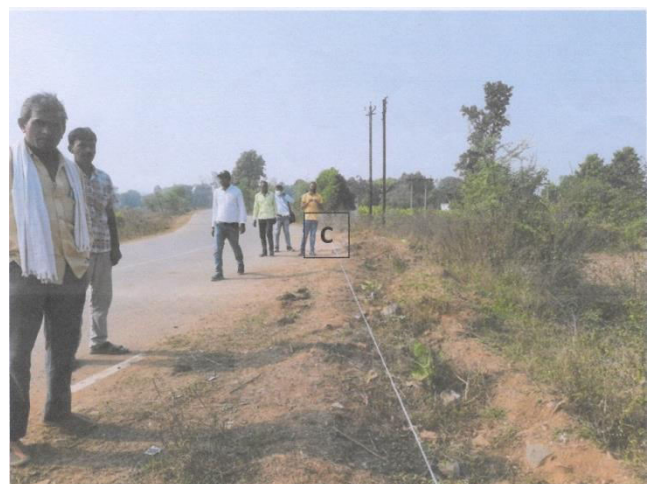
Fig. 12. Estimation of the Direction of Movement-I

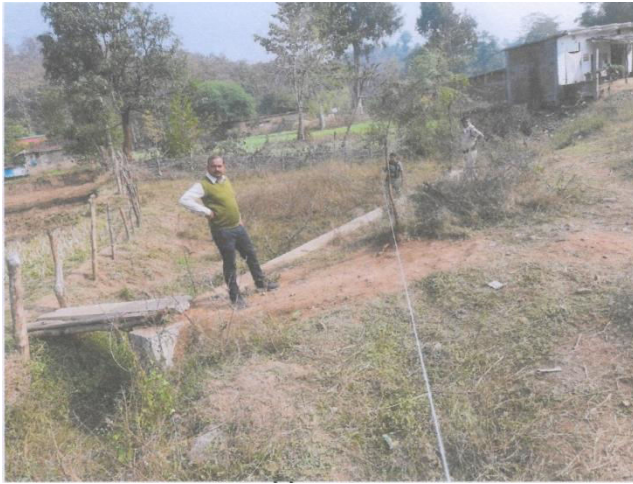
Fig. 13. Estimation of the Direction of Movement-II

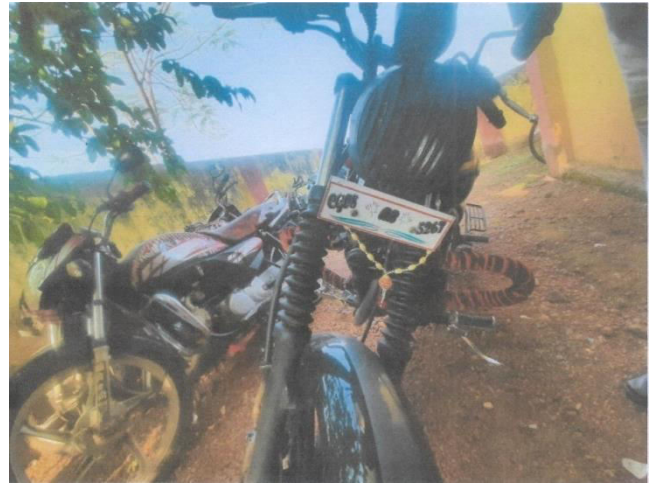
Fig. 14. Motorbike after the Incident
