# Study and Analysis of Structural Cracks and Rectifying by Innovative Method

D.Kumar<sup>1</sup>, K.Tamilvanan<sup>2</sup>P.G. Student, Department of Civil Engineering, Prist University, Thanjavur, Tamilnadu, India<sup>1</sup>Assistant Professor, Department of Civil Engineering, Prist University, Thanjavur, Tamilnadu, India<sup>2</sup>

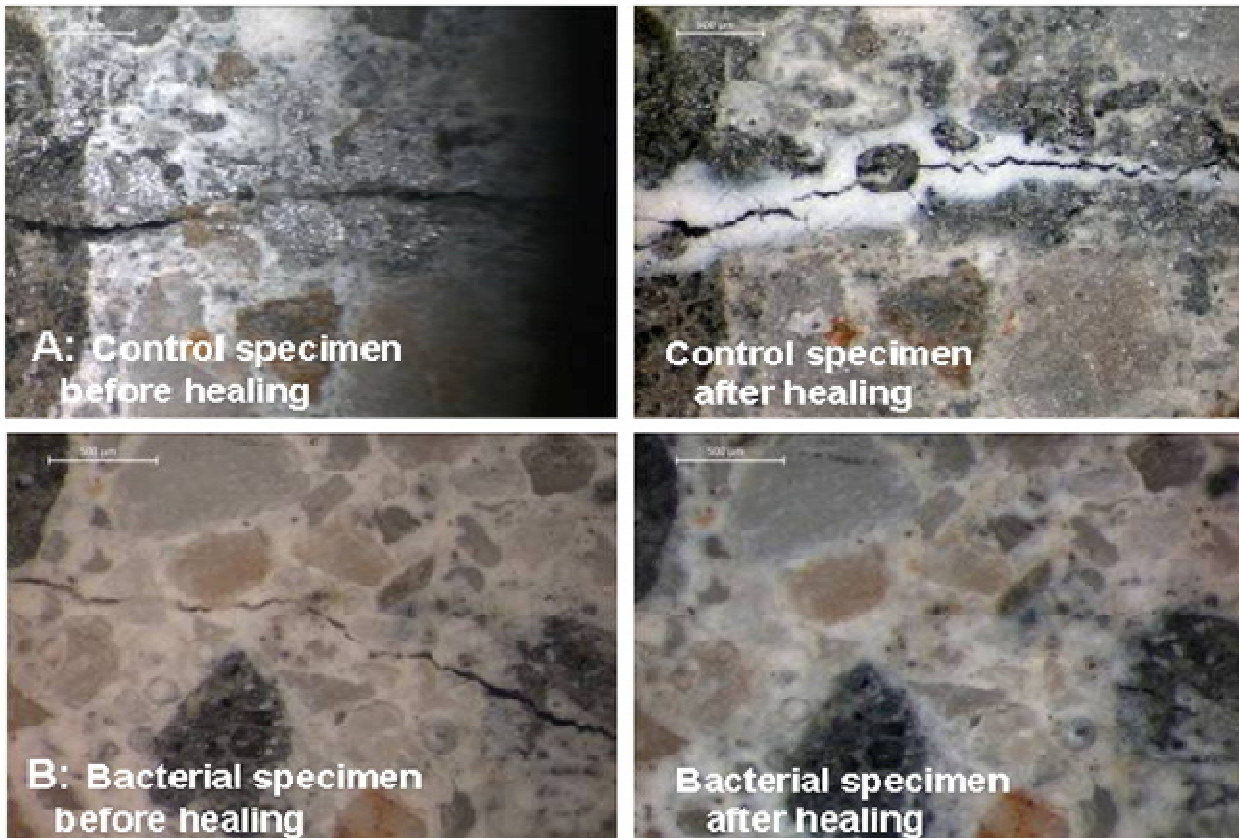
(Figure 1C). Additions of calcium lactate did not significantly affect strength development as values were only slightly lower or higher than control specimen.

As incorporation of healing agents to concrete may have unwanted negative effects on material properties, development of compressive strength of control specimen without additions as well as specimen with bacteria or organic compound additions was investigated. Incorporation of a high number of bacteria ( $5.8 \times 10^8$  cm<sup>-3</sup> cement stone) appeared to have a mildly negative effect on compressive strength development as bacterial test specimen appeared almost 10% weaker than control specimen at all tested times (Figure 1A). Effect of organic compound incorporation on development of strength appeared however strongly dependent on compound identity. Incorporation of peptone resulted in a catastrophic development as initial strength (after 3 and 7 days curing) was already less than 50% of the control, prolonged curing resulted in an even lower compressive strength. Strength development of calcium glutamate containing specimen appeared, like the bacterial specimen, parallel to control specimen albeit at a 25% lower level
