# Analysis of Tube Failure in Water Tube boiler

P.Sakthivel<sup>1</sup>, S.Kalaimani<sup>2</sup>, Dr. R. Sasikumar<sup>3</sup>

**ABSTRACT:** Boiler tube failure continues to be the leading cause for forced outages in fossil fired boiler. The tube failure may be a simple problem unless it causes damage to the power plant and affects safety of the human being. The problem due to tube failure is realized only when the cost due to failure estimated. The main objective of our project is to reduce the number of tube failures occurring in boiler accessories at thermal power station by analyzing the reason behind the tube failure and provide suitable remedies for it. Tube failures in boiler accessories occur due to various reasons and major reasons for failure among the various reasons are flue gas erosion, long term overheating and steam erosion. The major failure reasons are taken from the tube failure. Major causes for failure can be controlled by using following remedies such as optimization of flue gas velocity, using tube material with better creep strength and by providing coating along the wall of the tube. The optimization of flue gas velocity is done by computational fluid dyna

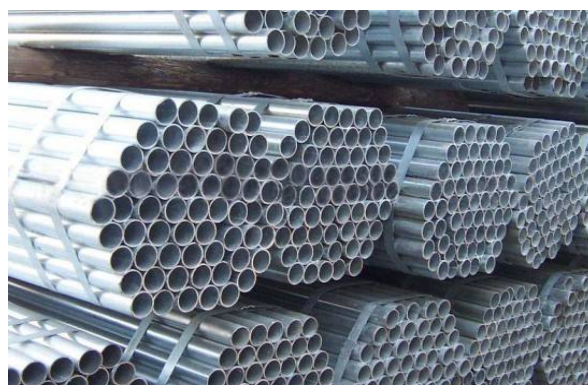
Boiler tubes are set of long goes several folds inside the furnace, sometimes their total length may be several kilometers mainly in the case of power plant boilers, and these tubes transfer heat from flue gas to water or steam. Fig 1.2 shows tubes of a typical water tube boiler in a power plant

Fig. 1.2 Tubes of a water tube boiler

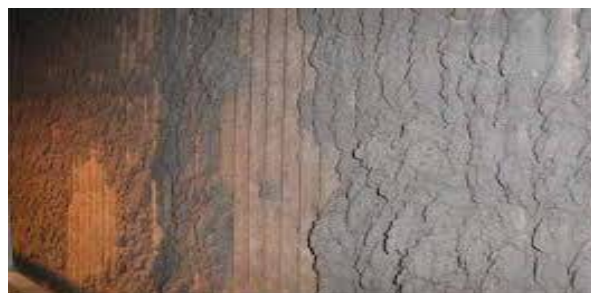
Slag is formed by the reaction of deposited ash particles with the boiler tube material, prolonged traveling of ash particles around boiler tube cause deposition of ash and at high temperature these ash deposit and boiler tube particle reacts to form molten metal slag, this falls on the lower tube and erodes those tubes. Fig. 2.4. represents the formation of slag around boiler tubes.

*Fig. 2.4. Slag formed around boiler tubes*

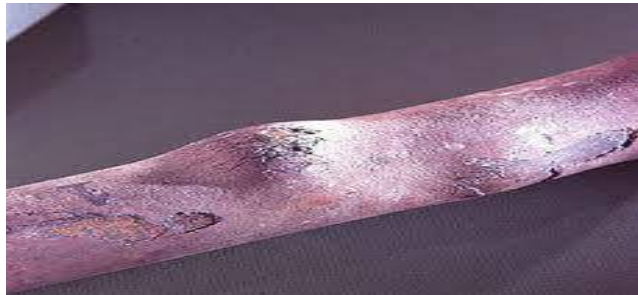
Short term over heating can occur if temperature of pressure part (tube, drum, pipe and header) increases rapidly in short period exceeding limitation of design temperature. It can occur at the pressure part which has high operating temperature such as superheated, reheater, water wall, roof wall, boiler bank, screen tubes and down comers and rarely occurs in low operating temperature of pressure part such as air heater and economizer. When the tube has insufficient

cooling from water flow inside and receives excessive heat input from combustion process will lead to short term overheating. Fig. 2.5 shows the boiler tube failed due to short term overheating.

*Fig. 2.5 Short term over heating*

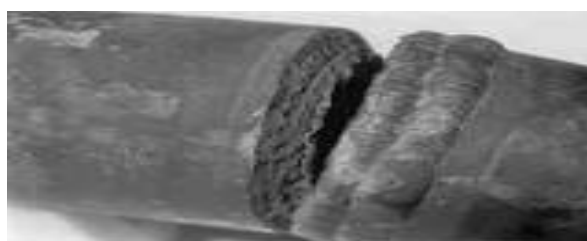
In the thermal power station, dissimilar metal welds (DMWs) are used to join ferritic low-alloy steels to austenitic stainless steels. Unfortunately, these welds can fail prematurely from accelerated creep. However, a transition joint where the composition changes from austenitic steel to ferritic steel could replace then one dissimilar weld with two similar welds. Fig. 2.7 shows the failure of dissimilar metal welds in boiler tube of a water tube boiler

*Fig. 2.7 Dissimilar metal weld failure*

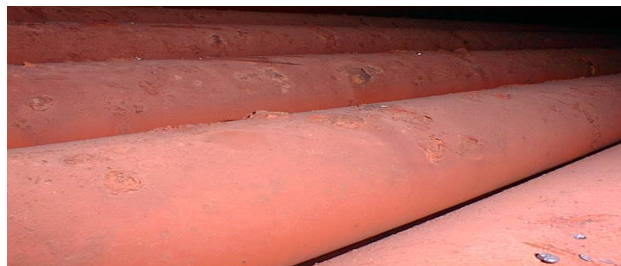
Caustic corrosion, a specific form of stress corrosion, results in the inter crystalline cracking of steel. Inert crystalline cracking results only when all of the following are present: specific conditions of stress, a mechanism for concentration such as leakage, and free NaOH in the boiler water. Therefore, boiler tubes fail from caustic embrittlement at points where tubes are rolled into sheets, drums or headers. Fig.2.8 shows the boiler tubes attacked by caustic corrosion.

Fig.2.8 Caustic corrosion

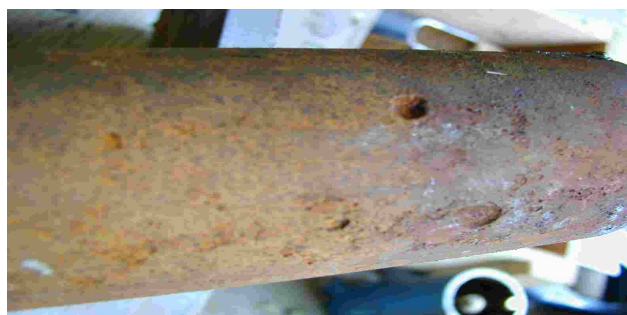
Fig.2.9 Pitting corrosion

Pitting corrosion is a form of extremely localized corrosion that leads to the creation of small holes in the metal. The driving power for pitting corrosion is the depassivation of a small area, which becomes cathodic; leading to very localized galvanic corrosion. The corrosion penetrates the mass of the metal, with limited diffusion of ions. Fig. 2.9 shows the pitting corrosion in a tube of water tube boiler.

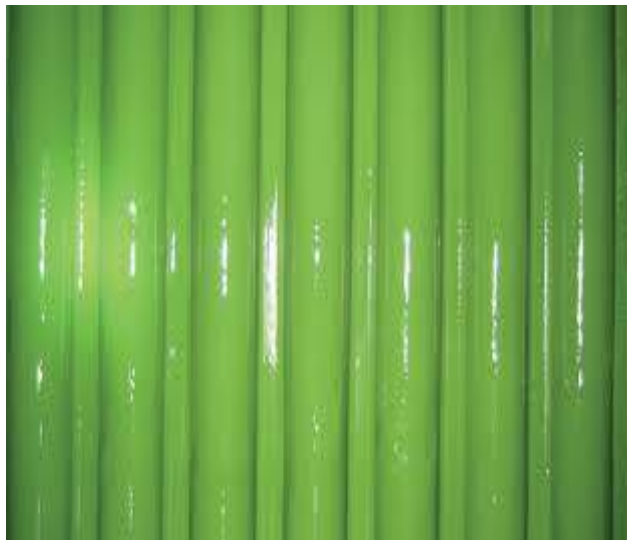
Fig. 3.4 shows a boiler tube sample coated by electrodeposited inter metallic coatings

Fig. 3.4 Electro deposited inter metallic coatings

One way to protect boiler tubes against corrosion is to apply a thin layer of pure chromium in an oxidizing environment the chromium layer forms a protective oxide layer which prevents deterioration of the underlying steel tube. This work led to the eventual development of a new type of coating intermetallic Aluminize which can be applied by a low electro deposition process.

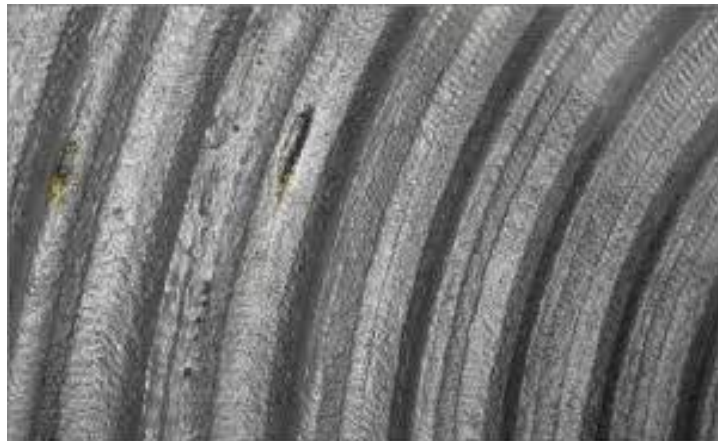
Fig 3.5 shows the boiler surface coating with weld overlay coating .

Fig. 3.5 weld overlay coating

The advantage of welded coatings is that they can be applied to the surface of the boiler tubes in the boiler as well as in a shop, without the usual penalties. However, selection proper weld alloy and control of the weld overlay process conditions are critical to producing coatings with desired properties.
