Defect Detection of Concrete Filled Steel Tubes with PZT based Technique

ABSTRACT: In this paper, Piezo Electric Transducers (PZT) sensor is employed to detect the artificially mimicked debonding and compaction defect in a Concrete Filled Steel Tube (CFST) column specimen. Total four CFST columns were casted. Debonding was imparted with help of Styrofoam plates at predefined locations. All four columns are with different properties in terms of bonding and compaction. PZT sensors were excited with help of LCR meter and the output was detected with LCR only. Based on RMSD index Defect is identified.

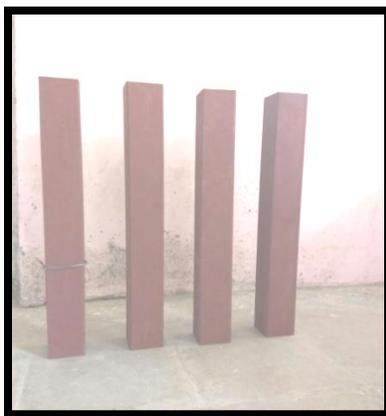
Fig 1 : (a) Steel Tubes Specimen

The Tests were conducted on four CFST columns with the help of LCR meter. LCR meter is shown in Fig 1 (c) below. Steel tubes of same sizes were used and the grade of concrete was maintained same for all the CFST specimen. All four specimen though seems externally similar but they differ internally. To mimic artificial debonding Styrofoam patches which are shown in Fig 1 (b) were attached on inner side of 2 CFST specimen. All Steel tubes shown in Fig 1 (a) confirm to IS:4923.

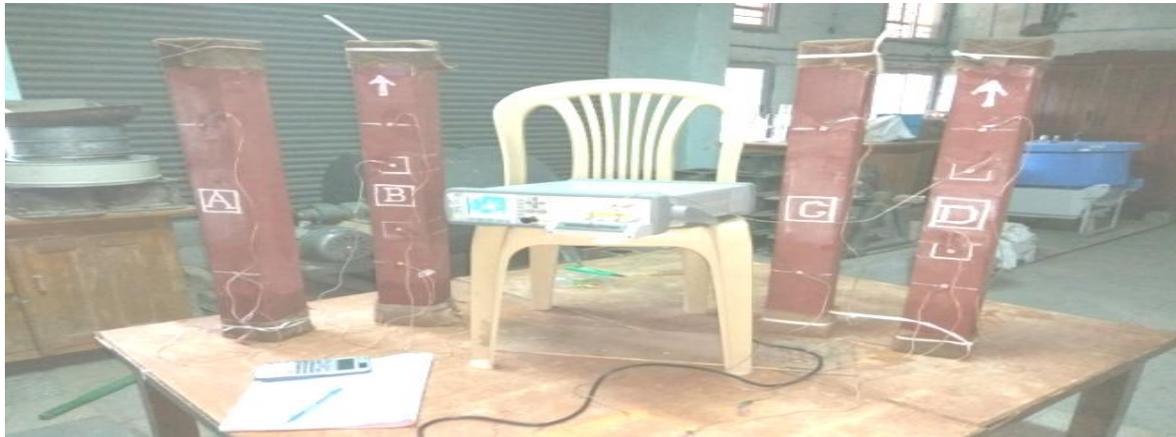
Fig 2 : Experimental setup of CFST

CFST with varied compactness were named as A, B, C & D and positions of PZT were given as 1, 2, 3 & 4. Position of Styrofoam plates that is debonding is shown externally with square boxes in Fig 2 & 3 and PZT patches were placed exactly on outer side of CFST at centre of patch.

A - Fully compacted and bonded CFST, B - Fully compacted but debonded partially, C - Not compacted but bonded internally and D - Not compacted and debonded partially.

CFST column dimensions are 100x100x1000 mm. Thickness of steel tube is 3mm. Grade of Concrete adopted is M25. High frequency PZT were used of size 10x10x1 mm. PZT were pasted at 230mm from both top and bottom of all CFST for position 1 & 4. Additional PZT were attached externally where debonding was mimicked from inside. the location was numbered as 2 & 3. Fig shows CFST specimens with naming given on its surface.

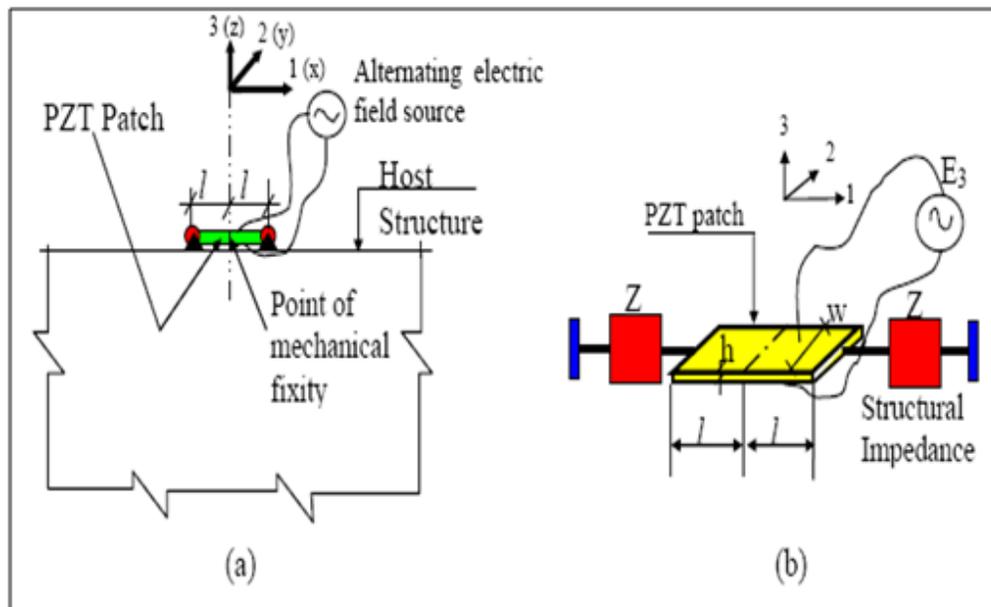
Fig 4 : (a) A PZT Bonded to the Structure (b) Interaction Model of One Half of PZT and Host Structure

When compared to host structure it is that the PZT patch assumed is infinitesimally small and possess negligible mass. When an alternating electric field is applied to PZT patch it expands and contracts dynamically in the direction '1' as shown in Figure 4 (b). Hence two end points of the patch can be assumed to encounter equal mechanical impedance Z from the host structure.

The governing equilibrium equation for the system shown in Figure 4 (b) solved using impedance approach [7]. Using Liang's derivation following equation can be written for the complex electro mechanical admittance Y (inverse of electrical impedance), of the coupled system shown in Figure 4

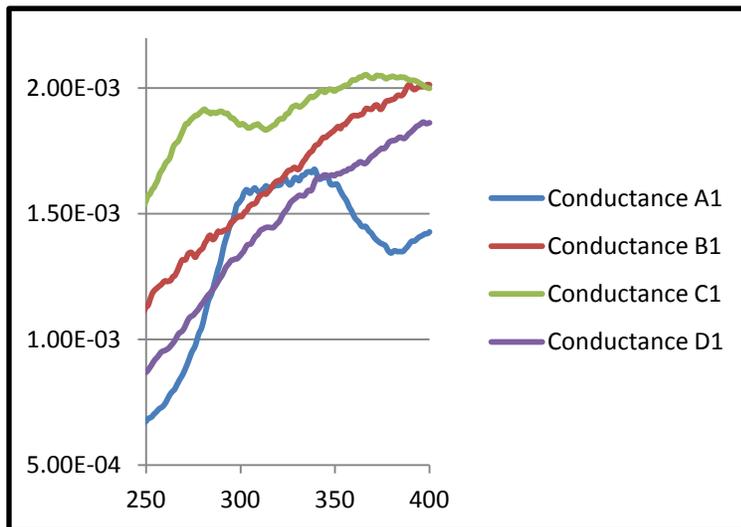
Fig 5 : Conductance variance at position 1 of all the CFST

The graph is plotted between conductance and frequency from data collected by response from PZT to LCR For position 1 of all the four columns the response is plotted and shown in fig 4 below. Where A1 denotes 1st position of PZT on column A similarly B1, C1 & D1 are plotted. This graph is plotted between Frequency and Conductance, frequency being the independent parameter.

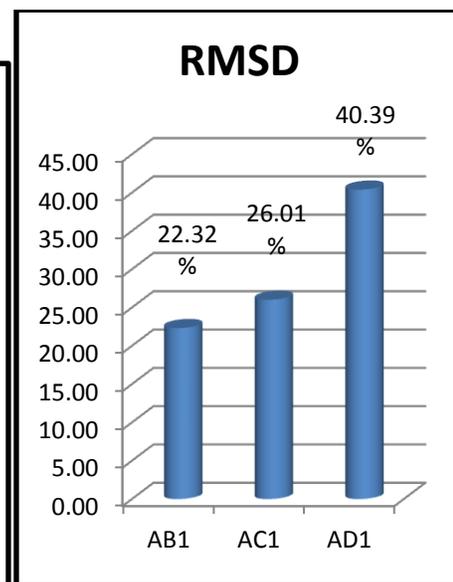
Fig 6 : RMSD index variation

Based on the RMSD index equation (1) different RMSD values are calculated and plotted as shown in fig 5. Here AB1 implies RMSD index between A & B at position 1 and similarly AC1 & AD1 implies RMSD index between A & C and A & D respectively at position 1. More the RMSD index better the sensitivity and greater the difference between two specimens. For e.g. for position 1 same column is considered twice (healthy & damaged)

then the RMSD index will be zero. The value will differ for two different specimen. Here AD1 has highest difference and this is in accordance with defect. Same is valid for other RMSD.

- Defects and its extent in CFST are effectively detected with PZT sensors
- Higher RMSD index shows that D column is most damaged as compared to other 3 columns
- The horizontal and vertical shifting of peaks are quantified in RMSD index
