Inhibition of Chloride Induced Corrosion in RCC Structures with Calcium Nitrate

Ramesh Nayaka¹, Diwakar G.S¹, Tejus Kabadi², Aditya Maheshwari²

International Journal of Innovative Research in Science, Engineering and Technology

Vol. 5, Special Issue 9, May 2016

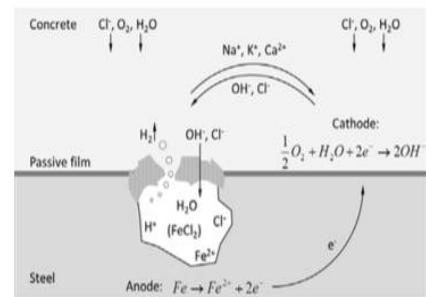
Figure 1 Mechanism of de-passivation by chloride ions

Nelson (2013) reported evidence of soluble iron-chloride complexes, i.e. green rust, generally represented in the Figure 1 below as $FeCl_2$ (although other forms have been proposed) The mechanism is believed to involve the formation of these compounds at the pit, diffusion to hydroxide and oxygen richer areas and formation of solid rust products, releasing the chloride ions to further attack the passive layer with the rust product $FeOOH$ representing one of several possible species (goethite, lepidocrocite or akaganeite) [12].

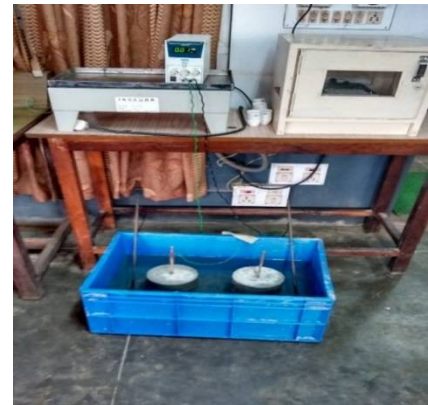
A. Accelerated Corrosion Testing In the accelerated corrosion test, corrosion is measured in an electrochemical way. The first set of samples was dried for a week before accelerated corrosion test was conducted on them. The samples after drying were placed immersed in a 5% NaCl solution in a tub. Two steel bars were kept in the tub which act as cathode. As shown in Figure 4 the positive terminal of a DC regulated power supply is connected to the rebars of the samples and the negative terminal is connected to the steel bars. A constant potential of 2.5 V is applied so as to produce a current of 10 mA flowing through the two samples. The concrete reinforcement bar acts as anode in the electric system and will attract the anions OH⁻, Cl⁻. The steel bar is the cathode of the system and O₂ reduces to OH⁻. The NaCl solution and the concrete cover realize the electrolytic environment. The electric potential forces the anions to the anode and the cations Na⁺, H⁺ to the cathode. By this means, the chemical reactions, which appear in the traditional corrosion process, are accelerated.

Figure 4 Set up of Accelerated Corrosion Test in the Physics Lab

The rate of corrosion is indicated by the amount of current passing for a given potential or the amount of potential required for a given current to pass through the sample. Measurements of potential required to produce 10 mA of current were made every 4 days to compare the rate of corrosion for the two samples. The test was conducted for 12 days post that the casts were subjected to split tensile strength and then rebars examined. For the second set, the samples were directly transferred from the curing tank to the tub, no time was given for the samples to dry. Instead of using NaCl solution, seawater from Malpe beach was used to realize the electrolytic environment. A constant potential of 2.5 V was applied. Measurements of potential required to produce 10 mA were made every day. Split tensile strength test was conducted post accelerated corrosion test. The experimental setup for the accelerated corrosion test is shown in Figure 4.

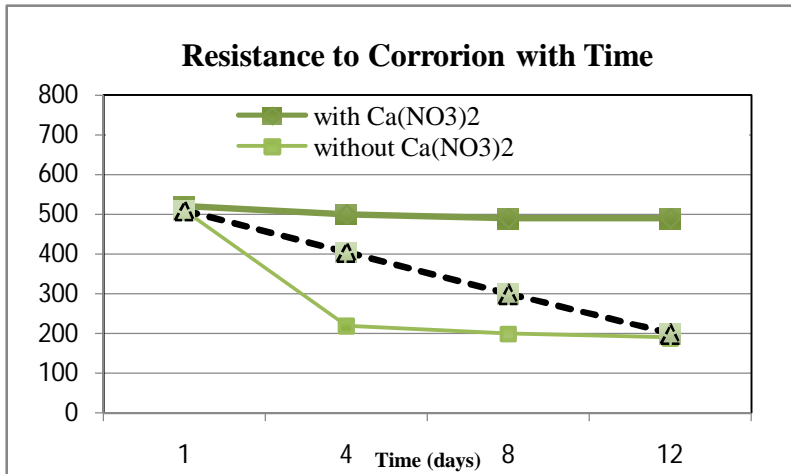
Figure 6 Graph of Resistance to Corrosion vs Time

Figure 6 below shows the resistance provided by the casts with time. The drop in resistance towards corrosion in the sample with calcium nitrate was 30 ohms and in the sample without calcium nitrate was 320 ohms. This implies the inhibitor successfully stopped 90% of the chloride-induced corrosion. We can also deduce from the Figure 6 that the chlorides have broken into the passive film in the first 3 days and hence the lower voltage required for the same amount of current to be produced. The chloride ion transport is driven by permeation through the pores since the samples were used after drying for a week and hence we see such a sudden change in the first 4 days. Visual examination (Figure 6) of both the samples clearly shows the corrosion

The voltage of the sample divided by the current values gives the resistance provided by the sample to corrosion. The

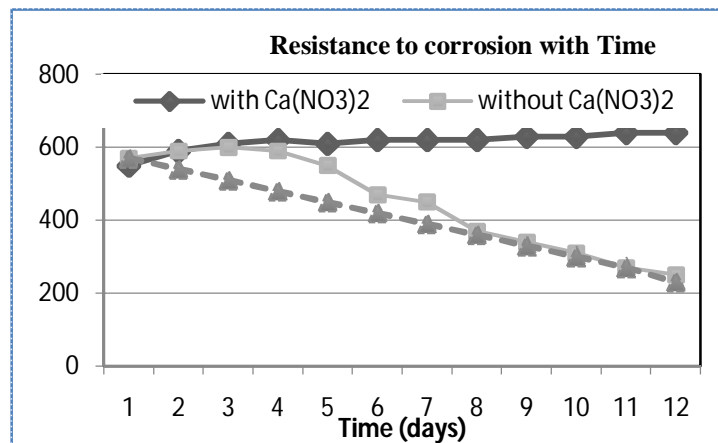
Figure 7 Graph of resistance to Corrosion 2nd set

In the first set of samples we observe that the resistance falls drastically in the first 3 days and then has a slow change in the later part of the experiment. But in the 2nd set of samples the change is gradual and only starts taking effect after day 3 observations have shown in Table 6. From the Figure 7 could be explained by the time taken by the chloride ions to reach the rebar surface. In the first set, the samples were let dry for a week before accelerated corrosion was carried out. The pores of the samples of the first set were thus empty and the chlorides rushed into the concrete with the water. But in the second set, the samples weren't allowed to dry and hence were saturated with water. The chloride ion transportation is taking place through diffusion and hence slow. We also notice that the resistance of the sample with

Calcium Nitrate increases by 90 ohm that indicates that all of the chloride corrosion is inhibited by the Calcium Nitrate and the passive layer has improved during the period.

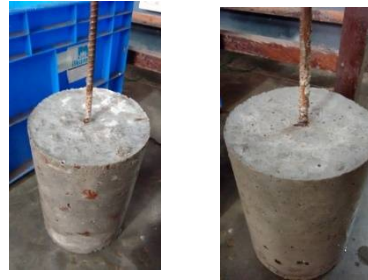
Figure 8 Sample without Calcium Nitrate and with Calcium Nitrate post accelerated corrosion test.

In the first set, the sample with Calcium Nitrate had developed surface rust. The cause for this could not be ascertained, but has to be directly or indirectly related to Calcium Nitrate, since the sample without Calcium Nitrate has no signs of any surface rust. Calcium Nitrate reacts with Sodium Chloride to form Sodium Nitrate and Calcium Chloride in the following way.

Examination of the rebars after the casts were cracked open revealed that most of the severe corrosion happened above the surface of the water. The expanding corrosion products which are seen in the Figure 8 only existed for the top 5 cm of the rebar in the concrete. A very obvious realization dawned on us, oxygen was one of the most necessary elements needed for corrosion and was abundantly available above the surface of water. Since the tub of the accelerated corrosion test was stationary, the available oxygen for corrosion under the surface of water was very limited. On the other hand, water from the tub had completely wet the samples and hence was available for corrosion for the part of the rebar above the water level too. Just as a rebar would not corrode if there was no moisture (i.e. water) in the air, it also doesn't corrode if there is no oxygen in the water. Hence the part of the rebar above the water level and in the concrete was an ideal situation for corrosion. Although chlorides were available in plenty below the surface of the water the rebars didn't corrode as much as the part of the rebar above water. This implies that chlorides don't actually cause corrosion but are a reason why it is accelerated by the destruction of the passive layer, and that is what all the theory about chloride corrosion also points to. This has huge implications for coastal structures. The parts of a concrete structure where water, chlorides and oxygen is present are the most susceptible to chloride induced corrosion.
