# **Assessment, Analysis and Retrofit Methods of an Existing Building against Earthquake Forces**

**ABSTRACT:** Important structures like historical, school, hospital and other tall buildings, that were built earlier 1980<sup>s</sup>, are probably now unsafe if checked by present seismic standards. Some of such buildings exhibit significant deficiencies in their global form or in individual members for not providing an adequate lateral resisting capacity to meet the seismic demand. Before retrofitting measures are taken, it is necessary to carryout assessment and evaluation on these buildings and identify the locations of deficiencies and distress that are found vulnerable. In the present study, an existing six storey R.C building situated in seismic zone III is chosen and analysis is carried out using existing codal provisions to calculate the additional seismic resistance required in the members or in the structure. Accordingly necessary retrofitting measures are suggested.

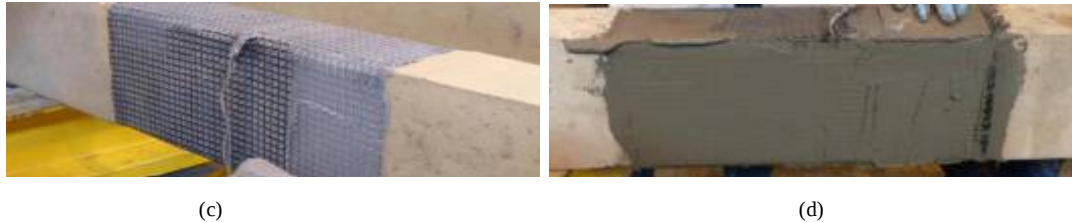
Fig. 3 Process of application of FRP jacketing (a) Cracked beam (b) Beam with grid of grooves (c) Impregnation of the textile fibers with epoxy resin (d) Addition of extra layer of mortar
