# A Step Towards Pollution Abatement of Karamana River by Constructing a Check Dam - A Case Study

**ABSTRACT:** Karamana River originates from the southern tip of the Western Ghats at Agastyar Koodam and it is an important water resource to meet the domestic and drinking water needs of the population in Trivandrum city. But it is highly polluted due to various activities. As part of management plan for pollution abatement, a proposal has been made to construct a check dam to prevent salt water intrusion from Poonthura Pozhi and sewage contaminated water from Parvathy Puthanar during high tide. This paper is a report on constructing a check dam at Kalady as a step to control pollution in Karamana River. The proposed location is at downstream of Karamana Bridge, at Dobhy Ghat Kadavu; 350 meters downstream of Karamana NH Road Bridge. The dam prevent up flow of water and sewage contamination to the upstream of check dam and enhances recharge of ground water to surrounding area.

The aim of the study is to check the environmental feasibility of constructing a check dam at Kalady in Karamana River and to determine the various effects of constructing the check dam at that site. The study

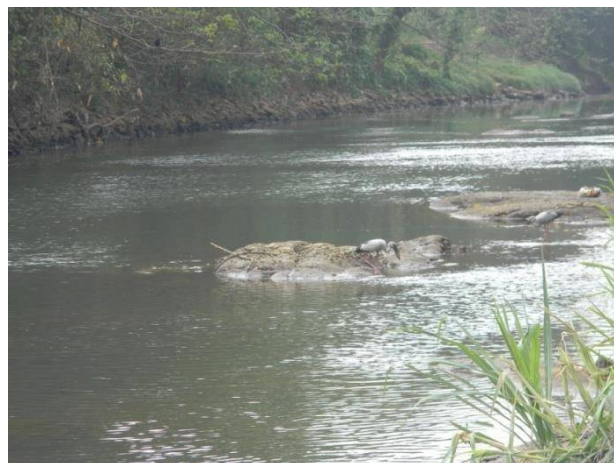
Fig 2 Migratory birds visiting the area (at Arattukadavu)

Migratory birds visit this area and are shown in Fig 2. The biodiversity board along with irrigation department is planning to convert the nearby area into a biodiversity park.

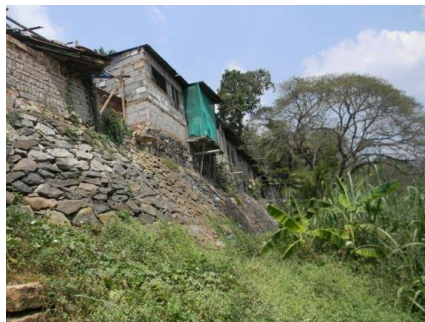
Fig 3 Discharge of liquid waste to karamana river (near Dhobi ghatt)

The Dhobi ghat kadavu which is located at 8° 28' 39.18" N latitude and 76° 58' 07.32" E longitude. It is also known as parekadavu. About twenty five families with a total population of about 100 to 120 persons live near to this kadavu. These are encroachers living on the banks of the river. A sewer line is provided at 1.5 m (5 feet) below the road surface. But at the time of overflow, it gets discharged into the Karamana River. Other waste water including raw water is discharged into this river and is shown in Fig 3.

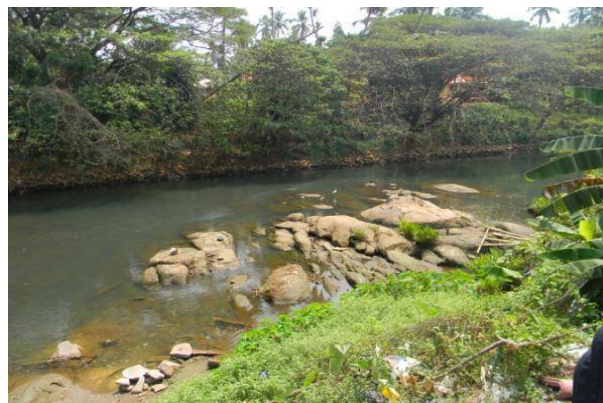
Fig 4. Proposed site for constructing check dam at Dhobi Ghat Kadavu

The site for the proposed check dam is in Dhobi Ghat Kadavu and is shown in Fig 4. Majority of the people living in this area are Brahmins and the people living on the side of the Karamana River are encroachers.

The width of the section is about 6m and depth of water is about 2 to 3m. The bund level at this site is higher than that of maximum flood level. Therefore it is an ideal place for constructing a check dam.

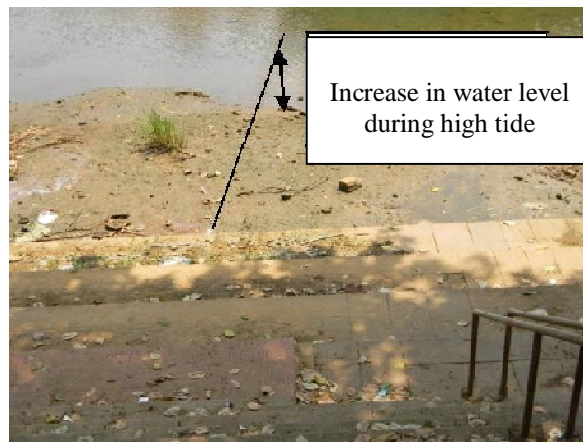
Fig 5 Increase in water level during high tide

The check dam will improve quality of life through multiple uses. The flow of water is high during morning and low at evening. There is a high upstream push during the time of high tide (afternoon). The water level rises about 2 feet at the time of high tide Line and is shown in Fig 5.

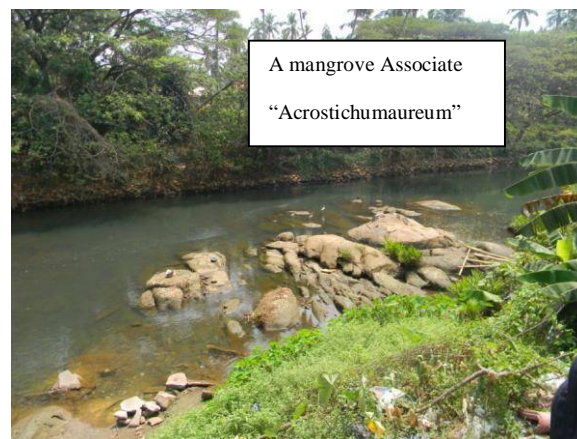
Fig 6 A mangrove associate seen in the crevices of rocks

Littering of sack and use of open ground for urinal etc causes unaesthetic view. A mangrove associate *Acrostichumaureum* which is adaptive in nature, were seen near to river bank and is shown in Fig 6. This plant indicates the presence of salinity, intrusion of saline water might be the reason for the survival of this species in the crevices of rocks which are seen projected over the water level.

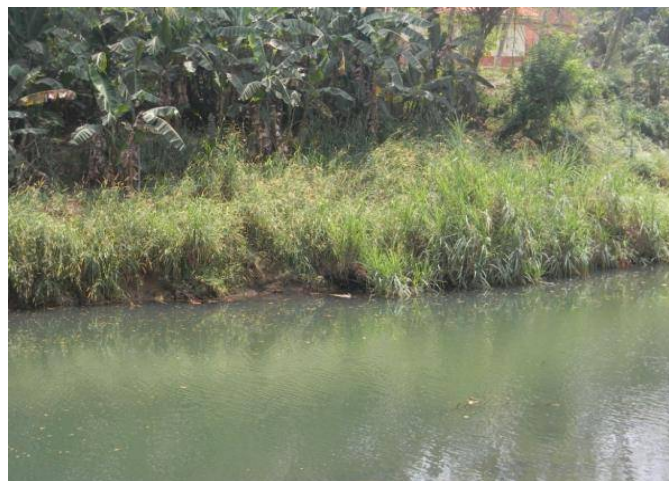
Fig 7 General terrestrial ecology of the area

The other species such as *Pennisetumso* (Grass), *Oryzasativa* (paddy), *Tridaxprocumbens* (weed), *Polygonumchinense* (Wetland species), *Ricinuscommunis*, *Enterolobiumsaman* etc were observed along the banks and is shown in Fig 7. No endemic species were observed in the area. The flora and fauna observed there are also seen in other places.
