International Journal of Innovative Research in Science, Engineering and Technology

National Conference on Technological Advancements in Civil and Mechanical Engineering – (NCTACME'17)

Traffic and Area Improvement of Baker Junction and Seematti Roundabout

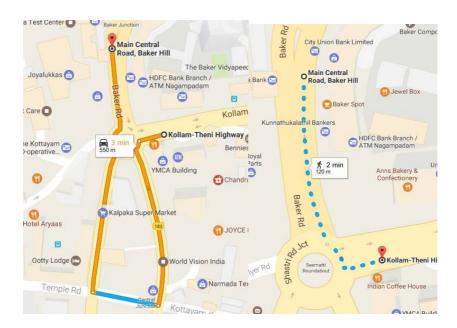
Fig.1 Traffic Movement: Shastri Road to Baker Jn.

Traffic demand at both Baker Jn. and Seematti Roundabout is very heavy and has large queue lengths. This leads to acute congestion in the area. There are 15 directions of vehicular flow at these intersections. These intersections are controlled by three police including one in the Baker Jn. There is no coordination between these three policemen. This further deepens the cause of congestion. The vehicles from Shastri road going to Baker Jn. has to travel about half a Kilometre while the actual distance between these two points is about 100m. This is because no traffic is allowed to go around the Seematti roundabout towards Baker Jn. This practice increases the traffic in the Nattakam– Baker Jn.leg.

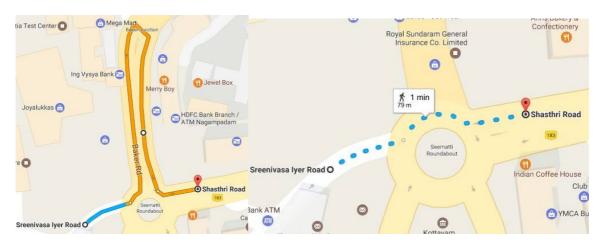
Fig.2 Traffic Movement: SreenivasaIyerShastri Road.

The vehicles from SreenivasaIyer road (Old Bus stand) going to Shastri road has to travel about half a Kilometre while the actual distance between these two points is about 80m. This is because no traffic is allowed to go around the Seematti roundabout towards Shastri road. These vehicles have to take a U-turn at Baker Jn. This practice increases the traffic in the Baker Jn.
