A Review on Comparative Study of Bridge Failure due to Corrosion and Scouring

Mayank Kaushal¹, Gurinderjeet Singh²

Student, Department of Civil Engineering, Chandigarh Polytechnic College, Gharuan, Mohali, India¹

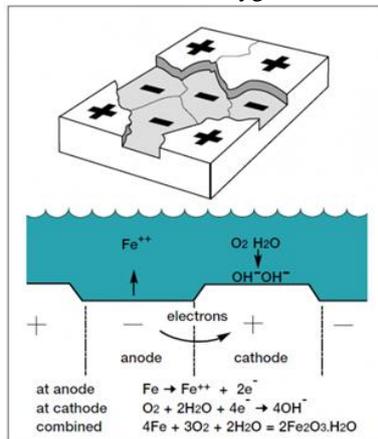
Fig. 3.2. Schematic representation of the corrosion mechanism for steel

The corrosion of steel can be considered as an electrochemical process that occurs in stages. Initial attack occurs at anodic areas on the surface, where ferrous ions go into solution. Electrons are released from the anode and move through the metallic structure to the adjacent cathodic sites on the surface, where they combine with oxygen and water to form hydroxyl ions. These react with the ferrous ions from the anode to produce ferrous hydroxide, which itself is further oxidised in air to produce hydrated ferric oxide (i.e. red rust.) [2]

(Steel) + (Oxygen) + (Water) = Hydrated ferric oxide (Rust)

The process requires the simultaneous presence of water and oxygen. In the absence of either, corrosion does not occur.

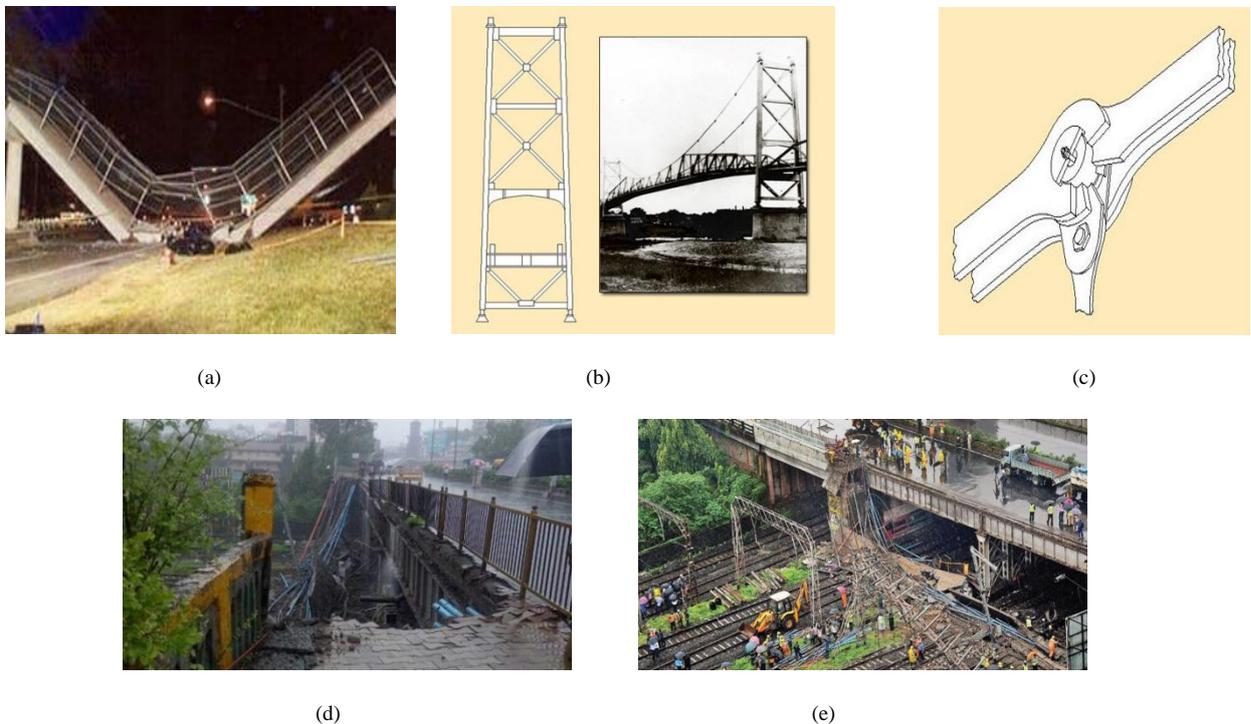
Fig. 3.4. Bridge failure due to corrosion (a) Charlotte Motor Speedway Concord, North Carolina, 13 mi (21 km) outside Charlotte (b) Tower of Silver Bridge (c) Section of an eye-bar joint in the Silver Bridge (d) and (e) Andheri bridge collapse, Mumbai (Image: Reuters)

After an inspection it was determined that all 11 steel cables that were holding the bridge together were corroded, and the bridge busted under the weight. The corrosion was caused by too much calcium chloride, an inorganic salt compound that's highly corrosive to steel, mixed into the grout that cemented the bridge's steel cables in place. The compound is acceptable in small amounts, but the construction company that built the bridge used about 40 times more calcium chloride than what was regulated. [4]

Investigation of the wreckage pointed to the cause of the collapse being the failure of a single eye bar in a suspension chain, due to a small defect 0.1 inch (2.5 mm) deep. Analysis showed that the bridge was carrying much heavier loads than it had originally been designed for and was poorly maintained. A small crack was formed through fretting wear at the bearing, and grew through internal corrosion, a problem known as stress corrosion cracking. Constructed in the mid-1920s, the steel used for the bridge was not known for being susceptible to corrosion, so disaster was inevitable. In addition, the bridge was designed for Model-T Ford, which had an approximate weight three times less than cars in 1967.

The pedestrian pathway at Andheri train station, accident occurred due to heavy/deep corrosion and pitting of cantilever steel brackets supporting the pathway resulting in thinning down of section. Also, the extra weight of nearly 124 tones — comprising dry sand, paver blocks and cable wires — that led to the collapse provided by the BMC without prior permission from the Western Railway, not contemplated when the bridge was designed, also contributed to its weakening. [6]

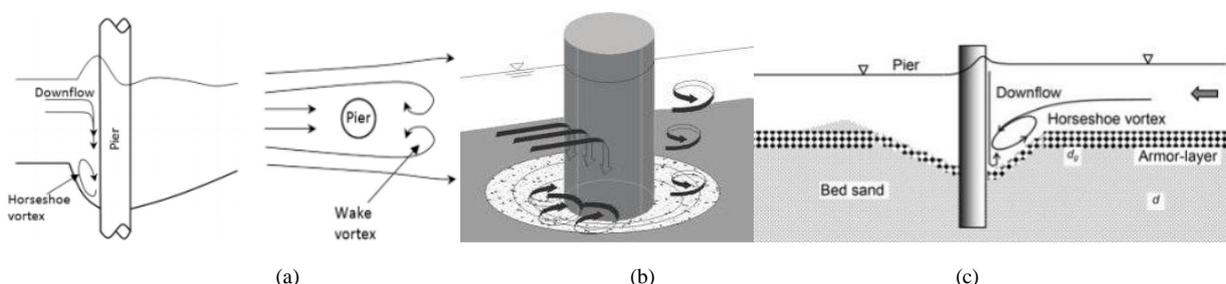
Fig. 4.2. Scouring mechanism (a) Presentation of vortex around a circular pier (b) System of vortex at a bridge pier (c) Scour in armored bed condition

At the obstruction in form of pier or abutment, the unidirectional flow changes into three dimensional as the water pileup in front face of the obstruction and the flow accelerates around the nose. This phenomenon results in formation of vortex at the base of the pier known as horseshoe vortex and the vortex form in the vertical direction downstream of the pier known as wake vortex as shown in figure 4.2 (a). [10]

The pileup of water due to obstruction because of decelerations of flow due to stagnation pressure of water causes a downward flow results in horseshoe vortex. The vertical component of the downward flow causes erosion around the base of the pier.

Due to rolling of unstable shear layers at the surface of the pier wake vortex are generated at the separation line and moves forward with flow downstream of the pier. It can be shown as in figure 4.2(b). [11]

In the practical case the river bed is generally composed of mixture of different sizes of material. Due to washing out of finer materials an armor layer is formed of coarser materials which protect the underlying finer particles from further scour. Due to presence of armor layer the clear water regime can be extended as the value of critical velocity increases. The armor layer is shown in figure 4.2 (c). [12]

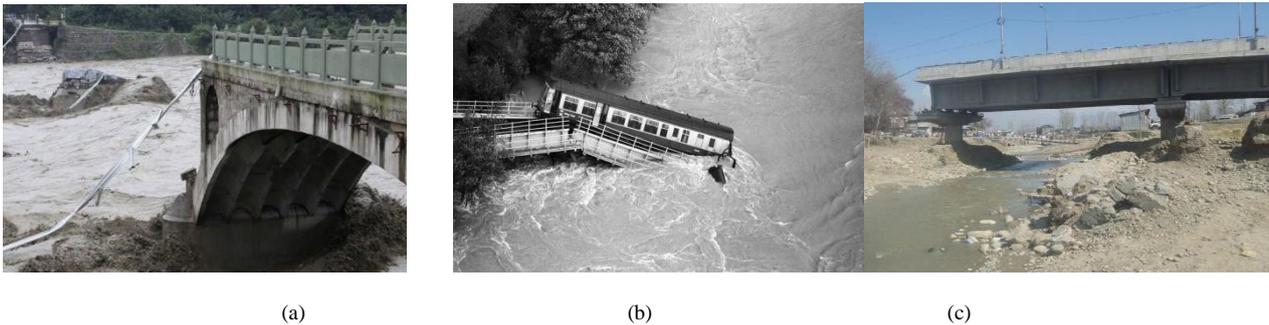
Fig. 4.4. Bridge failure due to scouring (a) Collapse of Jahu Bridge – (Jahu Bridge, Pankaj, 2018) (b) Glanhyd Bridge crossing Towy River in Wales in England, Llandeilo, Carmarthenshire (c) Chadoora Bridge

This bridge collapsed mainly due to scouring of soil below the foundation. Scouring of foundation can occur all over the year, it reaches peak when flood comes in water body over which a bridge is spanning. Scour at bridges is a very complex process. The sum and interaction of all these river processes create a very complex phenomenon. The interactions of scour and channel instabilities are very difficult to predict.

The collapse mainly caused by the scour at the downstream end of pier number 3 that undermined the foundations, allowing the pier to settle and eventually break its back. Many of the timber piles were missing and this had allowed the undermining to progress below the foundation slabs. A study of the river flow found that there was a re-circulating zone or eddy at the downstream end of pier 3 and up to 17000 tons of the sediment may have passed the bridge during the three hours of peak flows, indicating a major live bed scour with both erosion and deposition at the bridge. The depth of any anticipated scour at pier 3 could have been between 0.75 and 2.2m depth. It seems that local scour at the downstream end of pier 3 was the main cause of the collapse. The past arrangements whereby bridge superstructures were replaced without any check being made on the existing foundation construction to be unwise. The bridge severed from damage to the various parts of the steel superstructure of the bridge, the geometry of the collapsed structure, the secondary damage to the abutments. Bed was already being significantly eroded.

the bridges on river is scour. Scour is the result of the erosive action of the running water, excavating and carrying away material from stream beds and banks. Scour or soil erosion at a bridge is caused by the dynamic effects of the water in motion. The length of this bridge is 108.3metre long before flooding.[18] The main cause of the failure of this bridge is scour type failure. According to the reports, the discharge which was recorded earlier on 1973 was 5000 cusecs. But during the floods on 9 September 2014, it was 9504 cusecs. This high discharge is hardly a criterion for the failure of the Chadoora Bridge. The length of the bridge is 108.3mtrs, but during floods the linear waterway was recorded only 36.6mtrs which is negligible for such a major bridge. This waterway of the bridge was not enough to counteract the flood water. The flow of the water has been restricted to 36.6 meter with concentration of flow in only 27.8mtrs width while the bridge is about 108.3mtr in length with four piers in between and two side abutments. The waterway was grossly inadequate.

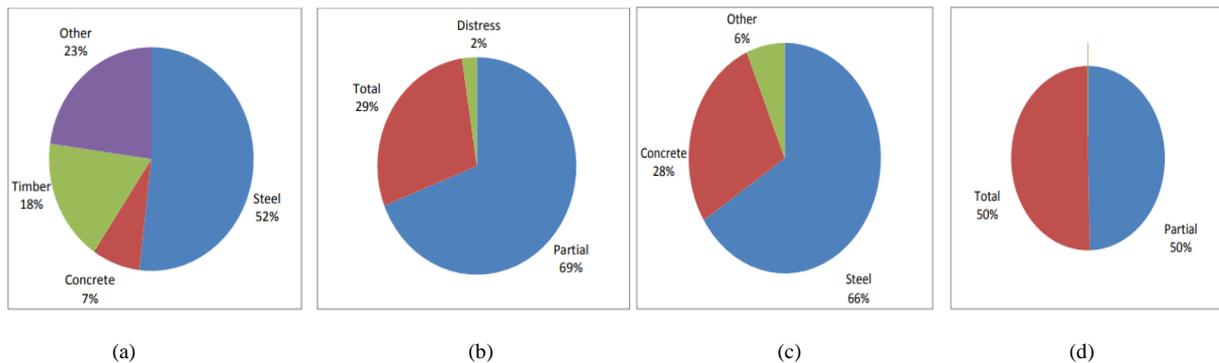
Fig. 5. Comparative study (a) Material type of the failed bridges due to environmental degradation, 71 failure (b) Type of failure due to environmental degradation, 71 failure (c) Material type of the failed bridges due to scour, 200 failures (d) Type of failure due to scour

As we had discussed bridge failure due to two major factors that are corrosion and scouring respectively. If we have to compare it, than we have to look back to the failures that took over in the past. In reinforced concrete bridges, corrosion and rust can cause problems because of the steel encased in the concrete. Bridges with other materials are also vulnerable to environment degradation, as shown in Figure-5(a), the number of timber bridges vulnerable to environment degradation is 18%. In this study, 17 out of 1,062 bridges collapsed because of environmental degradation. Whereas in this study, 200 bridges collapses happened because of scour. As seen in Figure 5(c) steel are more vulnerable to scour in comparison to other material. In Figure 5(d) the percentage of partial and total collapse is charted and it can be concluded that partial collapse and total collapse are equally distributed in bridge failure due to scour. [19]
