# A Perceptual Approach for Performing Road Safety Audit for Highway during Construction Stage

Abhishek Rajendra Ghinmine, Prof. Kapil Tiwari

A road stretch from College of Engg. & Tech., Akola to Vyalla on Amravati- Shegaon State Highway No-194. After taking image, finalization of the parameters of road safety i.e. Inventories, Geometry, Rules and regulation are done. Data collection is started from 5 km stretch per day including all the data. Then data collected is tabulated. Once the data collection process is completed, the entire section of

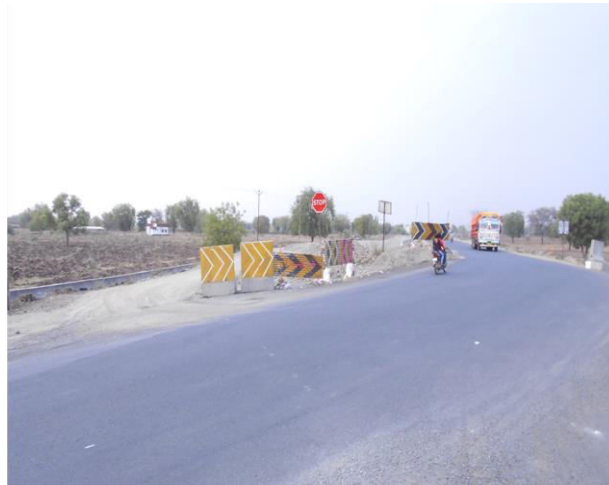
Speed limit sign and informatory sign boards must be present at consolidation and isolated ways of organization streets, genuine crossing points, petrol pump and specialist's offices. Delineators must be given on the centre and edge of longitudinal curve. Danger markers may be suited divisional and channelizing islands at all genuine crossing points, centre openings, before parapet bridge structures, before crash obstacles, before vertical posts of overhead gantry sign boards laying on shoulders. All signs are reflectorized sort with high power retro -canny boards of typified sort has been given.

**Fig 3: Hazard Marker Sign and Diversion Sign**

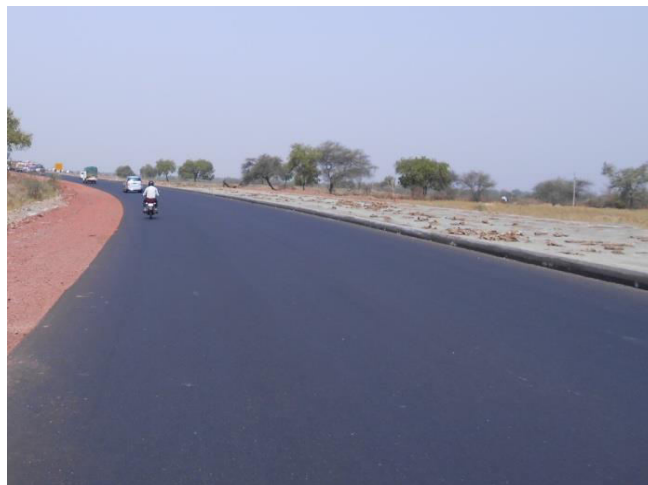
It is necessary to provide continuous regulatory sign boards on every curve as well as speed limit sign board as it warns the driver to reduce the speed of the vehicle so the vehicle should not topple in other lane and cause major accident.

**Fig4: Regulatory Sign Boards**

- Speed limit sign board and Regulatory sign board should be provided.
- Informatory sign board should be provided where there are arterial roads and old informatory boards should be painted at regular interval.

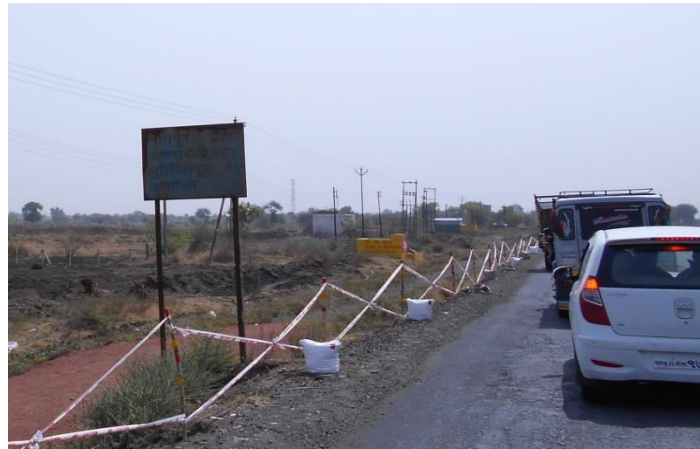
Fig 5: Informatory Sign Board

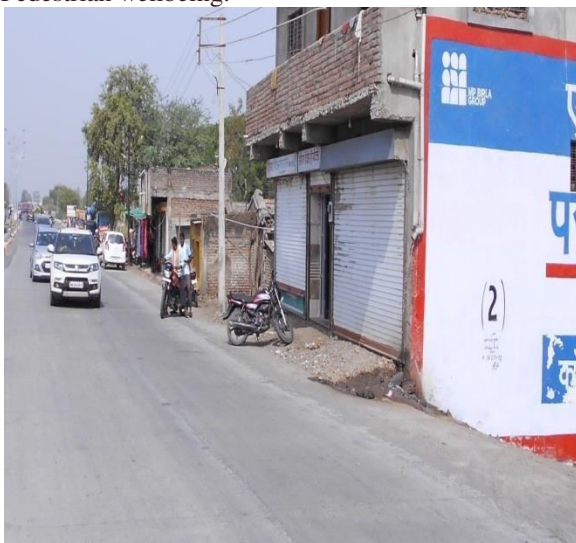
Separate pathway should be given around the local area and town territory for wellbeing of pedestrian. Pedestrian guardrail might be given at the spots where pedestrian movement is high and on raised pathway in favours of carriageway at transport stops and transport coves for satisfactory length yet at least 10 m on either side for Pedestrian wellbeing.

Fig 6: Footpath absent with barrier

- Footpath must be provided near village touching highway for ease village people without entering main carriageway.
- Speed breaker must be provided at the entrance of the village to slow the village traffic from immediate entering in main traffic stream.

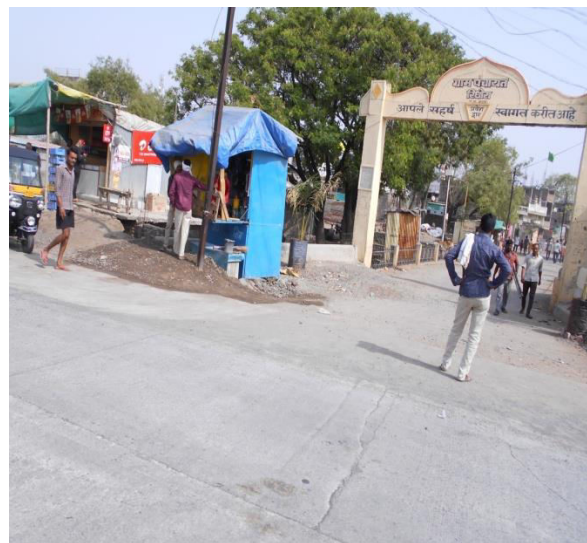
Fig 7: Unraised Pathway

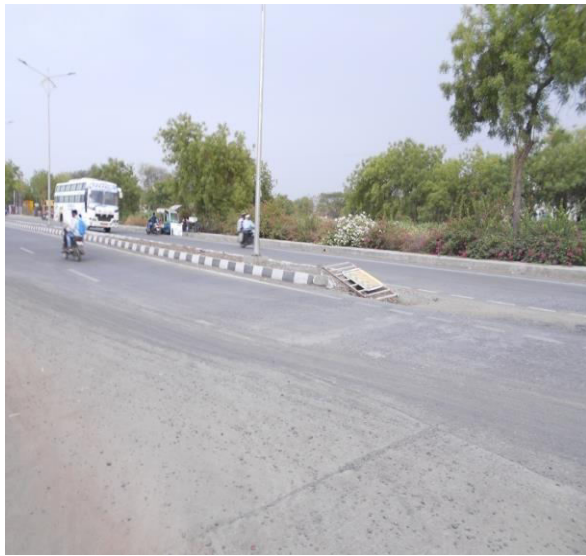
Most of the median openings are not provided with proper sign boards. No vegetation must be planted in median (upto 100m) to keep up clear sight separate at median opening areas. Pre warning sign board must be provided on high speed national highways. It is observed that at a few areas of the venture extend, nearby individuals were harming the middle kerbs and utilizing as unapproved middle openings. These might be confined and every single such openings might be shut close.

**Fig 8: Dangerous meridian opening**

- Dangerous meridian opening must be provided with crash barrier with appropriate reflective color.
- Kerbs must be completed when work is done on the specific part.

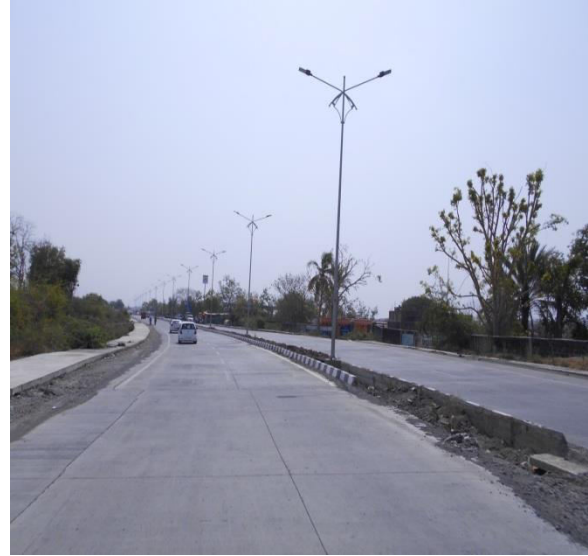
**Fig 9: Kerbs missing dangerous at night**

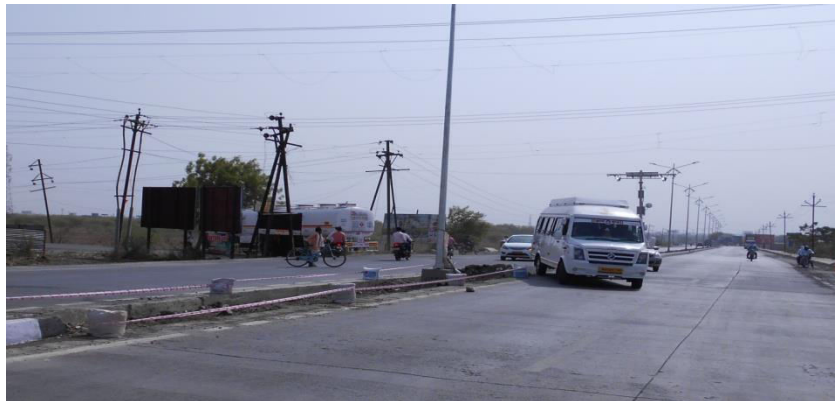
Median opening must be given large where there is frequent turning of vehicle for specific town / village.”STOP” line and ‘U-turn’ marking must be taken up to manage the drivers legitimately.

**Fig 10: On proper size meridian opening is provided**

- Proper size of meridian opening should be provided where there is crossing of heavy vehicle.
- Bridge railing must be maintained regularly and should be painted with reflective paint.

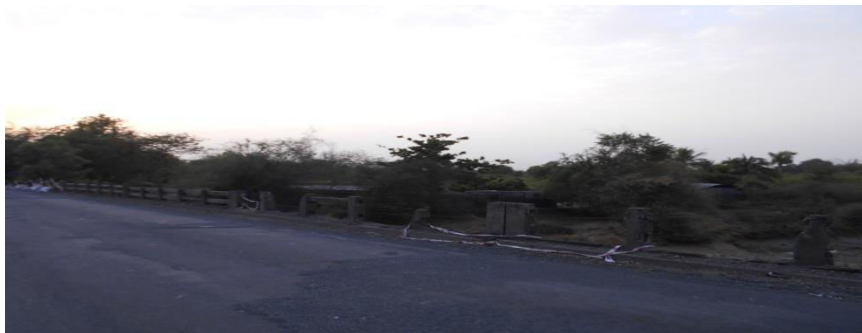
Bridge Railing must be maintained regularly and height of the railing also be increased so as to avoid any future hazard to the road users

**Fig 11: Bridge railing missing**

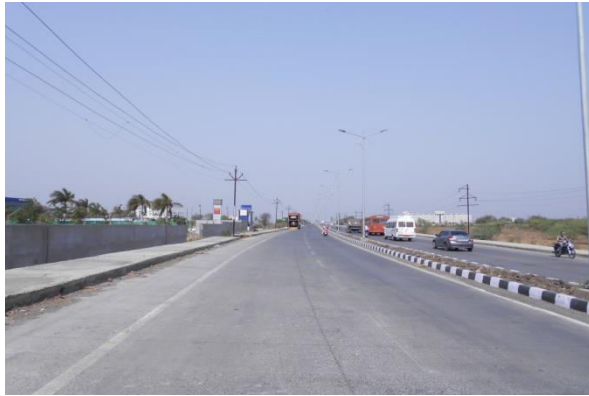
The street markings were missing and blurred at specific areas while old markings controlling impermanent activity had not

been expelled viable. New markings are suggested as absence of the marking will confuse and mislead the drivers about their boundaries of lanes. Use of an excellent retro intelligent material compelling in rain and haziness with sufficient slip resistance qualities was prescribed.

**Fig 12: Blurred Marking**

- Blurred old marking should be scraped off and new paint should be painted.
- Warning sign should be provided where there is necessity.

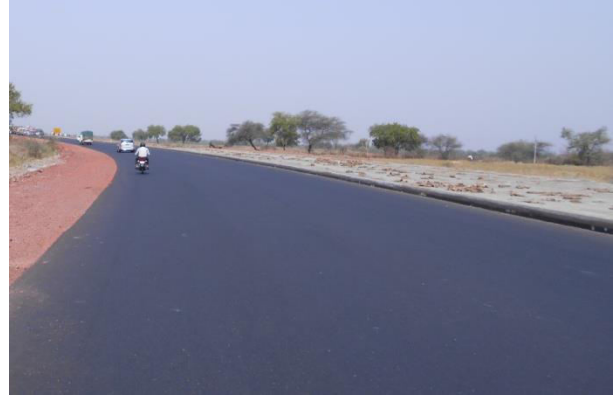
**Fig 13: No Marking**

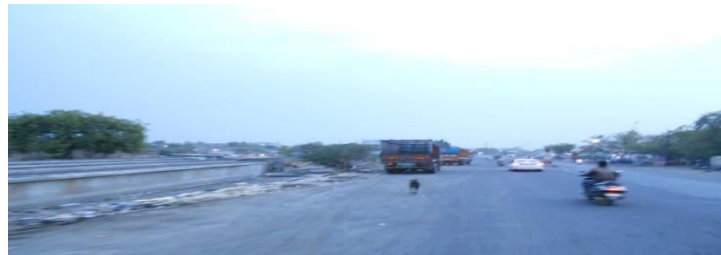
**Fig 14: Roadside parked vehicles**

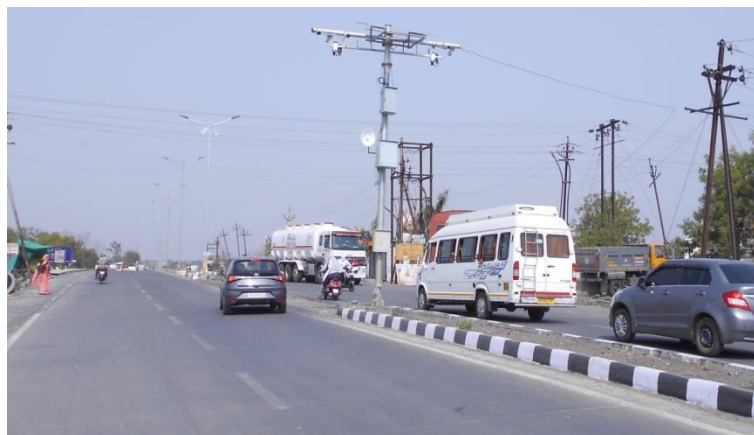
**Fig 15: Speed sign board and warning sign board missing**

Proper Informatory sign boards, hazard marker as well as storage lane is suggested as this spot of intersection.
