Volume 12, Issue 9, September 2023

Assessment of Physico-Chemical Parameters of Perumal ERI

K.SOUNDHIRARAJAN¹, I.NELSON²

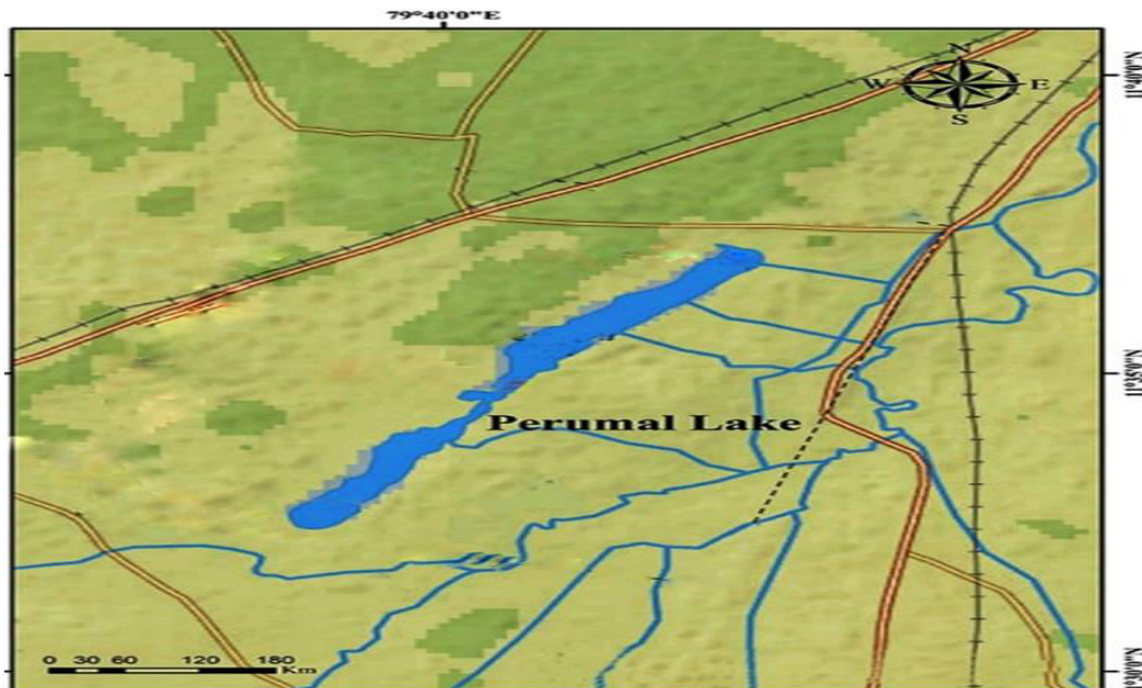
Figure: It denotes the location of samples collected in Perumal eri.
