# International Journal of Innovative Research in Science Engineering and Technology (IJIRSET)

**Volume 14, Issue 4, April 2025**

# Water Quality Assessment of Vembanad Lake, Alappuzha

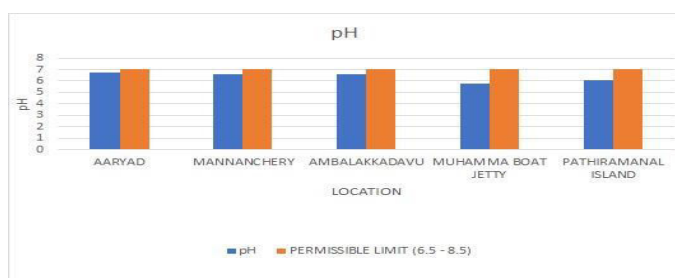
FIG 4.1:Ph

#### COMPARISON OF OBSERVED VALUE WITH PERMISSIBLE LIMITS

Parameters	Units	Aaryad	Mannanchery	Ambalakkadavu	Muhamma Boat Jetty	Pathiramanal Island	Permissible Limit
Temperature	°C	31	29	29.9	28.9	29.36	10-22.22°C
pH @25°C	-	6.71	6.62	6.61	5.8	6.09	6.5-8.5
Turbidity	NTU	6.8	3.13	1.5	1.53	1.04	5 NTU
Total Dissolved	mg/L	282.06	253.5	361.63	1380.3	1656	500ppm

Solids							
Nitrate	mg/L	0	0	0	0	0	45 mg/l
Phosphate	mg/L	0	0.03	0	0.013	0.036	0.1 mg/l
Feacal Coliform	Cfu/100ml	34.66	9	56.66	0	0	0/100ml
Dissolved Oxygen	mg/L	5.63	5.1	5.46	4.167	3.53	5 mg/l
BOD @27°C (5 days)	mg/L	1.23	1.7	1.66	1.5	1.76	<5 mg/l
