# **Foot Over Bridge Health Monitoring with Reliable Solution for Retrofitting**

**Mangesh Hindurao, Dr. V.A. Patil**

In my research project, the structure under inspection, the Kalyan West Skywalk, is a composite structure constructed by the Mumbai Metropolitan Region Development Authority (MMRDA), located in Kalyan, Maharashtra, to the North-West side of Thane railway junction. The skywalk is currently under Kalyan Dombivali Municipal Corporation (KDMC)'s management.

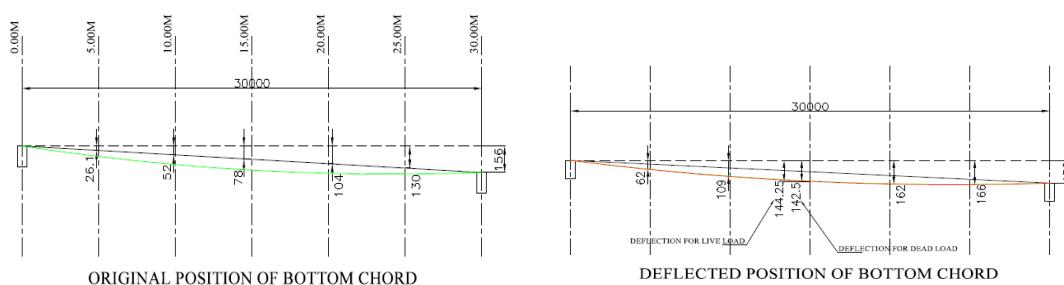
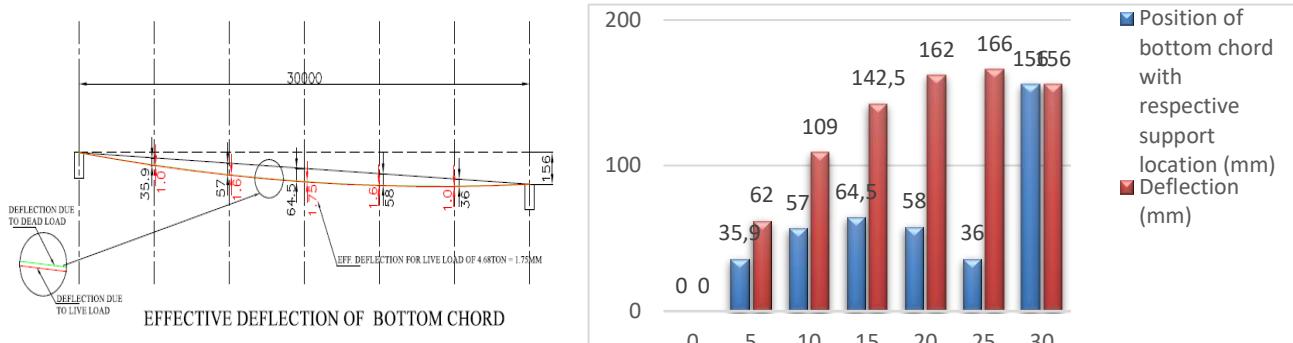
Fig: 3 (a) Deflected position of bottom chord, (b) Original position of bottom chord, (c) Effective deflection of bottom chord, and (d) Position of Maximum deflection

Example: For a 30 m span: Vertical Deflection: Theoretical condition by using STAAD Pro., Max Allowable Deflection=L/250

Where L = span length in mm. Max Deflection=30000/250=120 mm

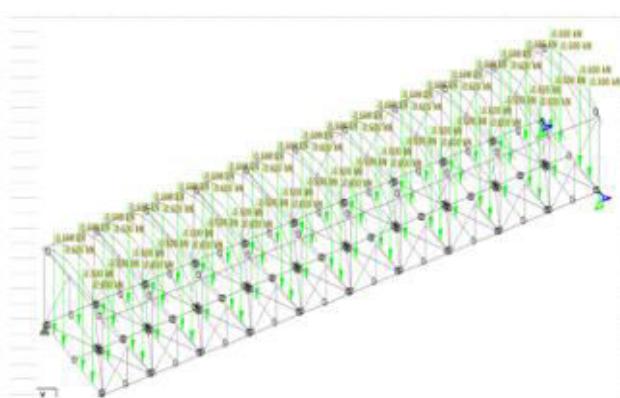
##### Case-I

Deflection for LL - 3.00ton. (Equally distributed)					
	Node	L/C	Horizontal X mm	Vertical Y mm	Horizontal Z mm
Max X	1414	4 LL ON A6	0.206	-0.026	-0.036
Min X	1465	4 LL ON A6	-0.029	-0.026	-0.035
Max Y	978	4 LL ON A6	0	0	0
Min Y	1028	4 LL ON A6	0.088	-0.886	-0.043
Max Z	978	4 LL ON A6	0	0	0
Min Z	1028	4 LL ON A6	0.088	-0.886	-0.043
Max rX	1417	4 LL ON A6	0.203	-0.092	-0.037
Min rX	1092	4 LL ON A6	0.073	-0.875	-0.043
Max rY	1042	4 LL ON A6	0.009	-0.402	-0.004
Min rY	1467	4 LL ON A6	0.174	-0.132	-0.002
Max rZ	1467	4 LL ON A6	0.174	-0.132	-0.002
Min rZ	1416	4 LL ON A6	0.001	-0.133	-0.001
Max Rst	1028	4 LL ON A6	0.088	-0.886	-0.043

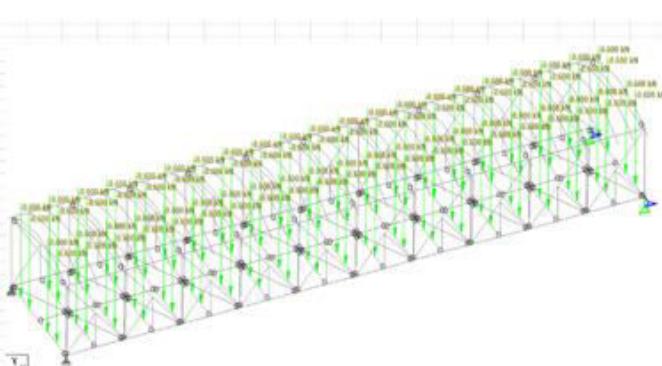
##### Case-II

Deflection for LL - 4.68ton. (Equally distributed)					
	Node	L/C	Horizontal X mm	Vertical Y mm	Horizontal Z mm
Max X	1411	4 LL ON A6	0.289	-0.038	-0.006
Min X	1462	4 LL ON A6	-0.047	-0.038	-0.006
Max Y	978	4 LL ON A6	0	0	0
Min Y	1001	4 LL ON A6	0.121	-1.26	-0.007
Max Z	987	4 LL ON A6	0.081	-1.195	0.001
Min Z	1028	4 LL ON A6	0.12	-1.242	-0.008
Max rX	980	4 LL ON A6	0.12	-1.242	-0.005
Min rX	989	4 LL ON A6	0.121	-1.26	0.001
Max rY	1042	4 LL ON A6	0.01	-0.565	-0.001
Min rY	1055	4 LL ON A6	0.231	-0.564	-0.001
Max rZ	1460	4 LL ON A6	0.241	-0.191	0
Min rZ	1410	4 LL ON A6	0.001	-0.19	0
Max Rst	1001	4 LL ON A6	0.121	-1.26	-0.007

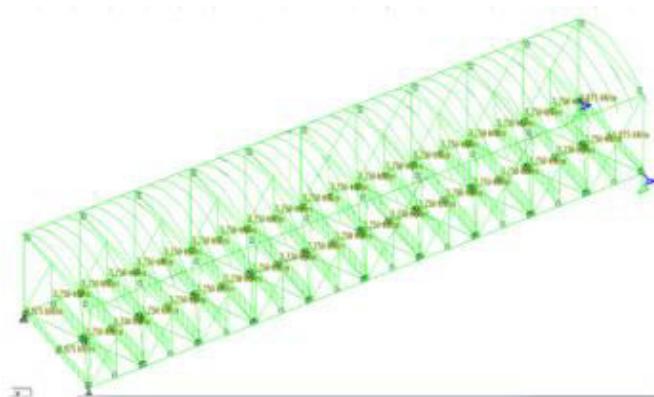
**Case-III**

Deflection for LL -25% of Design Live Load. (Equally distributed)

Node	L/C	Horizontal X mm	Vertical Y mm	Horizontal Z mm
Max X	1414	4 LL ON A6	1.37	-0.178	0
Min X	1465	4 LL ON A6	-0.22	-0.178	0
Max Y	978	4 LL ON A6	0	0	0
Min Y	1028	4 LL ON A6	0.575	-5.962	0
Max Z	978	4 LL ON A6	0	0	0
Min Z	980	4 LL ON A6	0.575	-5.962	-0.016
Max rX	980	4 LL ON A6	0.575	-5.962	-0.016
Min rX	1048	4 LL ON A6	0.48	-5.902	-0.004
Max rY	1065	4 LL ON A6	0.731	-4.146	-0.005
Min rY	1070	4 LL ON A6	0.419	-4.146	-0.005
Max rZ	1467	4 LL ON A6	1.146	-0.901	-0.001
Min rZ	1416	4 LL ON A6	0.004	-0.901	-0.001
Max Rst	1028	4 LL ON A6	0.575	-5.962	0

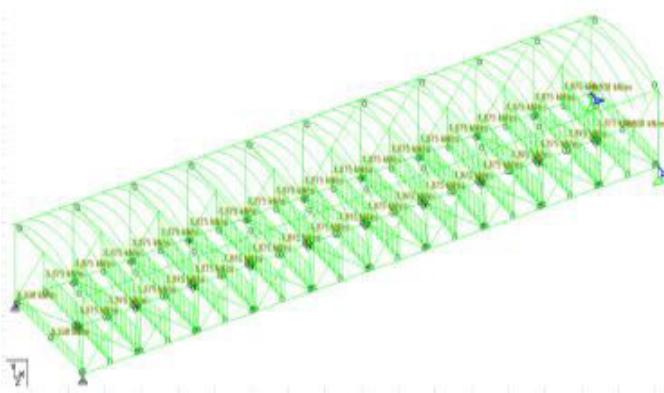
**Case-IV**

Deflection for LL - 50% of Design Live Load. (Equally distributed)

Node	L/C	Horizontal X mm	Vertical Y mm	Horizontal Z mm
Max X	1414	4 LL ON A6	2.74	-0.357	0
Min X	1465	4 LL ON A6	-0.441	-0.357	0
Max Y	978	4 LL ON A6	0	0	0
Min Y	1028	4 LL ON A6	1.15	-11.924	0
Max Z	978	4 LL ON A6	0	0	0
Min Z	980	4 LL ON A6	1.15	-11.924	-0.033
Max rX	980	4 LL ON A6	1.15	-11.924	-0.033
Min rX	1048	4 LL ON A6	0.959	-11.803	-0.008
Max rY	1065	4 LL ON A6	1.463	-8.293	-0.01
Min rY	1070	4 LL ON A6	0.837	-8.293	-0.01
Max rZ	1467	4 LL ON A6	2.291	-1.802	-0.001
Min rZ	1416	4 LL ON A6	0.008	-1.802	-0.001
Max Rst	1028	4 LL ON A6	1.15	-11.924	0

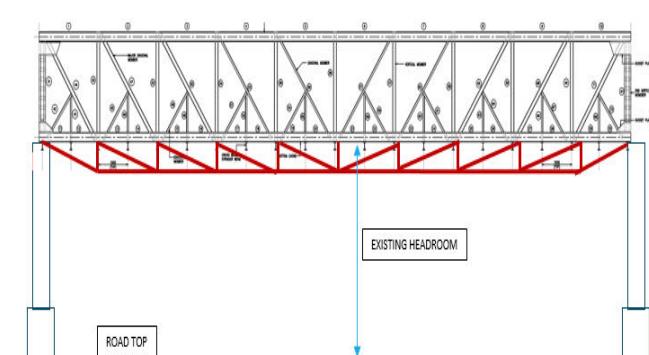
**Option 1 – Additional frame below**

Node	L/C	Horizontal X mm	Vertical Y mm	Horizontal Z mm	Resultant mm	Rotational rX rad	Rotational rY rad	Rotational rZ rad
Max X	1411	3 DEAD LOAD	8.539	-0.702	-0.006	8.568	0	0	-0.003
Min X	1462	3 DEAD LOAD	-0.528	-0.702	-0.006	0.878	0	0	0.003
Max Y	978	3 DEAD LOAD	0	0	0	0	0	0	-0.004
Min Y	989	3 DEAD LOAD	4.005	-31.438	0.105	31.693	0	0	0
Max Z	989	3 DEAD LOAD	4.005	-31.438	0.105	31.693	0	0	0
Min Z	980	3 DEAD LOAD	4.005	-31.438	-0.105	31.692	0	0	0
Max rX	1472	3 DEAD LOAD	-0.388	-5.508	-0.043	5.521	0	0	0.003
Min rX	1421	3 DEAD LOAD	8.399	-5.508	0.043	10.044	0	0	-0.003
Max rY	1465	3 DEAD LOAD	-0.528	-0.702	0.006	0.878	0	0	0.003
Min rY	1414	3 DEAD LOAD	8.539	-0.702	0.006	8.568	0	0	-0.003
Max rZ	1461	3 DEAD LOAD	8.01	0	0	8.01	0	0	0.004
Min rZ	978	3 DEAD LOAD	0	0	0	0	0	0	-0.004
Max Rst	989	3 DEAD LOAD	4.005	-31.438	0.105	31.693	0	0	0

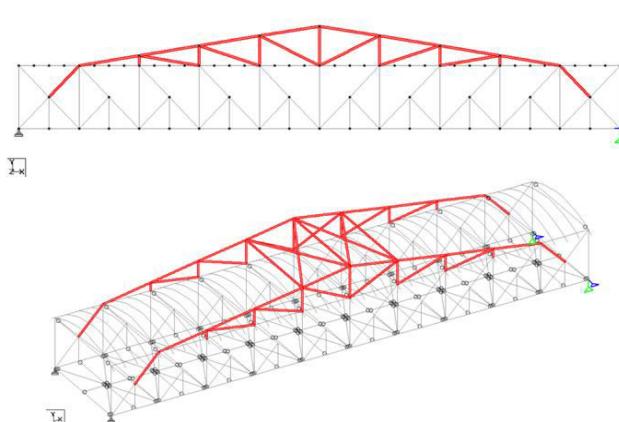
Node	I/C	Horizontal X mm	Vertical Y mm	Horizontal Z mm	Resultant mm	rx rad	ry rad	rz rad
Max X	1461	3 DEAD LOAD	6.918	0	0	6.918	0	0	0.003
Min X	978	3 DEAD LOAD	0	0	0	0	0	0	-0.003
Max Y	978	3 DEAD LOAD	0	0	0	0	0	0	-0.003
Min Y	988	3 DEAD LOAD	2.953	-22.817	0.021	23.008	0	0	0
Max Z	1594	3 DEAD LOAD	3.459	-22.279	0.16	22.546	-0.001	0	0
Min Z	1609	3 DEAD LOAD	3.459	-22.279	-0.16	22.546	0.001	0	0
Max rx	1609	3 DEAD LOAD	3.459	-22.279	-0.16	22.546	0.001	0	0
Min rx	1594	3 DEAD LOAD	3.459	-22.279	0.16	22.546	-0.001	0	0
Max ry	1411	3 DEAD LOAD	5.649	-0.608	-0.006	5.682	0	0	-0.002
Min ry	1462	3 DEAD LOAD	1.269	-0.608	-0.006	1.407	0	0	0.002
Max rz	1461	3 DEAD LOAD	6.918	0	0	6.918	0	0	0.003
Min rz	979	3 DEAD LOAD	0	0	0	0	0	0	-0.003
Max Rst	990	3 DEAD LOAD	3.966	-22.817	0.021	23.159	0	0	0

Maximum deflection for dad load is **37.501mm**

Maximum deflection for live load from STAAD pro. Is **23.849mm**

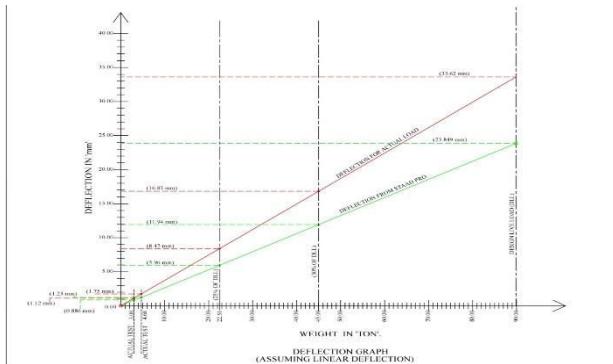
Fig: 4 (a) Graphical representation for Actual Deflection On Site & Staad Pro. For Live Load, (b) Deflection for Live Load of different Cases

Actual deflection on site for dead load is **64.5mm**.

Actual deflection on site & STAAAd Pro. For live load as follows.

Sr. No.	Total Wt. (Ton)	Deflection from STAAD (mm)	Deflection on site / (linear graph) (mm)	Remark
1	$60 \times 78 = 4.68$	1.26	1.75	Defl. On field & STAAD.
2	$60 \times 50 = 3.00$	0.886	1.02	
3	22.5(25% DLL)	5.96	9.44	Defl. From Line graph.
4	45(50% DLL)	11.94	19.27	
5	90(DLL)	23.849	38.740

- 1] The measured deflection of the skywalk bridge under both cases dead load and live load is increased, which exceeds the allowable deflection limits prescribed by standard design codes. This excessive deflection indicates that the structure is not performing as intended and may be experiencing inadequate stiffness, material deterioration, or under-designed structural elements.

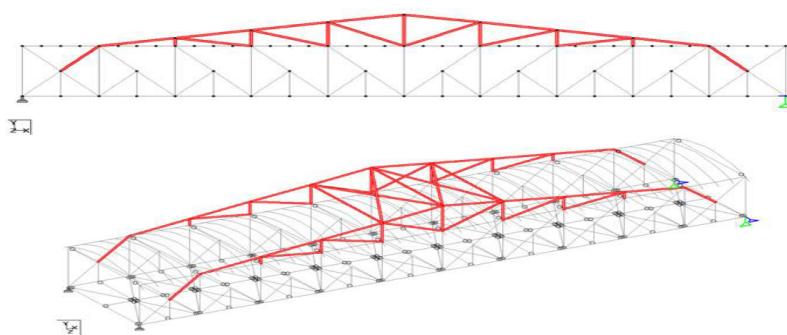
Fig: 4 The Adopted New Frame on Top of Girder to Control Further Deflection

5] Installing a new frame above the girder increases the girder's moment of inertia, which helps control additional deflection. In addition, the frame enhances the overall aesthetic appearance of the bridge.
