# Types and Mechanisms of Corrosion in Prestressing Bars

**ABSTRACT :** Prestressed bars, due to their high-stress state and small cross-sectional characteristics, often exhibit no obvious signs during the initial stages of corrosion. However, their corrosion hazards are more severe compared to those in ordinary reinforced concrete. An in-depth investigation into the corrosion types and mechanisms of prestressed bars is crucial for addressing durability issues in prestressed concrete structures. This paper categorizes the corrosion of prestressed bars in concrete into four types, systematically elaborating on the occurrence conditions, corrosion mechanisms, and influencing factors for each type. The study highlights that the steel strands in prestressed bars, owing to their unique lamellar pearlitic microstructure induced by stretching, are less prone to anodic dissolution-type and hydrogen-induced cracking-type stress corrosion. Additionally, prestressed bars may still suffer corrosion even in alkaline environments. Furthermore, compared to the other three corrosion forms, chloride-induced corrosion poses a more frequent threat to prestressed bars in concrete. The findings of thi

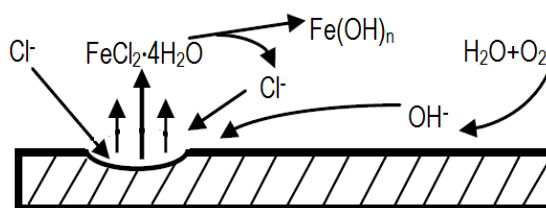
Fig. 1: Schematic diagram of steel strand corrosion in concrete under chlorine salt environment

The chloride ions that invade the surface of the prestressing bars from the outside will destroy the passivation film on the surface of the steel bar to varying degrees, causing part of the surface of the steel bar to be reactivated. They will not be consumed during the corrosion reaction but will play a catalytic role, accelerating the corrosion rate of the prestressing bars. At present, the mechanism of destruction of chloride ions on passivation films is not clear, because it is difficult to study this process from the atomic scale in extremely thin passivation films. Steel strands show obvious pit corrosion patterns in chlorine salt environment. First, because the passivation film on the surface of the steel strand is relatively flat and complete, only few chloride ions can penetrate the passivation film, forming a corrosive nucleus and causing rust of the blocked battery, which continues to develop into pits and corrosion holes, while other surfaces protected by the passivation film are not rusted; second, because steel strands are similar to hot-rolled ribbed steel bars, they are uneven at the macroscopic, and the interface between the steel bars and concrete is prone to form microscopic or even macroscopic bubble defects, and the corrosion medium is prone to gather here and cause strong local corrosion [6].

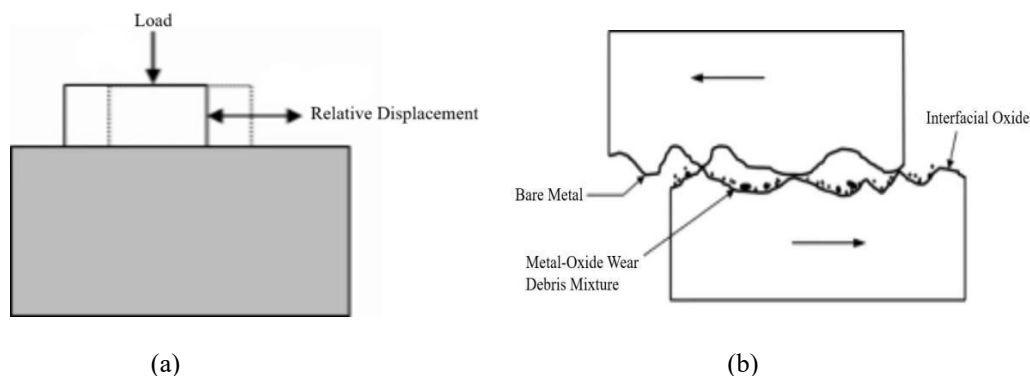
Fig. 2: Schematic diagram of contact corrosion (a)Contact corrosion generation conditions (b)Contact corrosion interface

Contact corrosion occurs where two different metals come into contact. The specific schematic diagram is shown in Figure 2. For prestressed concrete structures, contact corrosion mainly occurs in post-tensioned prestressed reinforced concrete structures, which affects the fatigue performance of prestressing bars. According to Fontana's research[20] the following conditions must be met for the occurrence of contact corrosion:

- (a) The contact interface must be in a stressed state;
- (b) The contact interface must undergo repeated displacement misalignment;
- (c) The load and displacement of the contact interface shall cause relative slip and deformation on the two metal contact surfaces, and the slip and deformation shall be controlled within a smaller range.

The displacement staggering that causes contact corrosion can be as small as  $10^{-7}$  mm. If oxygen is also present in the displacement staggering area, it will cause wear and corrosion of the metal contact interface. In post-tensioned prestressed concrete, there will be displacement and dislocation between the anchoring end of the prestressed member and the prestressed. The prestressing bars in the bending prestressed steel bundle section and the pipeline will cause displacement and dislocation due to alternating loads. The displacement and dislocation between the prestressing bars and the stressed rib connectors and the prestressing bars will also occur due to alternating loads and solar radiation. Contact corrosion is very likely to occur at the location of the above-mentioned prestressed concrete structure. Fatigue cracks in prestressed bars will also cause during contact corrosion. Fatigue cracks can occur prematurely due to a combination of surface damage (from contact corrosion) and very high local contact stress

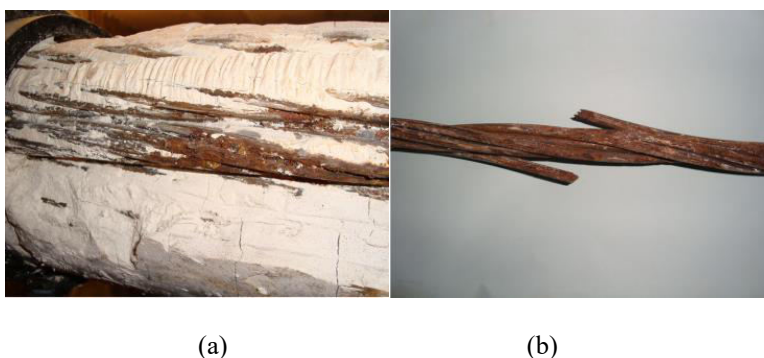
Fig. 3: Prestressing bar corrosion in white grout body in extracorporeal prestress cable[16] (a)White paste-like substances isolated from grouting bodies (b) Rust-broken prestressing bars

In addition to the above common corrosion, some scholars have discovered a relatively special corrosion situation in the external prestressing bars, as shown in Figure 3.

This corrosion mainly occurs at the highest part of the box beam prestressing bars near the anchor end. The cement mortar slurry poured by the prestressed pipeline at the rust location is uneven. The bottom of the pipeline is gray hardened cement slurry, the middle is a white crumbly slurry part, and the upper part is a moist white paste substance, which becomes brittle after hardening. It was found that prestressed bars often have serious corrosion in the isolated white paste substances. Through the chemical analysis of this substance, it is characterized by alkaline pH and high content of sulfate ions, and does not contain any chloride ion components.

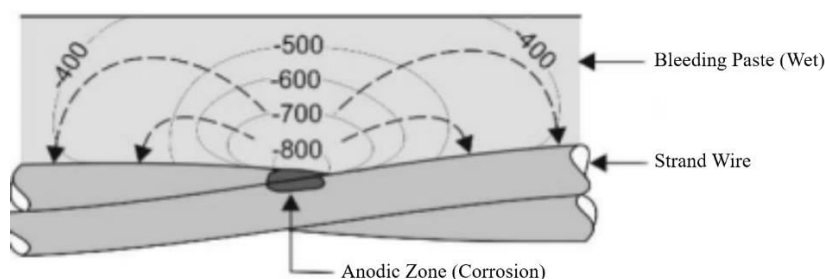
Fig. 4: Schematic diagram of prestressing bar corrosion in high alkaline environment[13-25]

caused by concrete carbonization, because the segregated slurry around the corrosion prestressing bars are highly alkaline, and the prestressing bars show obvious pit corrosion forms, which is different from the uniform rust caused by carbonization. In addition, there are a large number of rust products on the rusted prestressing bars, which shows that prestressed corrosion is generated through the dissolution process rather than the development of cracks. The fractured prestressed steel wire has no brittle fracture (only tough fractures are observed in the area not covered by the corrosion product), and there is no secondary crack caused by hydrogen embrittlement expansion on the outer surface of the prestressed steel wire. From this we can see that this type of corrosion does not belong to the type of stress corrosion and hydrogen embrittlement corrosion. Bertolini and Carsana[22] studied the mechanism of this type of corrosion through a series of experiments. The wet segregation slurry dissolves the alkali ions and forms an alkaline solution with a pH value of close to or above 14. There are gaps between the wires of a single prestressed steel strand and between adjacent prestressed steel strands.

The available environment of low oxygen generated in the gap is similar to the conditions of gap corrosion and is the cause of initial rust of prestressing bars. The alkaline environment and sulfate ions in the separating slurry will accelerate the occurrence of initial rust of prestressed bars. The subsequent corrosion development is mainly caused by corrosion of macrocells. Macrocells are mainly formed by deblunt zones, passivation zones and conductive separators around the prestressing bars, as shown in Figure 4. Initial corrosion usually starts from the contact point between the steel stranded wires, the area of the deblunt zone is very small (i.e. the anode area), while the passivation area of the corresponding steel stranded wire (the cathode area) is very large. The smaller the area ratio between the anode and the cathode, the higher the penetration rate of corrosion. The resistivity of the segregated slurry is a key factor affecting corrosion and is affected by the composition of the slurry, microstructure and its moisture content. The isolated slurry has a fairly low resistivity due to high ion content ( $\text{Na}^+$ ,  $\text{K}^+$ ,  $\text{OH}^-$ ,  $\text{SO}_4^{2-}$ ) and low hydration (high void ratio) under wet conditions. Under the influence of the above factors, the prestressed tendon pits in the segregated slurry are significantly corroded.
