Structural Assessment and Performance Evaluation of Structural Integrity and Providing Remediation Strategies

ABSTRACT: This study presents the structural assessment of a G+7 reinforced concrete (RCC) building located in Seismic Zone III (Thane, India) to evaluate its safety and serviceability. The analysis was performed using STAAD Pro, considering dead, live, seismic (IS 1893:2016), and wind loads (IS 875 Part 3). Structural adequacy was verified through Demand-to-Capacity (D/C) ratios as per IS 456:2000, with all values within permissible limits. Non-destructive testing using the rebound hammer method estimated in-situ concrete strength. Results from deflection, shear, and bending moment analysis indicate satisfactory performance. The building is structurally stable, requiring structural repairs for improved durability.

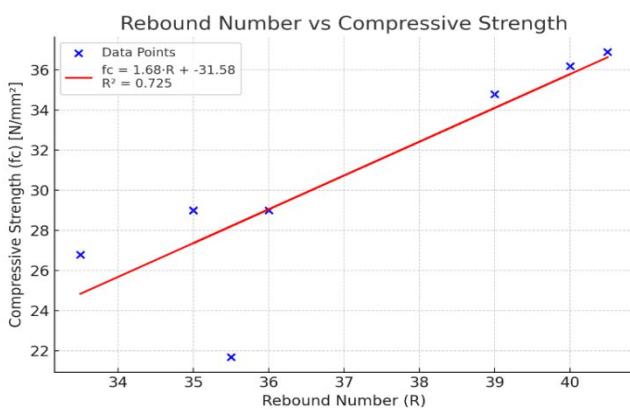
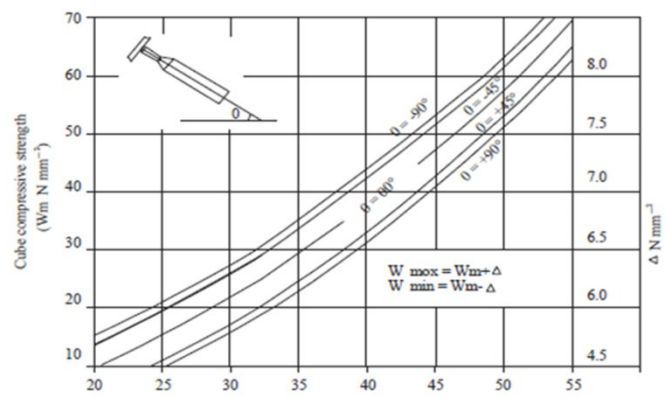
Figure: - 3 Rebound number and compressive strength

ID	Location	Avg. Rebound index	Comp Strength (N/mm ²)	Direction	Surface
C-1	Ground	33.5	26.8	Horizontal	Dry
C-2	Ground	40.0	36.2	Horizontal	Dry
C-3	Ground	39.0	34.8	Horizontal	Dry
C-4	Ground	35.0	29.0	Horizontal	Dry
C-5	Ground	36.0	30.4	Horizontal	Dry
C-6	Ground	35.0	29.0	Horizontal	Dry
C-7	Ground	35.5	21.7	Vertical Up	Dry
C-8	Ground	40.5	36.9	Horizontal	Dry

Parameter	Value
Number of data points (n)	8
Sum of rebound (r)	294.5
Sum of strength (fc)	243.4
Sum of (r*fc)	9041.8
Sum of r ²	10889.75
Mean compressive strength	30.42 n/mm ²
