The Collapse World Trade Center Building 7

Auysh Dubey, Ankur More, Ganesh Yewale , Prof. Shivkumar Hallale

Department of Civil Engineering, Dr. D. Y. Patil Institute of Engineering Management and Research, Akurdi,
Pune, India

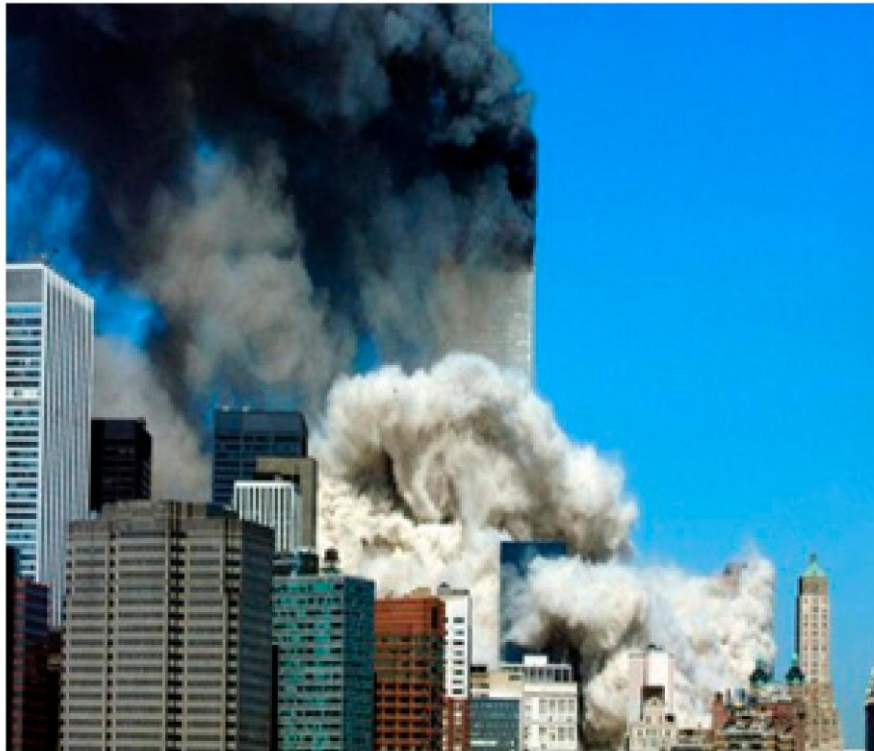
. To use the FDS simulation for structural analysis, a desirable but consistent temperature setting of 1 hour at 800 ° C and 1 hour cooling at 20 ° C was used [9]. This method was based on the level of the ceiling level in most monitoring areas throughout the eastern region of the navel, and despite its simplicity, it calculated the type of fire movement, pre-heating, and energy conservation. Considering the fire protection used, especially considering that the space between the ribbed floor slab and gutters was left blank with SFRM, heat transfer analysis was performed at the University of Edinburgh.

The collapse of WTC 7 according to NIST models and the investigation launched primarily, due to the failure of the connection. The connection between the inner column 79 and the belt connecting it to the perimeter 44 column failed with the release of the belt during the heating phase. East of column 79, many lower beams have lost direct support or lateral torsional flexion. Heavy heat and restricted expansion of the floor slab caused the rest of the floor to lose its strength by crushing the concrete, and severely weakened the fire floors resulting in a small, unstoppable collapse and led to the collapse of the floor that left column 79 unsupported. The 9 floors that cause its failure to collapse caused the kink seen in the folded video. The binding of column 79 was followed by the same failures of columns 80 and 81, as well as the further collapse of the adjacent column lines. The obvious installation of the interior of the building was followed by a perimeter failure from the area near the entrance of the major WTC1 damage to the southwest of the building. The circular columns failed in rapid succession and complete structural failure occurred.
