Volume 5, Special Issue 6, May 2016

NATIONAL WORKSHOP ON DISASTER MANAGEMENT (August 29th & 30th, 2014)

Rehabilitation of Flood Eroded Tea Land – A Field Study in North – East India

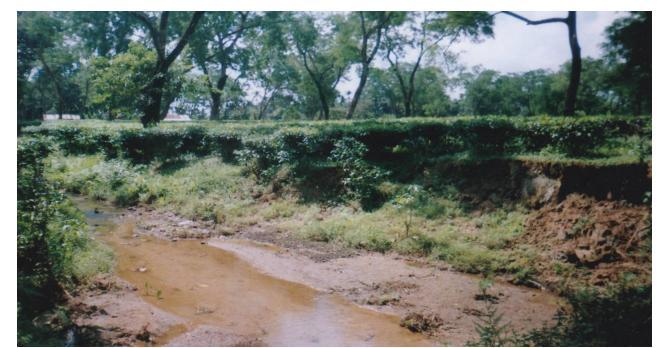
Flood was found one of the most devastating natural calamities, badly affecting tea gardens in north east India. First wave of flood was in first week of June, during previous years. |After that, there were several intermittent spells of flood depending on intensity and frequency of precipitation. Two characteristics of flood were found during study. The flood water from river or stream entered plantation with a high velocity, inundating large area, within a short time and raised level of water. It was found a specific characteristic of flood. Due to that tea bushes and even good amount of fertile soil were washed off in its current. This was found severe in sloping tea land. In second type, silt was carried by flood water, which was deposited on surface of soil. Debris materials like sand, etc were also brought along with silt. Due to that there was loss of productivity of soil. The drains were found congested with silt, debris materials, etc. The severe and unmanageable problem was due to sudden increase in volume of rain water. A badly eroded drain by flood water is shown in Fig. 1.

Fig. 1. A badly eroded drain.

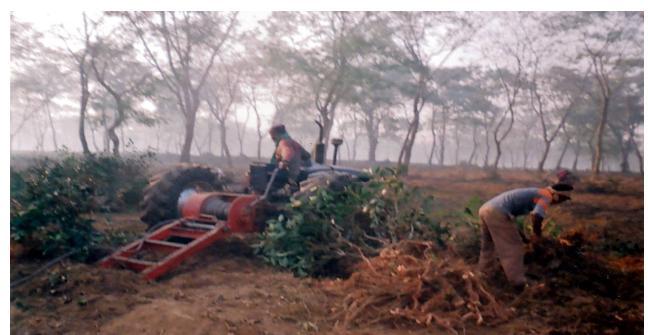
Digging soil for uprooting flood affected tea bushes in haphazard manner by engaging a group of labourers was found highly uneconomical, susceptible to soil erosion and time consuming. The soil erosion was more serious on slope. The stagnated water in depressions and pits, dug by labourers was found hinderance for next field practice, as soil was moist. The tractor mounted with scraper could be utilized for clearing field from all kinds of debris materials. The winch fitted on tractor was needed for uprooting tea bushes with little disturbance to soil. It was found quite capable to uproot 7 to 8 tea bushes at a time, when soil moisture content was 15 to 16 per cent. Which was found optimum for this operation. The tractor mounted with winch was found capable to pull out all the roots and rootlets at this moisture content of soil and no further digging was required, Fig. 2.

Fig. 2. Uprooting tea bushes with tractor.

It was found during study that root fragments left in subsoil were found inviting harmful insects. After uprooting tea bushes, all pits, depressions, etc were earth filled with the help of tractor mounted leveler, then land was smoothened. Also, loose soil was packed with the help of planker or packer. It was found necessary to check soil erosion as rain was uncertain. It also, facilitated to mark contour lines and then carry out subsoiling. The application of farm yard manure at the rate of 15 to 20 quintals per hectare was found beneficial. The land was harrowed after mixing farm yard manure. After soil preparation land was again operated with the help of packer to make it level. Then contour lines were marked on the level ground manually. The subsoiling was recommended along contours to check loss of soil by runoff water.

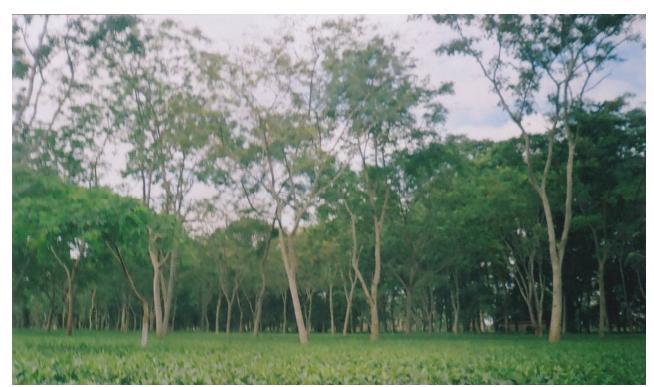
Then a tea plantation of adjoining area, having shade trees planted 10 to 11 metre apart was visited. Shade trees were found beneficial for the growth of tea bushes in a variety of ways such as addition of organic matter and nutrients to soil through leaf fall, fixation of atmospheric nitrogen by nodules of roots (in case of leguminous shade trees), conservation of moisture in soil, reduction in incidence of red spider and other mites, suppression of weed growth, provision of comfortable shade to labourers and so on. Albizzia chinensis and Albizzia adoratissima shade trees were found fixing atmospheric nitrozen to soil by their nodules of roots. Their roots were found going deeper into soil to extent of 3 to 5 metre beyond root depth of tea bushes, which was 1.50 to 1.75 metre only. Due to that absorption of nutrients by shade trees was from deep soil. The maintenance of favourable and conducive environment, protection of soil from flood water, etc were found benefits derived from shade trees planted in flood prone tea area, Fig. 3.

Fig. 3. A plantation having shade trees.
