An ISO 3297: 2007 Certified Organization Volume 7, Special Issue 7, June 2018 One Day National Conference on "Recent Trends in Mechanical Engineering & Applied Sciences 2018"

Erosion of HVOF Sprayed (CrC-Ni Cr Fe Si)Coatings of Comparison with Substrate Metal SS-306

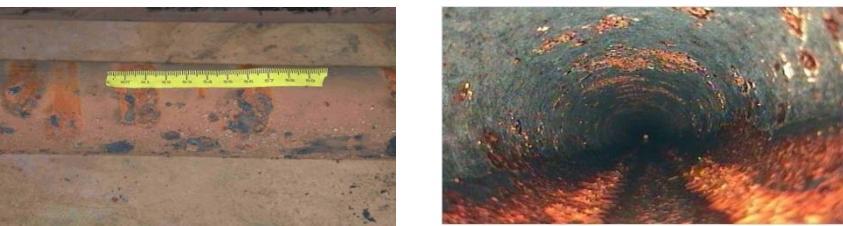
Fig 1.1 Erosion on Metal Surface

Erosion results from impact of particulates, such as coal ash, dolomite and unburned carbon particles on the surface of heated boiler tubes. It is generally believed that the most erosive species in the fly ash are quartz, which is a crystalline from of SiO_2 . More than one quarter of all the boiler tube failures worldwide are caused by fly ash erosion [5,6].

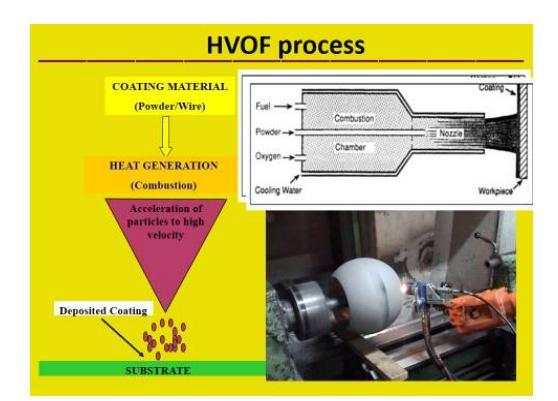
Fig 2.1 Block Diagram of HVOF Process

- HVOF is a method of propelling molten particles on to work surfaces for each coating. As an essential feature of thermal spray coatings, sprayed particles upon and after impact deform so as to interlock with the impact surface's profile. While the initial thermal spray technology focused on guaranteed deformation through excessive heating, a new method is introduced with the high velocity of HVOF.

- A small chamber is used to create supersonic velocity of exhaust. The focused exhaust stream receives the powder material at a velocity that the resultant impact forges adequate bonding. In fact, the impact from the kinetic energy is so great that most of the porosity is eliminated. As such, the less porous coating provides the best wear resistance and densest coatings available. The HVOF thermal spray process uses the combustion gases such as propane, propylene hydrogen or a liquid fuel such as a kerosene fuel and oxygen.[1],[2],[3],[5]

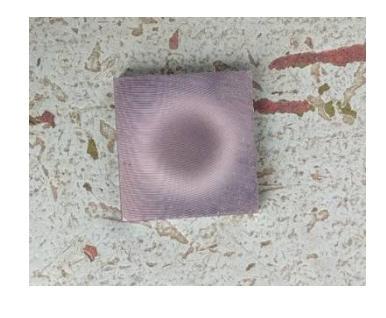
Cycle	Initial	Final
5	15.6445	15.6440
10	15.6440	15.6395
15	15.6395	15.6393
20	15.6393	15.6392
25	15.6392	15.6392

Fig 4.1 Erosion Test for 30⁰

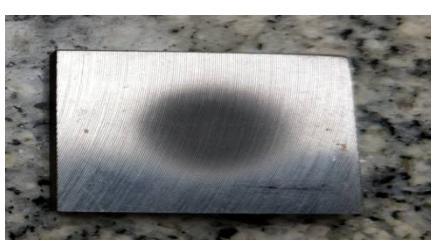
Cycle	Initial	Final
5	19.6329	19.6326
10	19.6326	19.6324
15	19.6324	19.6323
20	19.6323	19.6323

Fig 4.2 Erosion Test for 60°

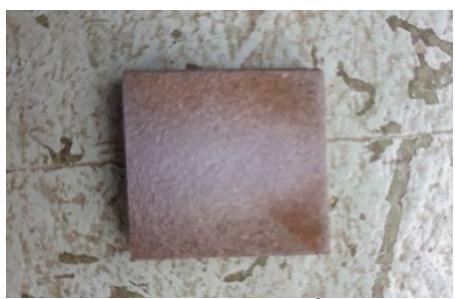
Cycle	Initial	Final
5	16.574	16.5712
10	16.5712	16.5699
15	16.5699	16.5619
20	16.5619	16.5619
25	16.5619	16.5619
30	16.5619	16.5619

Fig 4.4 Erosion Test at 30^o

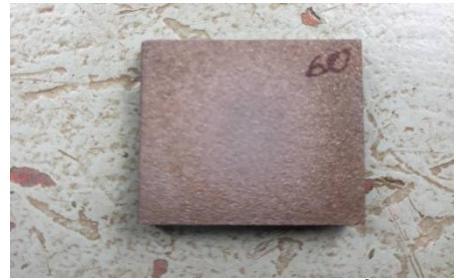
Cycle	Initial	Final
5	21.847	21.8467
10	21.8467	21.8466
15	21.8466	21.8464
20	21.8464	21.8457
25	21.8457	21.8454
30	21.8454	21.84539

Fig 4.5 Erosion Test at 60⁰

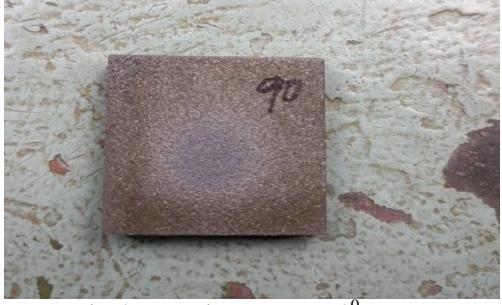
Cycle	Initial	Final
5	21.84539	21.8448
10	21.8448	21.8438
15	21.8438	21.8430
20	21.8430	21.8423
25	21.8423	21.8418
30	21.8418	21.8417

Fig 4.6 Erosion Test at 90⁰

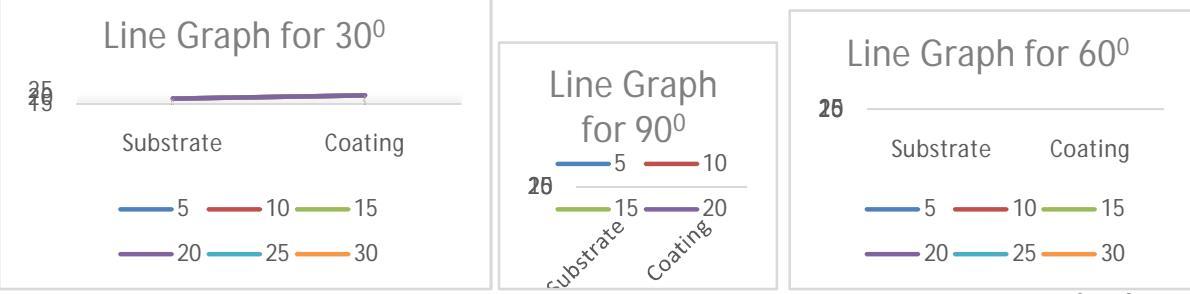
4.1.1 Graph for Coating and Substrate at 30° , 60° and 90°

Explanation: From the above graph the erosion rate increased in coating compared to substrate at 30° , 60° and 90°

- Substrate steel exhibit slower steady state volume erosion rate in comparison to HVOF sprayed CrC -NiCrFeSi coatings under similar test conditions. The higher hardness ratio between silicon erodent particle and substrate steel might have caused the penetration of silica particles into the surface.

- Erosion rate with respect to angle of impact is maximum at 30degree and minimum at 90degree. Erosion rate with respect to stand of distance is maximum at 100mm and lower for 200mm. This implies that lower the stand of distance greater is the rate of erosion.

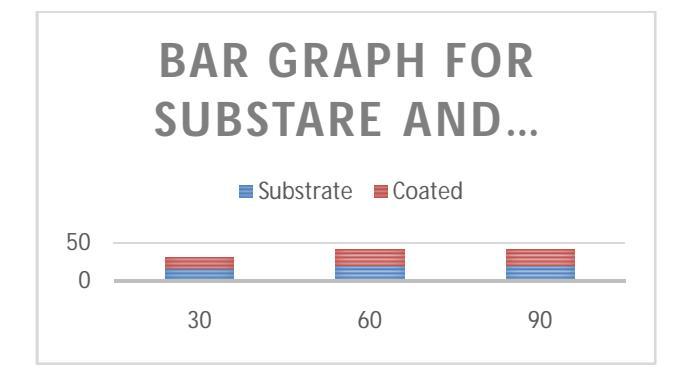
Explanation: Bar Graph shows the erosion rate of Substrate and Coated materials.
