Rehabilitation Methods and Materials for Chloride Induced Corrosion of Offshore Structures

A.A. Surawashe¹, Dr. M.B. Kumthekar²

ABSTRACT: Marine conditions are the most aggressive conditions exposed to reinforced concrete. To provide proper repairs and rehabilitation measures one needs to have a clear understanding of the distress mechanism in such environment and proper construction methods to be adopted. chloride induced corrosion is the primary cause for deterioration of concrete in sea structure. The paper presents some of the materials that can be used to counter this mechanism of distress. However, the method to be adopted will be influenced on extend to damage to structure.

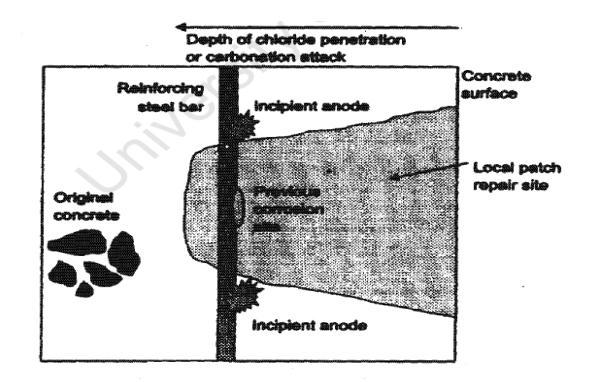
Figure 10: A typical patch repair

1. Concrete removal and surface preparation.

The first step is to remove the surrounding concrete to expose all the corroded rebar. The purpose is to remove only the damaged concrete without damaging the remaining concrete. You can use a light power chisel with a hand hammer. When the chisel is complete, use a hand wire to remove the debris and then use compressed air to remove the loose particles. The surface should remain rough and clean to ensure good adhesion of the repair material to be applied later.

3. PATCH APPLICATION.

In terms of materials, repair mortar is used as an alternative to original concrete. It is usually a cement-based slurry containing fine aggregates or even microfiber reinforcement. Some of the materials that can be selected as patch repair material are

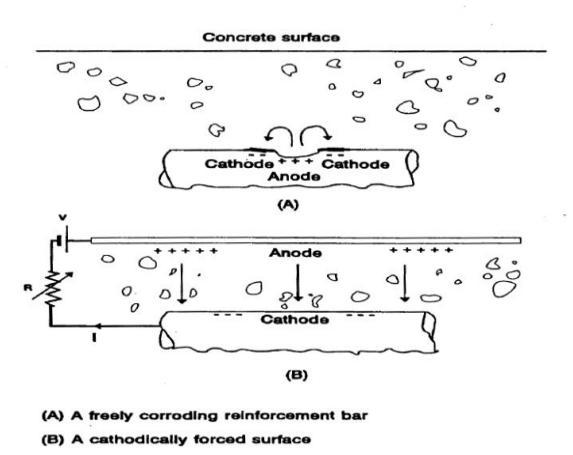
Figure - working of cathodic protection

Corrosion of steel is caused by the formation of electrochemical cells. Because concrete acts as a coupling electrolyte, an anodic reaction occurs at some point on the steel surface, and the cathodic reaction consumes dissolved electrons in the rest of the steel surface. The presence of chloride ions causes local passivation. A small external current shifts the potential between steel and concrete to critical levels. Therefore, the electrons imprinted on the steel cause the steel to

function as the cathode of the electrochemical cell. One method of cathodic protection is, for example, to apply a conductive overlay to the deck of the bridge and apply an applied current between the overlay and the rebar to effectively re-immobilize the steel. The potential shift caused by direct current is very important for cathodic protection. Due to the high resistivity of electrolytic concrete, it is necessary to evenly distribute the protection current throughout the structure.

The main advantage of this system is that once activated, it can completely stop the corrosion process, providing a permanent solution even if more chloride can penetrate. In fact, the concrete on top is electrochemically highly conductive, so this concept works better in the presence of chlorides.
