Flexible Pavement Assessment of Selected Highway in Srinagar Local Government, Jammu and Kashmir, India

KEYWORDS: Geotechnical Analysis, Manual Survey, Subgrade Material.

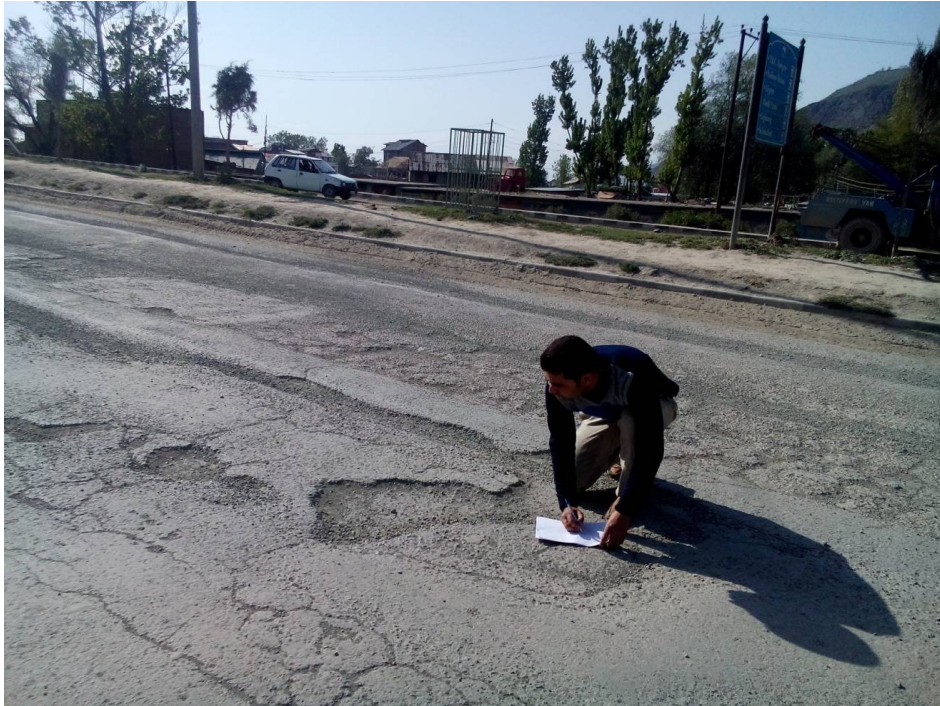
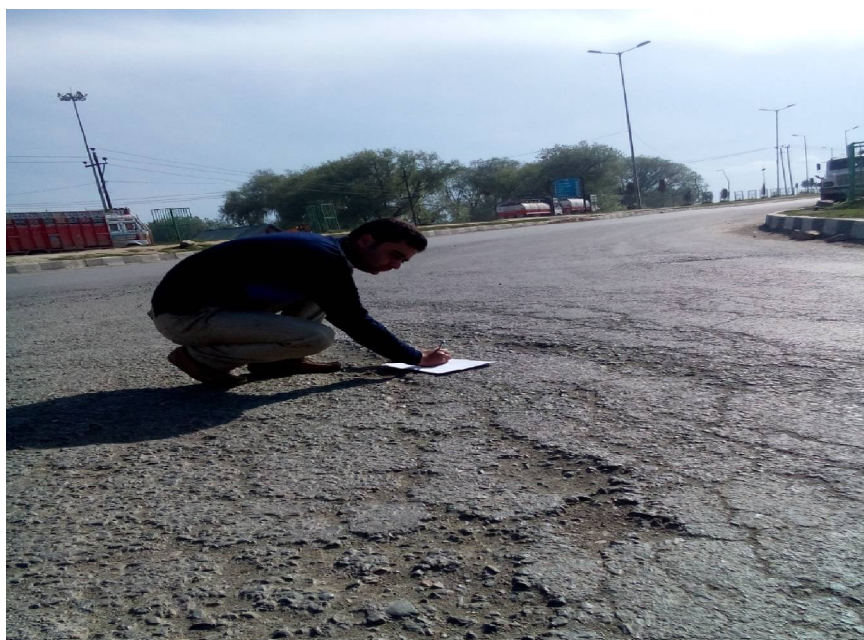
APPENDIX

The manual surface distress mapping method was carried out for 7 roads so as to determine the extent of failure of the road. The predominant distress failure on the road is Pothole and cracks. The Survey was carried out for 50m of the road RD5 and RD4 are in good condition, with little distress on the pavement surface in some road area. RD1 and RD2 are in fairly good state condition while RD6 and RD7 are in very poor state. During the survey, road furniture such as shoulder, walkway and median were invariably absent in all roads as specified by the Highway Manual.

Route	Description	Length of	Wide of	Predominate distress	Severity No.
RD1	Panthachowk	36	7.30	Cracks	Severe
RD2	Lasjan	1	8.2	Longitudnal cracks	Low
RD3	Railway	0.5	8.3	Pothole	Severe
RD4	Pohru chowk	0.7	8.0	Pothole	Low
RD5	Nowgam	0.4	8.64	Longitudinal cracks	Low
RD6	Chanapora	0.7	8.0	Pothole	Extensive
RD7	Sanatnagar	0.8	7.4	Pothole	Throughout
