International Journal of Innovative Research in
SCIENCE | ENGINEERING | TECHNOLOGY

Seismic Analysis of Multistory Building by Using the is 1893:2016 Having Stiffness Irregularity in RCC Structure and Composite Structure

Sandip B. Chavan¹, L. G. Kalurkar²

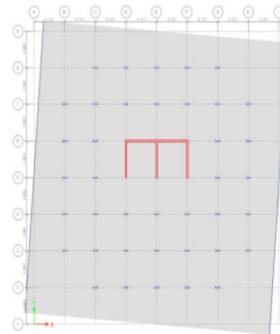
Figure 1: (a) Plan view of G+20 regular shaped building

(b) Plan view of G+20 building

(d) 3D view of G+20 building

(e) 3D solid view of G+20 building

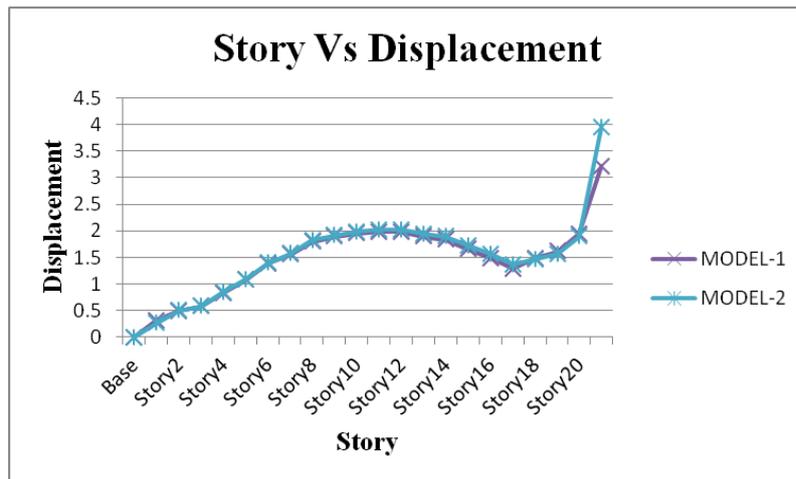
Figure 2: Story and Displacement graph

The two frames have been analysed and their lateral storey-displacements, storey drifts and base Shears have been computed to study the effects of irregularities on the vertically irregular frames. The results are presented and discussed hereafter. Below Table shows displacement of storeys of various frames in X-direction which is horizontal. These have been plotted and shown in graph.

It has been seen that Model-2 gets displaced the most since the lateral stiffness at its bottom two Storeys are quite less than other storeys.

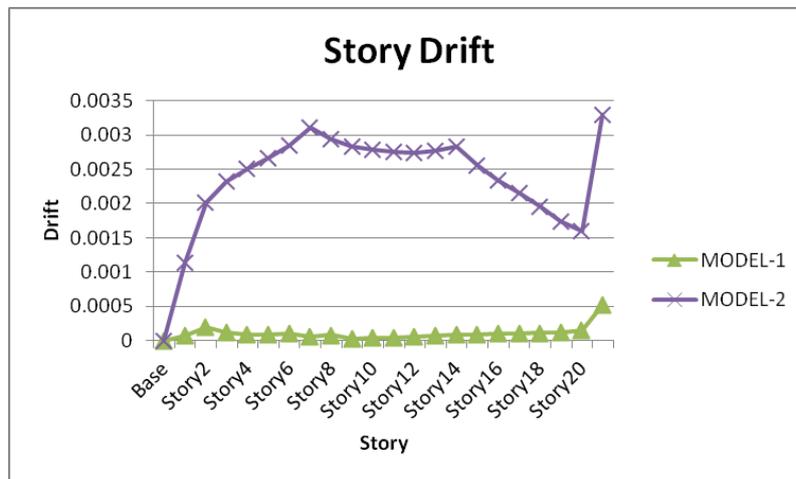
Figure 3: Story and Drift graph

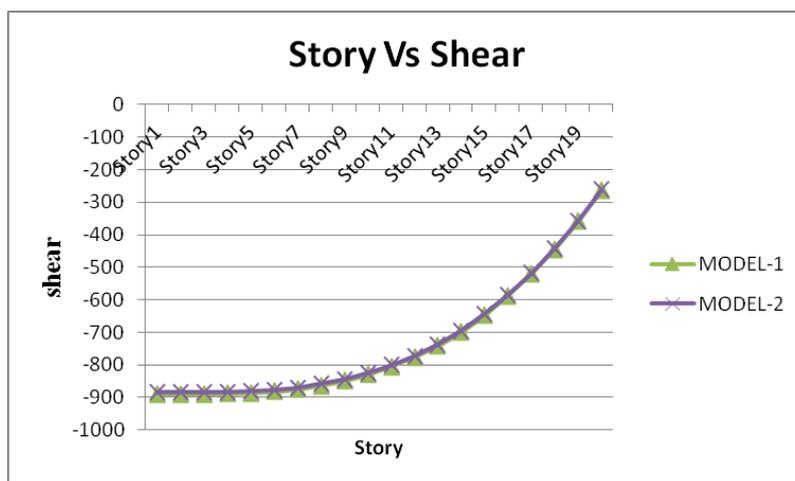
Figure 4: Story and Shear graph
